FIU bridge collapse, Miami FL Investigation of Failure (15/03/18) ~ Engineering aspects ~

(FESA presentation 22/08/19)

Geoff Fletcher CPEng
Temp Works Engineer
Euro Precast

Investigation of March 15, 2018 Pedestrian Bridge Collapse at Florida International University, Miami, FL

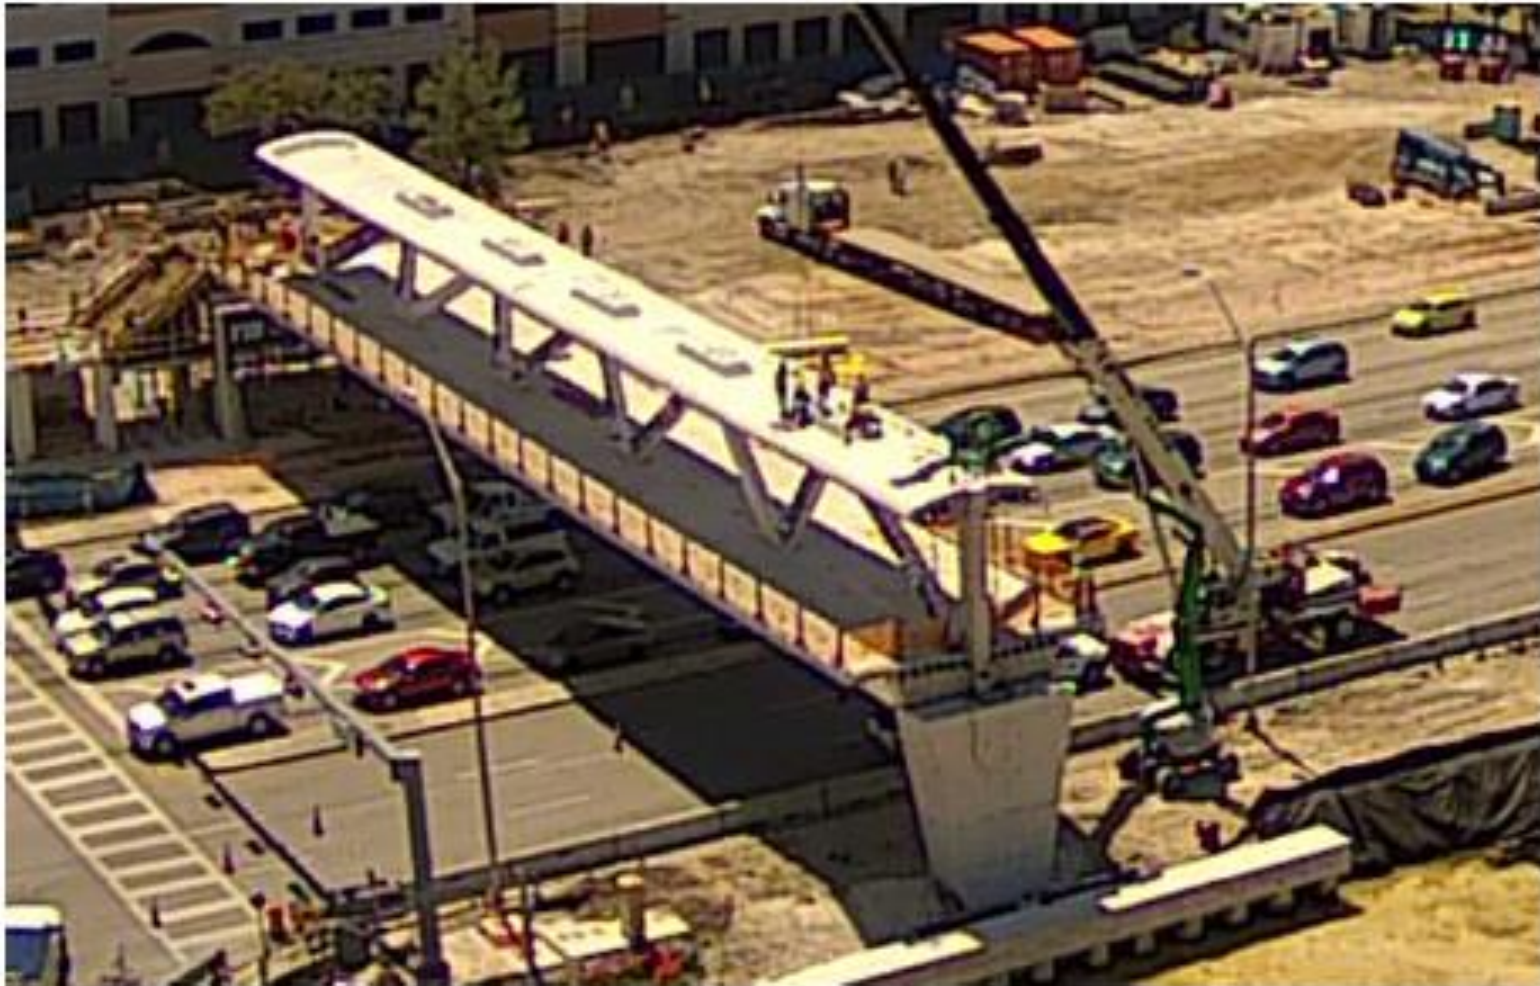
Figure 48 Bridge immediately prior to the collapse, March 15, 2018 – camera #2

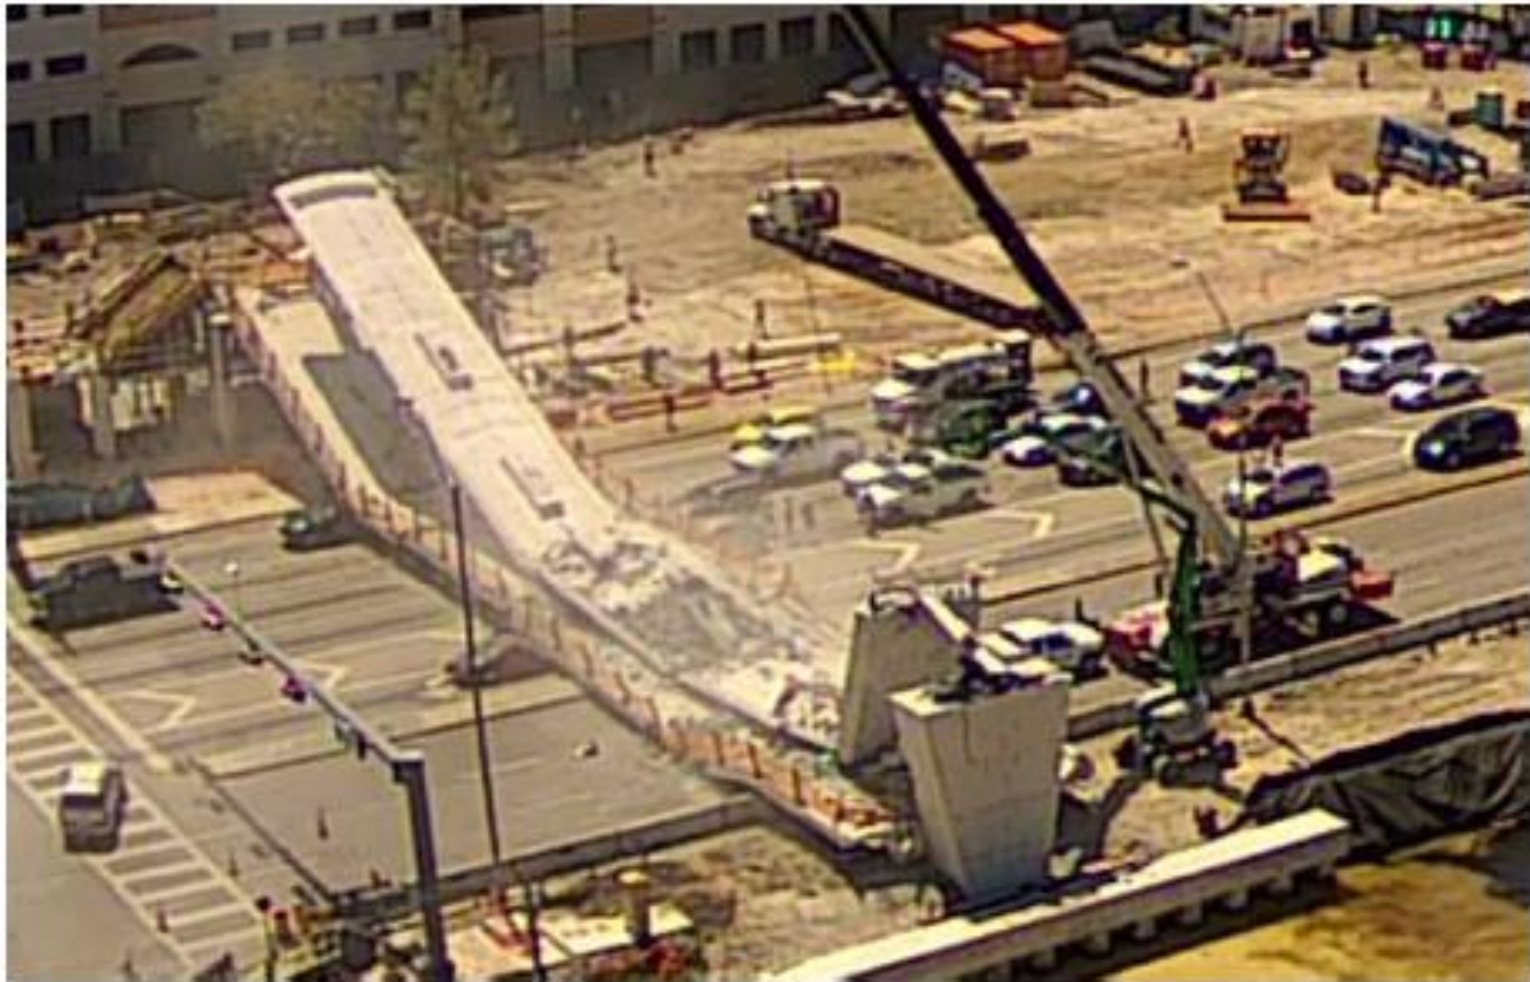
Figure 49 Bridge immediately after the collapse, March 15, 2018 – camera #2
Employees engaged in re-tensioning the PT bars in diagonal 11

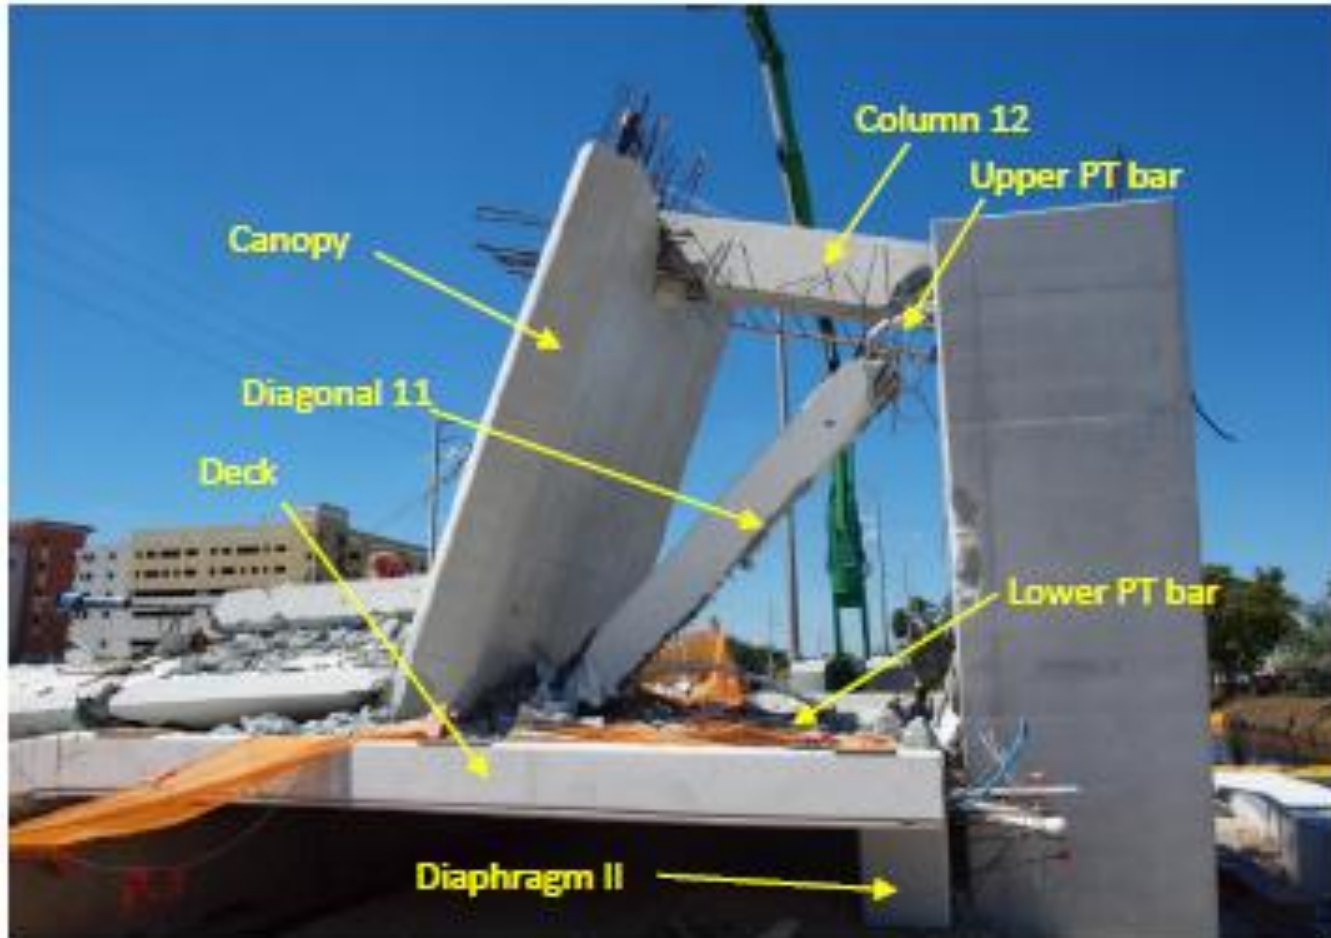
Figure 52 Column 12, diagonal 11 and part of the canopy after bridge deck and diaphragm fell to the ground, March 17, 2018, by OSHA

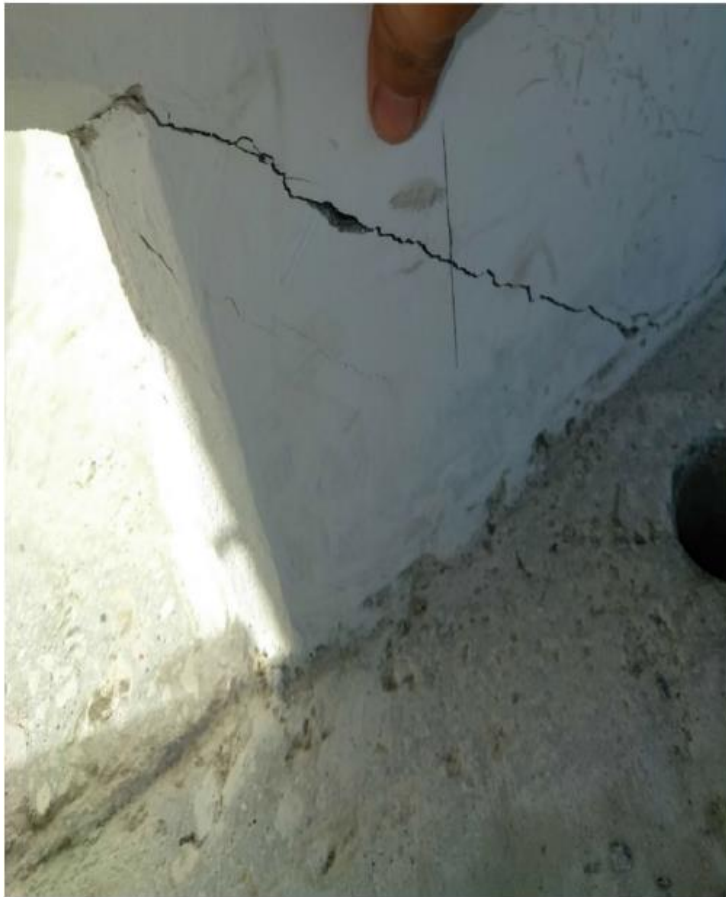
When the shores under the bridge were removed and the truss was self-supported over the mega shores, a loud popping sound was heard by at least three employees - one from The Structural Group (TSG), and two from MCM. The employee from the TSG and one of the employees from the MCM walked over the bridge and noticed cracks at the bases of diagonal 2 and 11.

Figure 18 Photo #4 in 2/28/2018 E-mail from MCM to FIGG

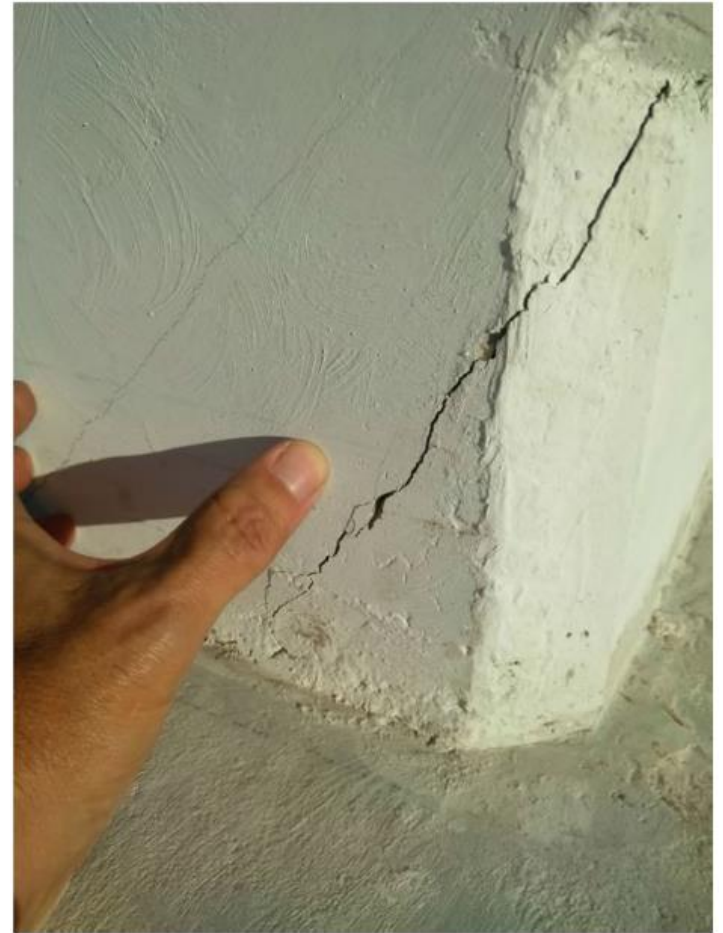
Figure 20 Photo #6 in 2/28/2018 E-mail from MCM to FIGG

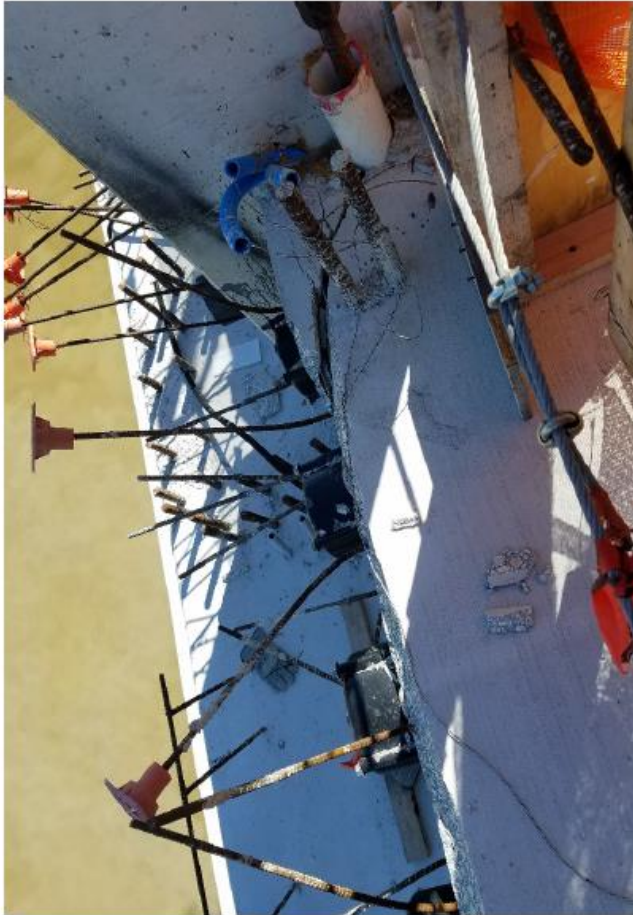
Figure 28 Diagonal cracks on the west side of diaphragm II on 3/13/2018, by BPA – top face

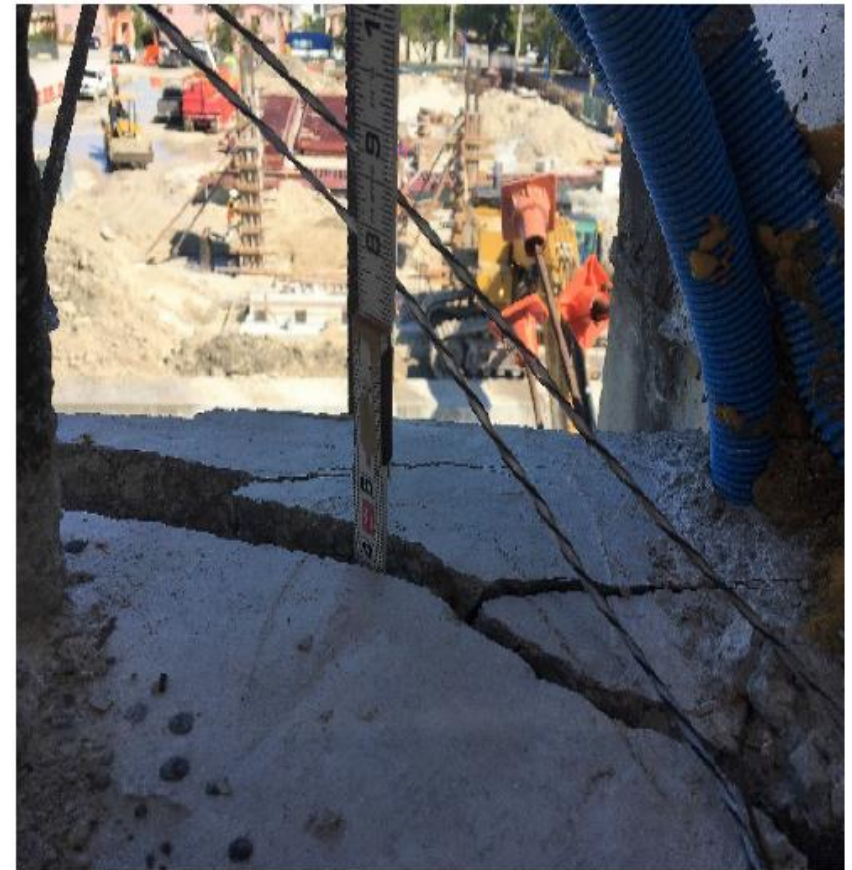
Figure 30 Notice the depth and width of diagonal cracks at the west side of diaphragm II on 3/14/2018 by BPA

4. The magnitude of the cracks warranted that SW 8th Street be immediately closed, and the concrete truss be shored and supported at multiple intermediate locations to reduce the loads in the north diagonal and the node until final evaluations were done and remedial measures implemented.

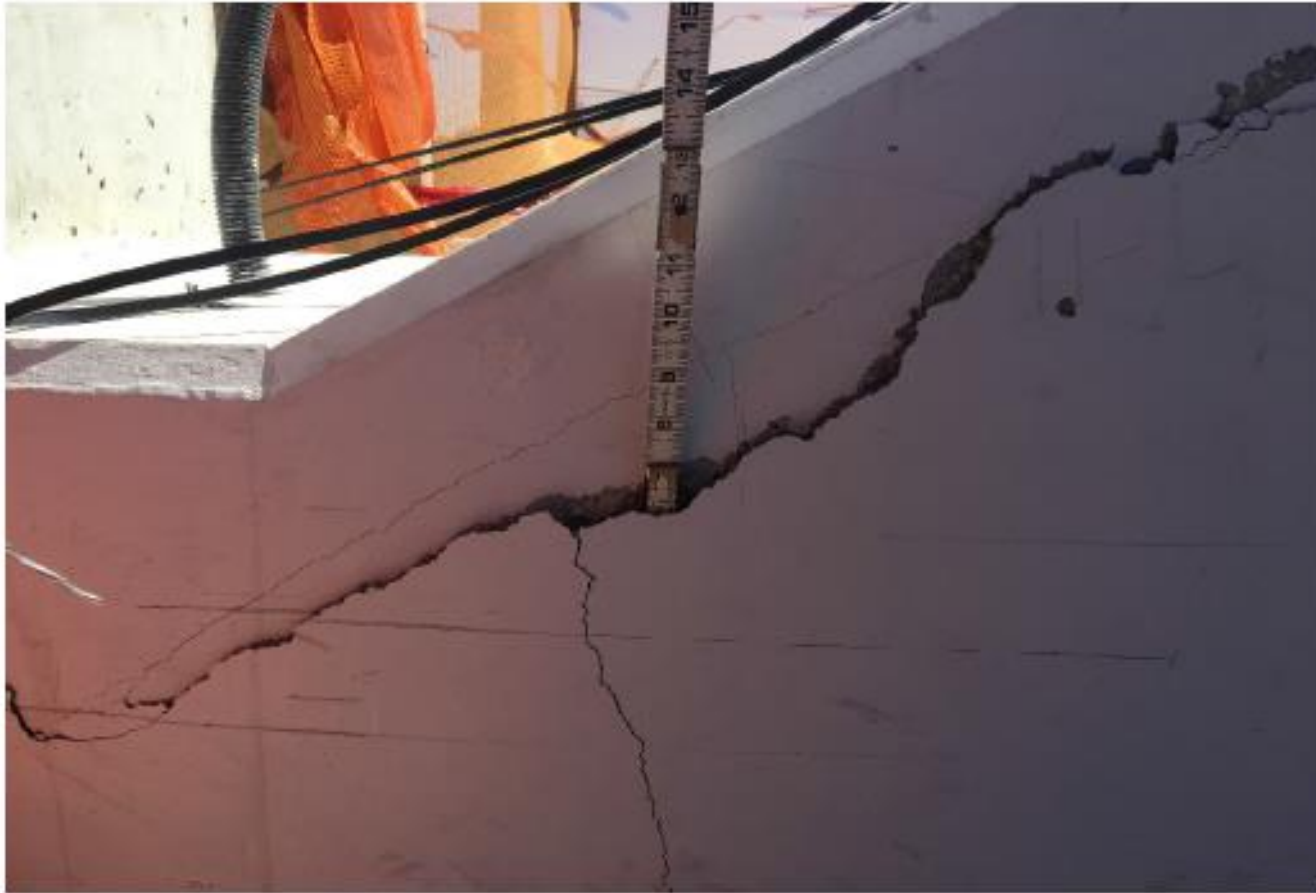
Figure 39 Close-up of longitudinal cracks in diagonal 11 on 3/14/2018 by BPA

2. The bridge had structural design deficiencies that contributed to the collapse during construction stage III. The cracks on the bridge occurred due to deficient structural design.

8. The evaluations of the cracks by EOR, and his recommendation to re-tension the post-tensioning bars of diagonal 11, were not included in the original design and therefore should have been subject to peer review.
