# Investigation of March 15, 2018 Pedestrian Bridge Collapse at Florida International University, Miami, FL

U.S Department of Labor  
Occupational Safety and Health Administration  
Directorate of Construction

June 2019

**Report prepared by**  
**Mohammad Ayub, PE, SE**  
Director, Office of Engineering Services  
Directorate of Construction  
OSHA National Office  
Washington, D.C.

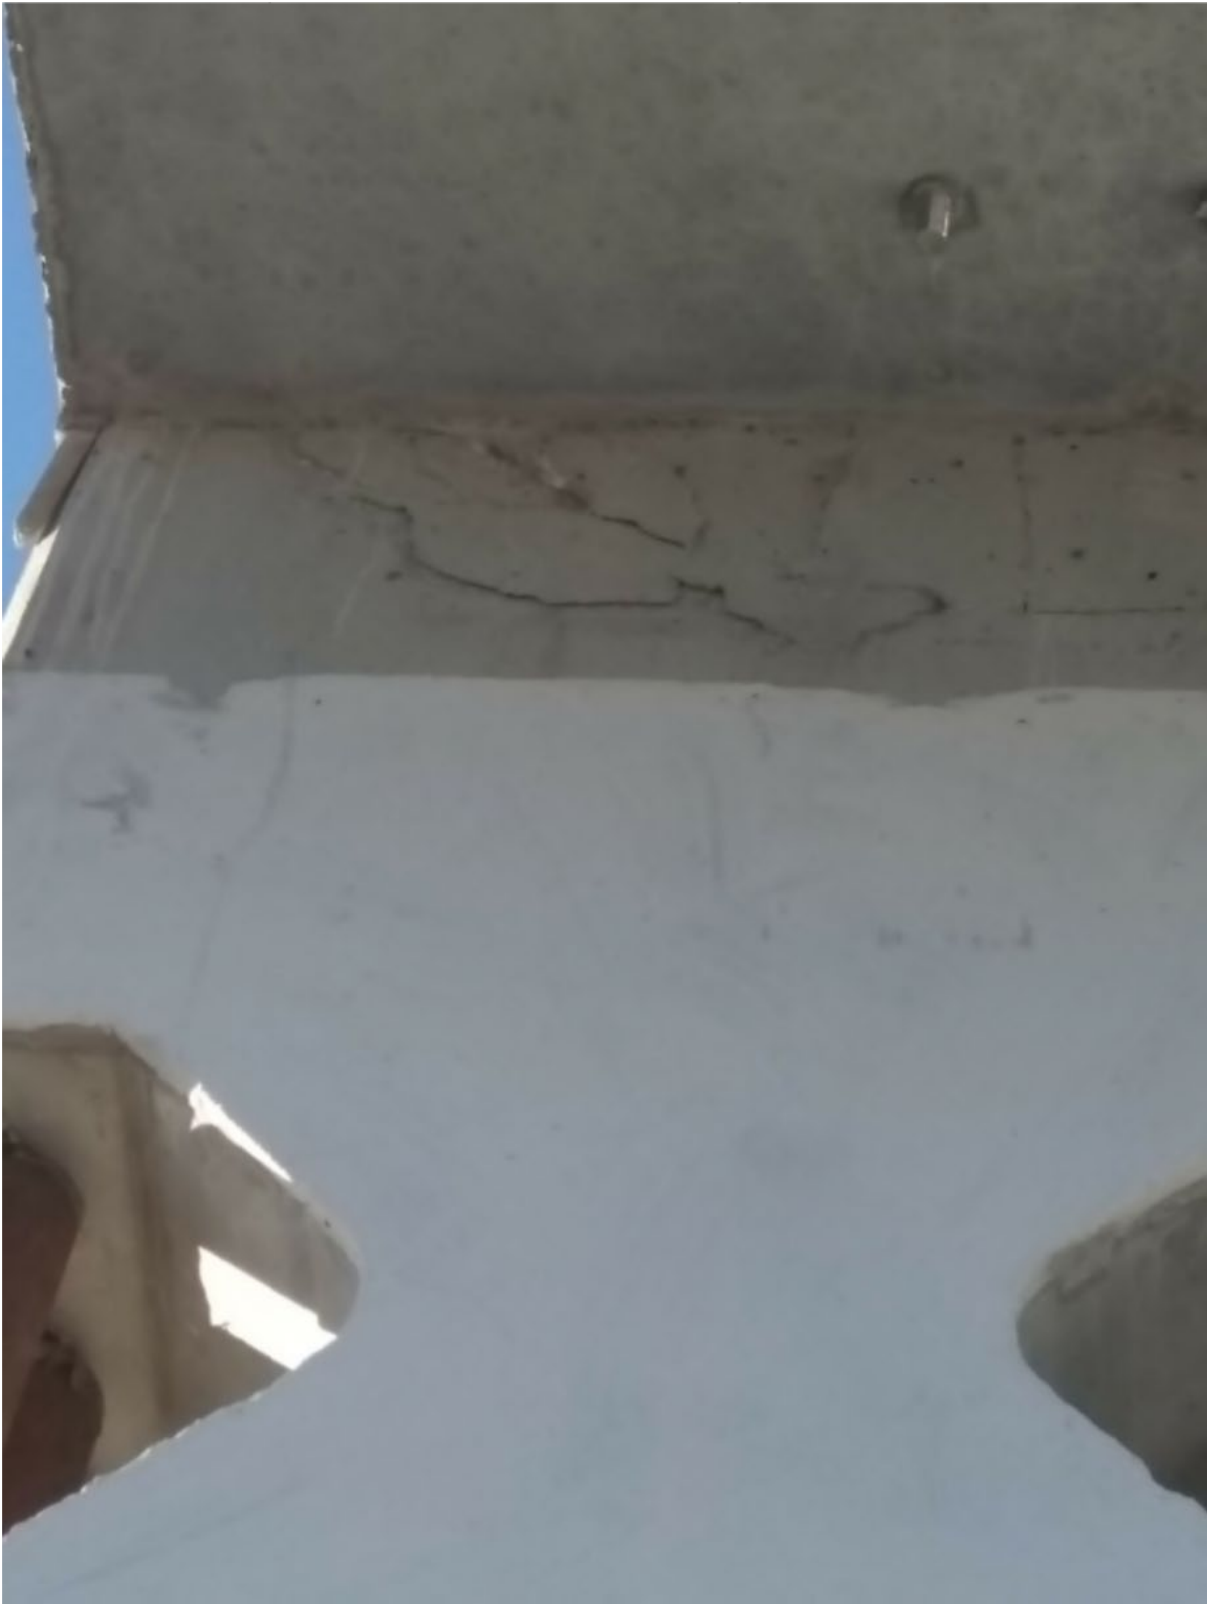
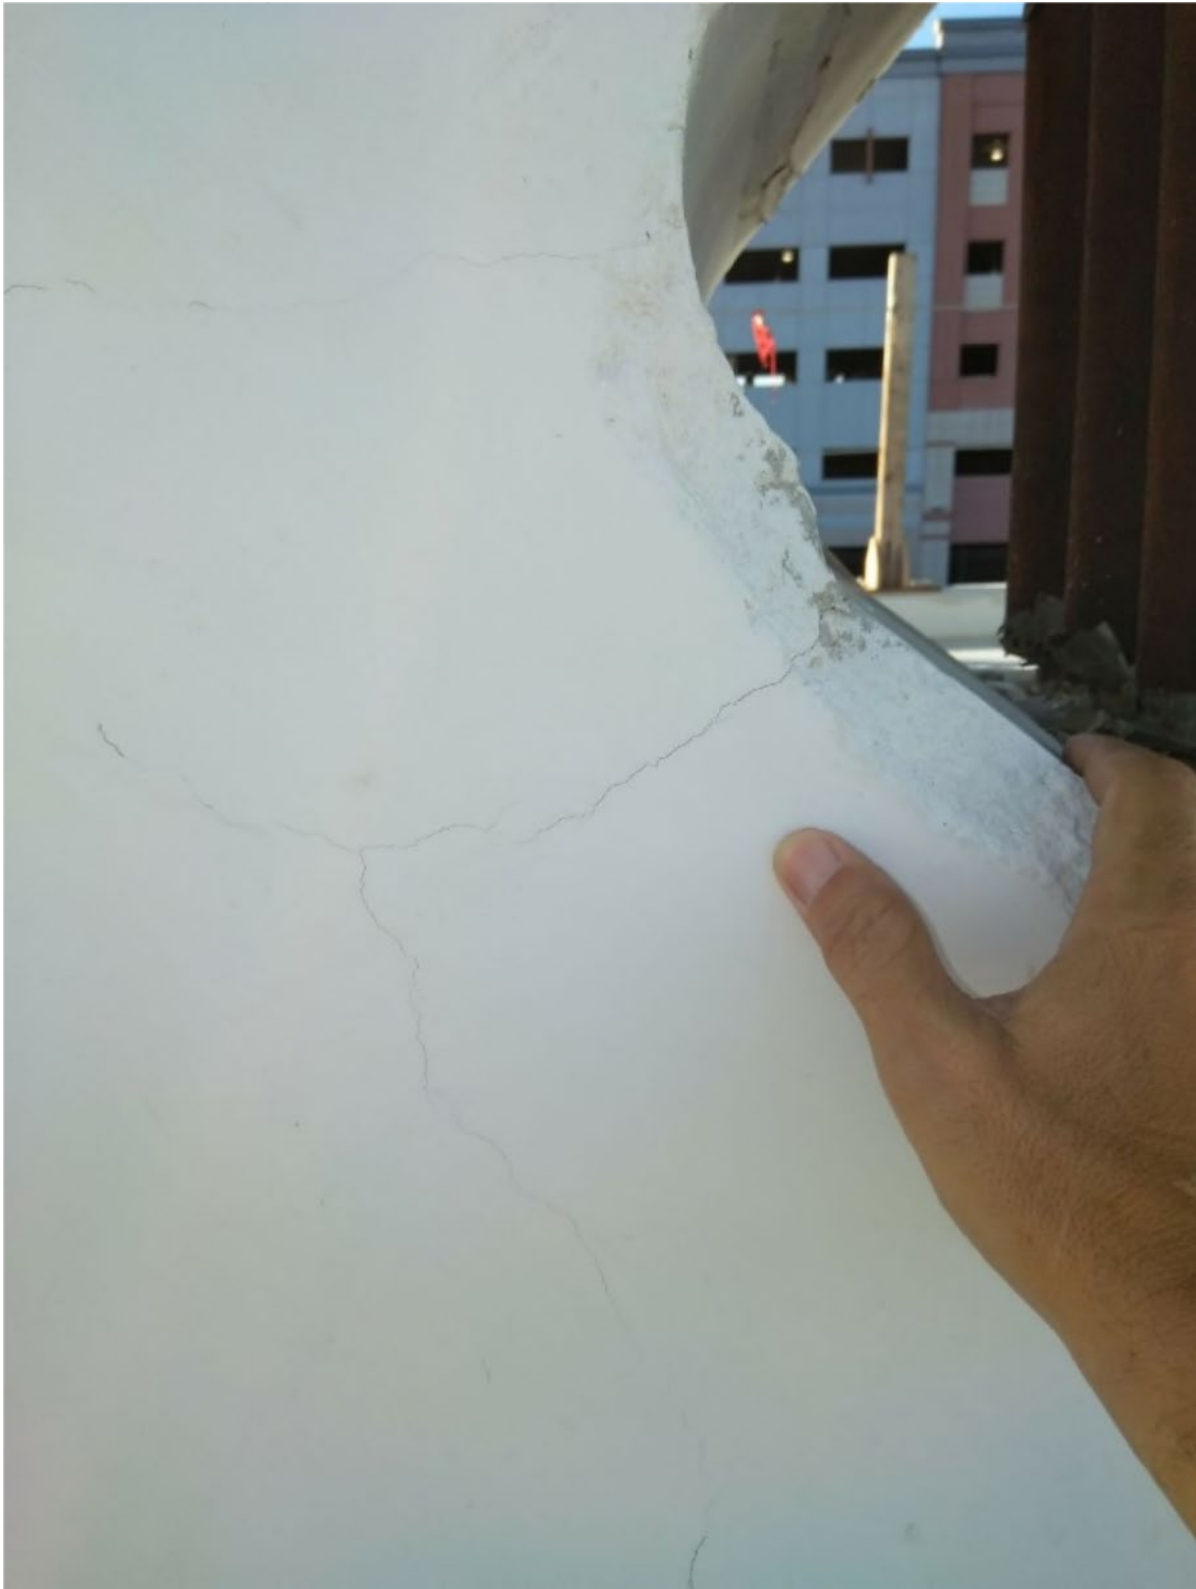
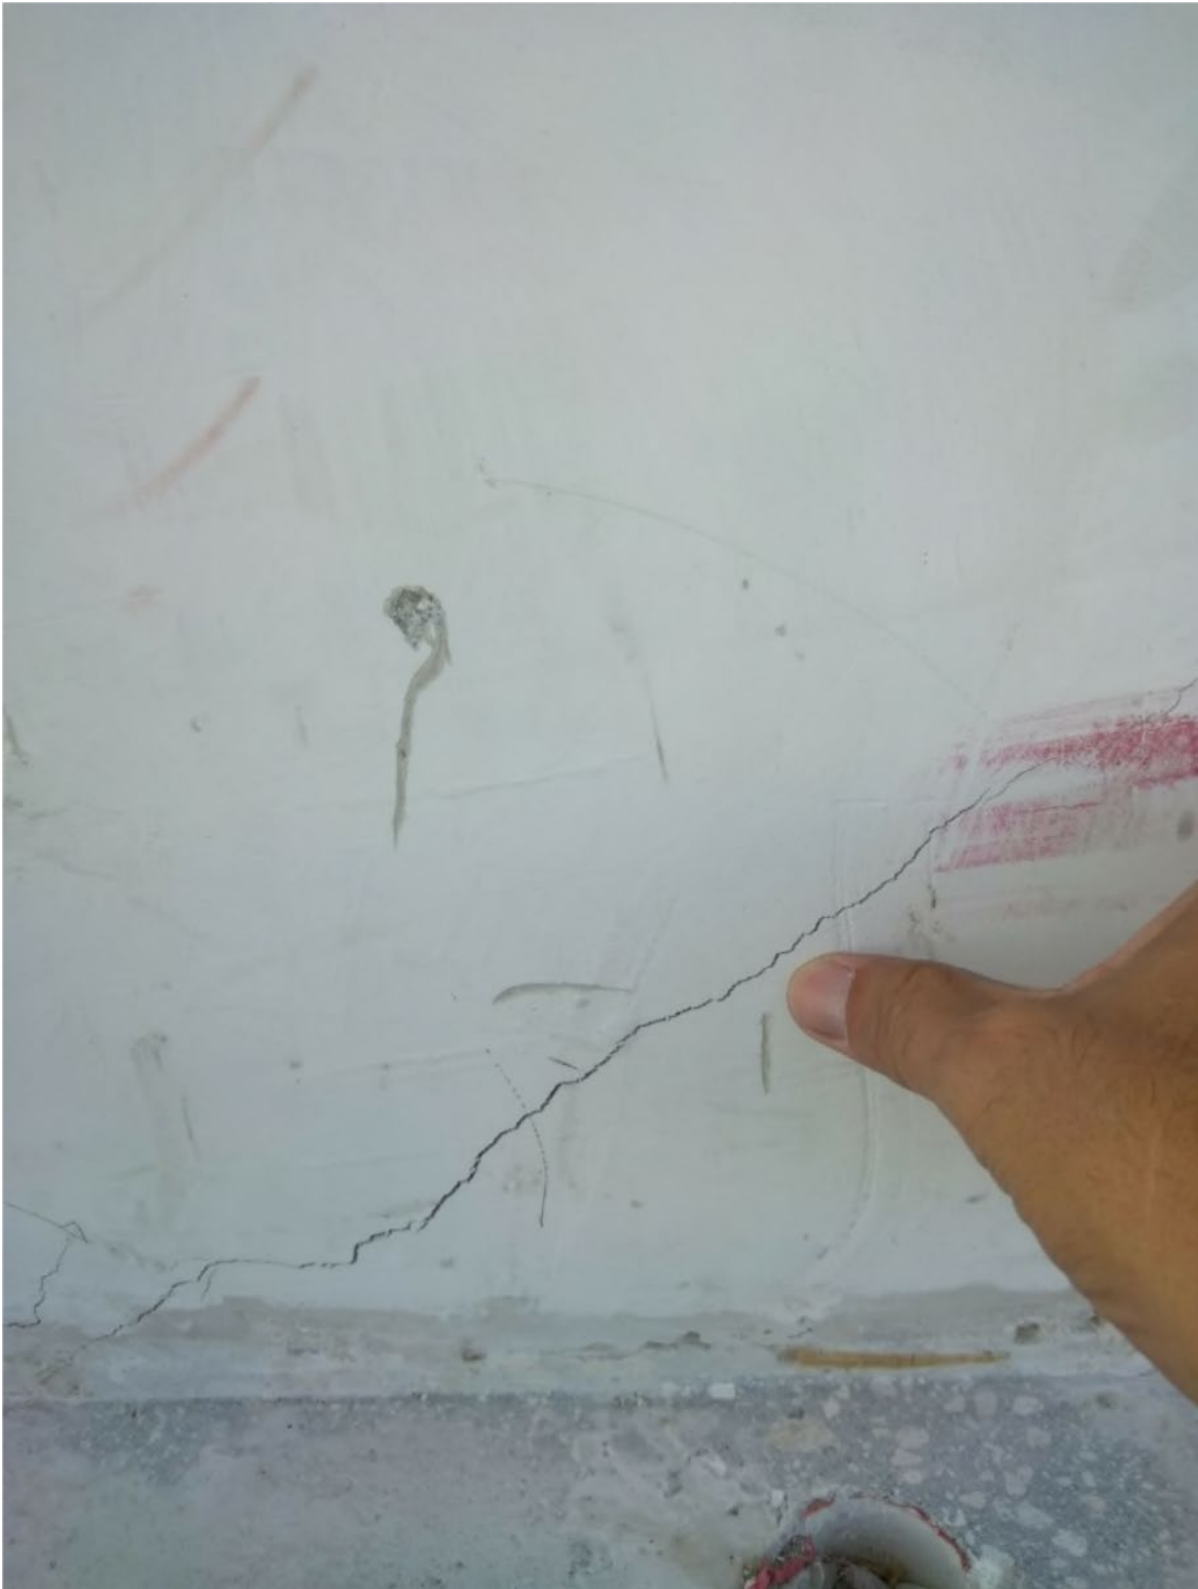
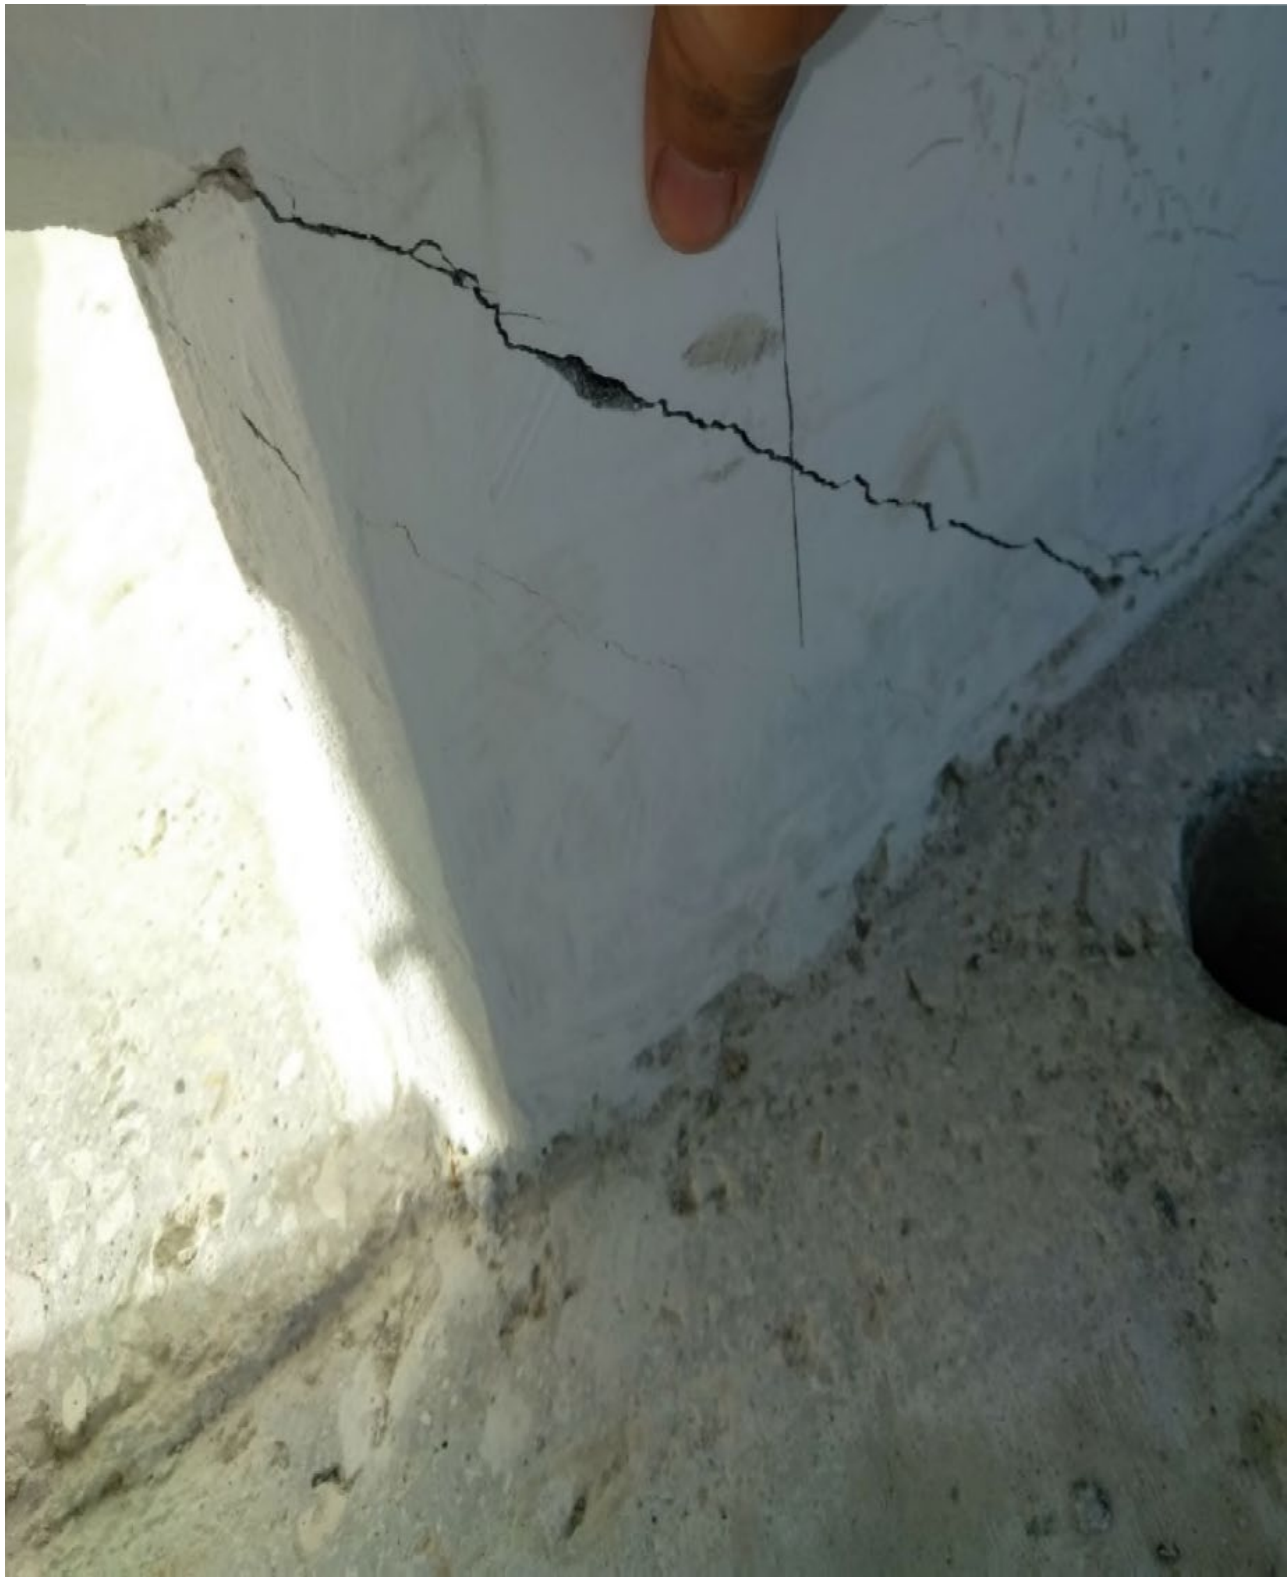
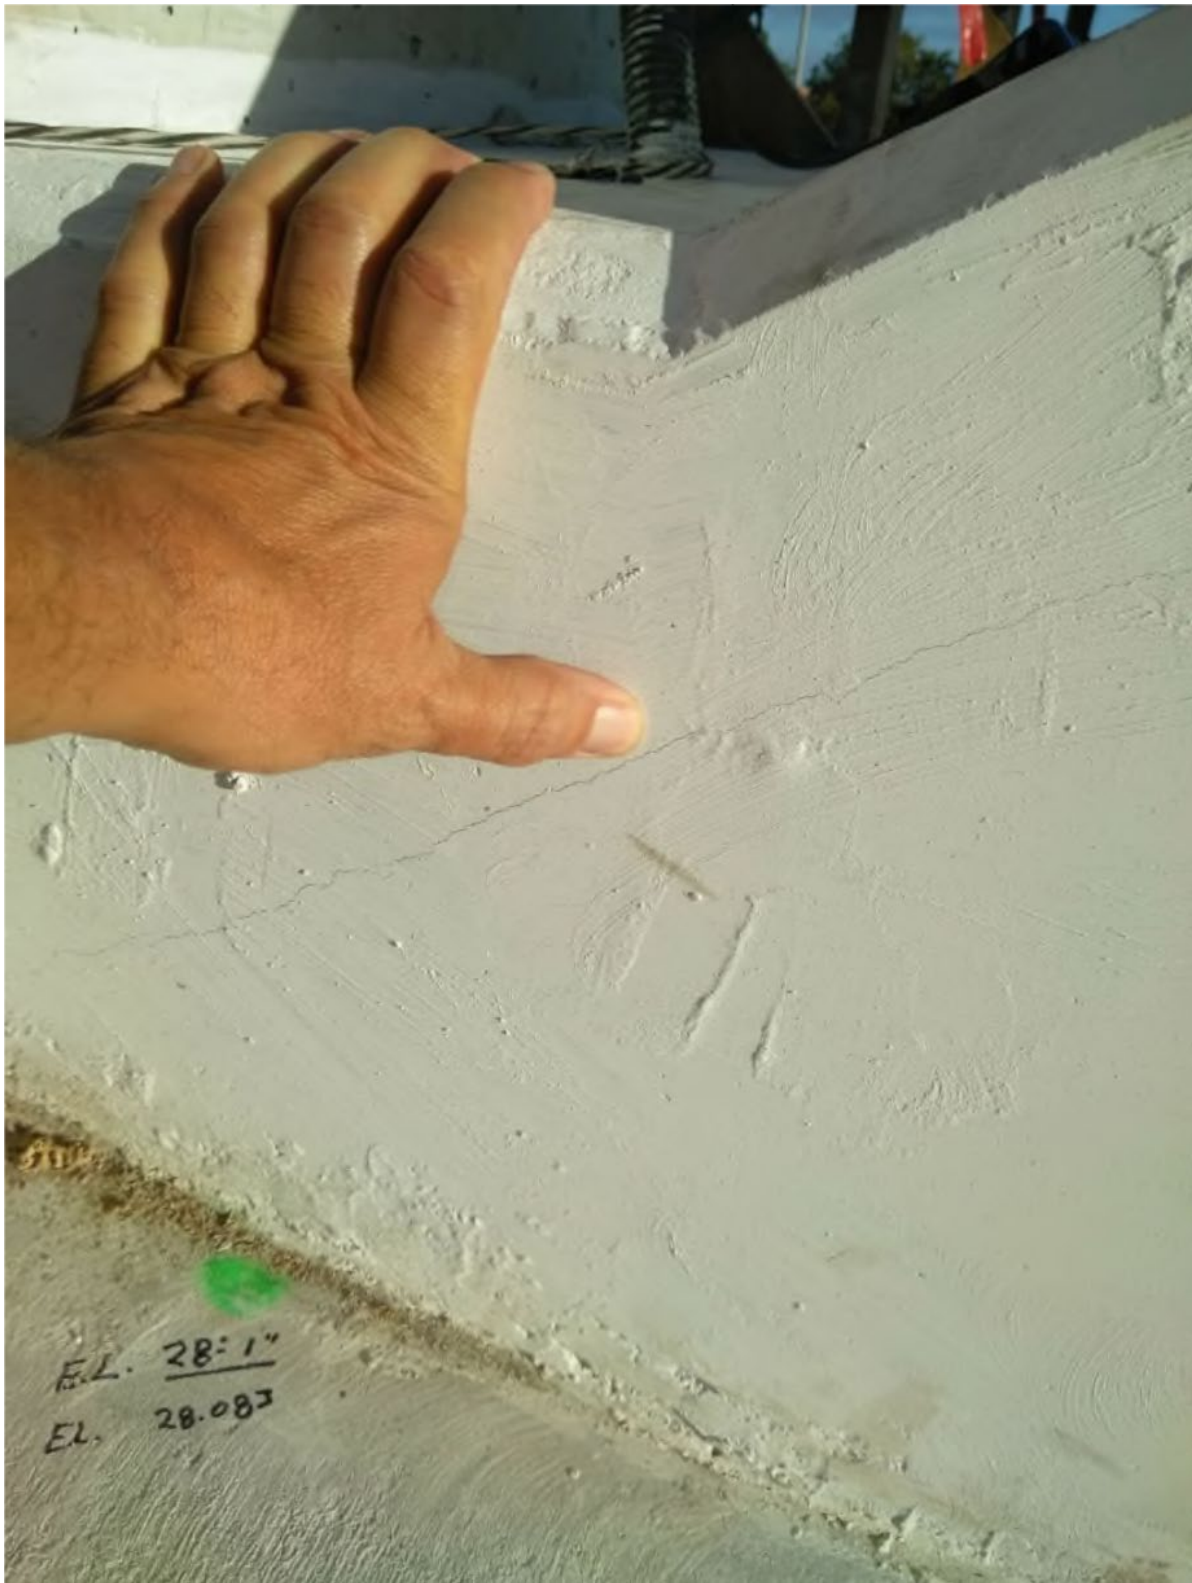
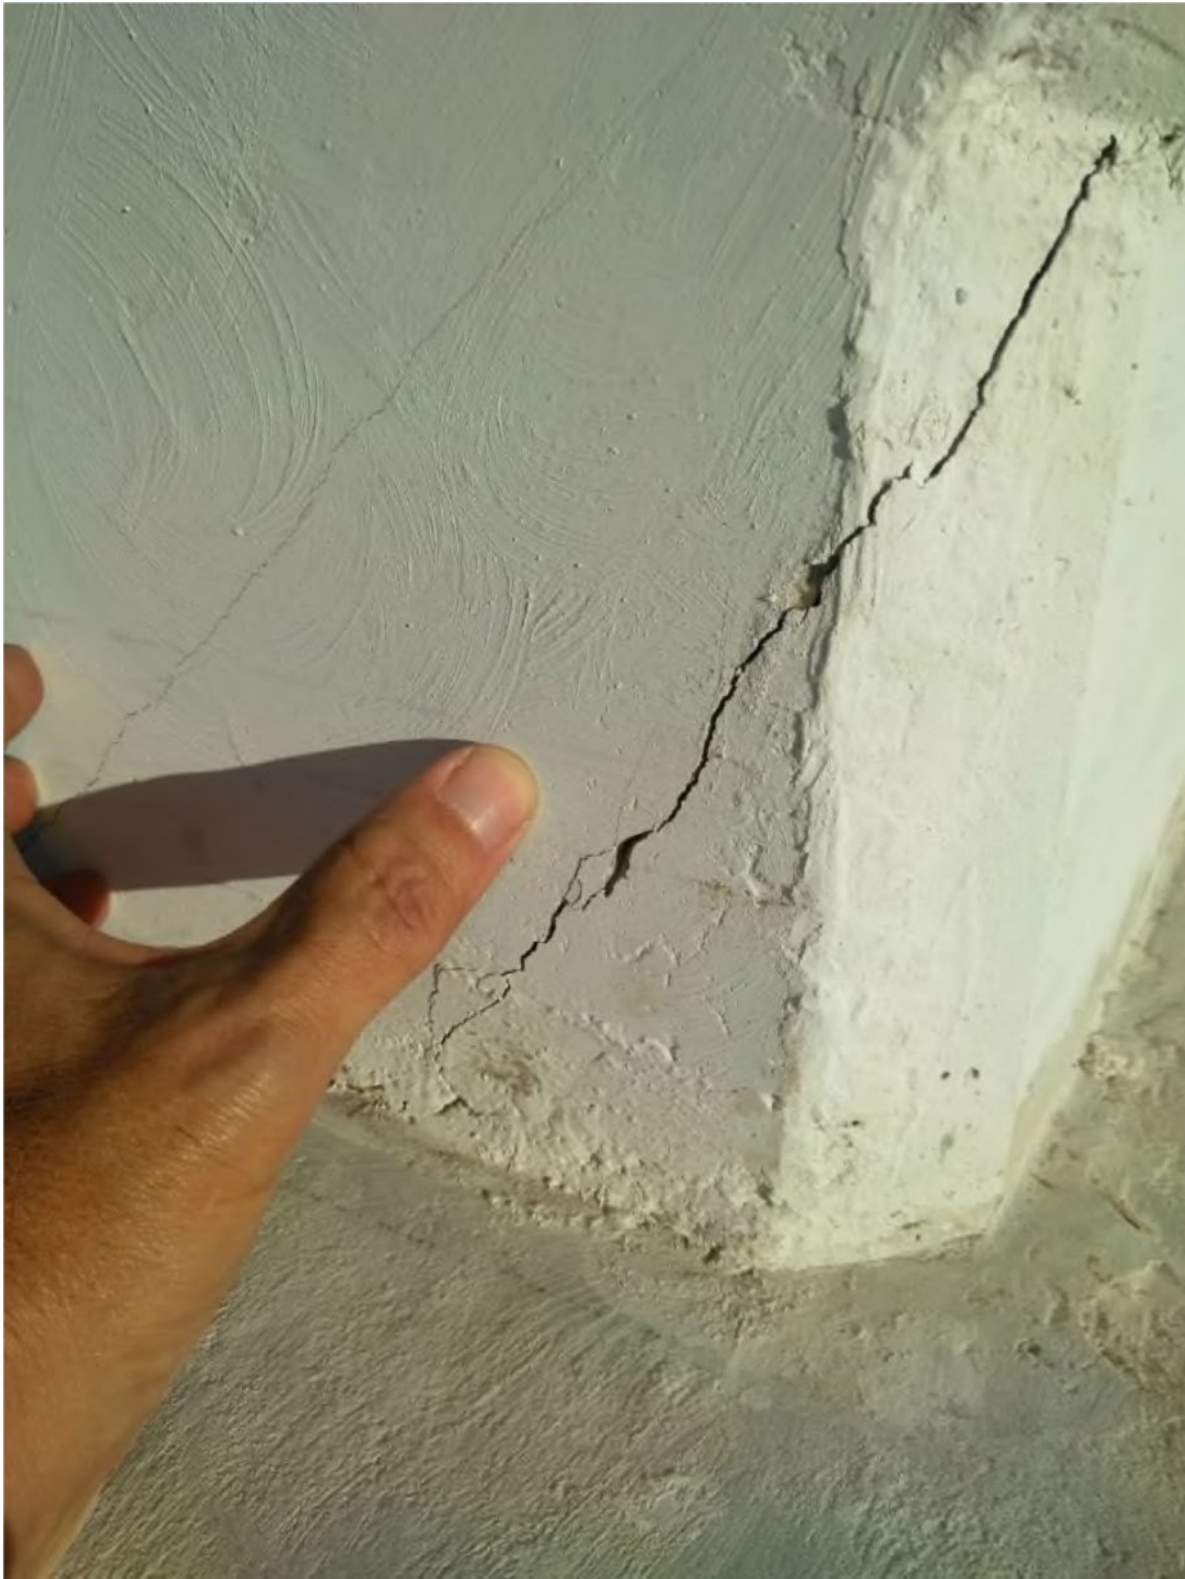
Figure 16 Photo #2 in 2/28/2018 E-mail from MCM to FIGG

February 26, 2018      Photographs of the cracks were taken by BPA.

February 28, 2018      BPA forwarded the photos of cracks to MCM asking for response from FIGG, as cracks needed “special attention.”

Photo 2 (Figure 16): Cracks expected.

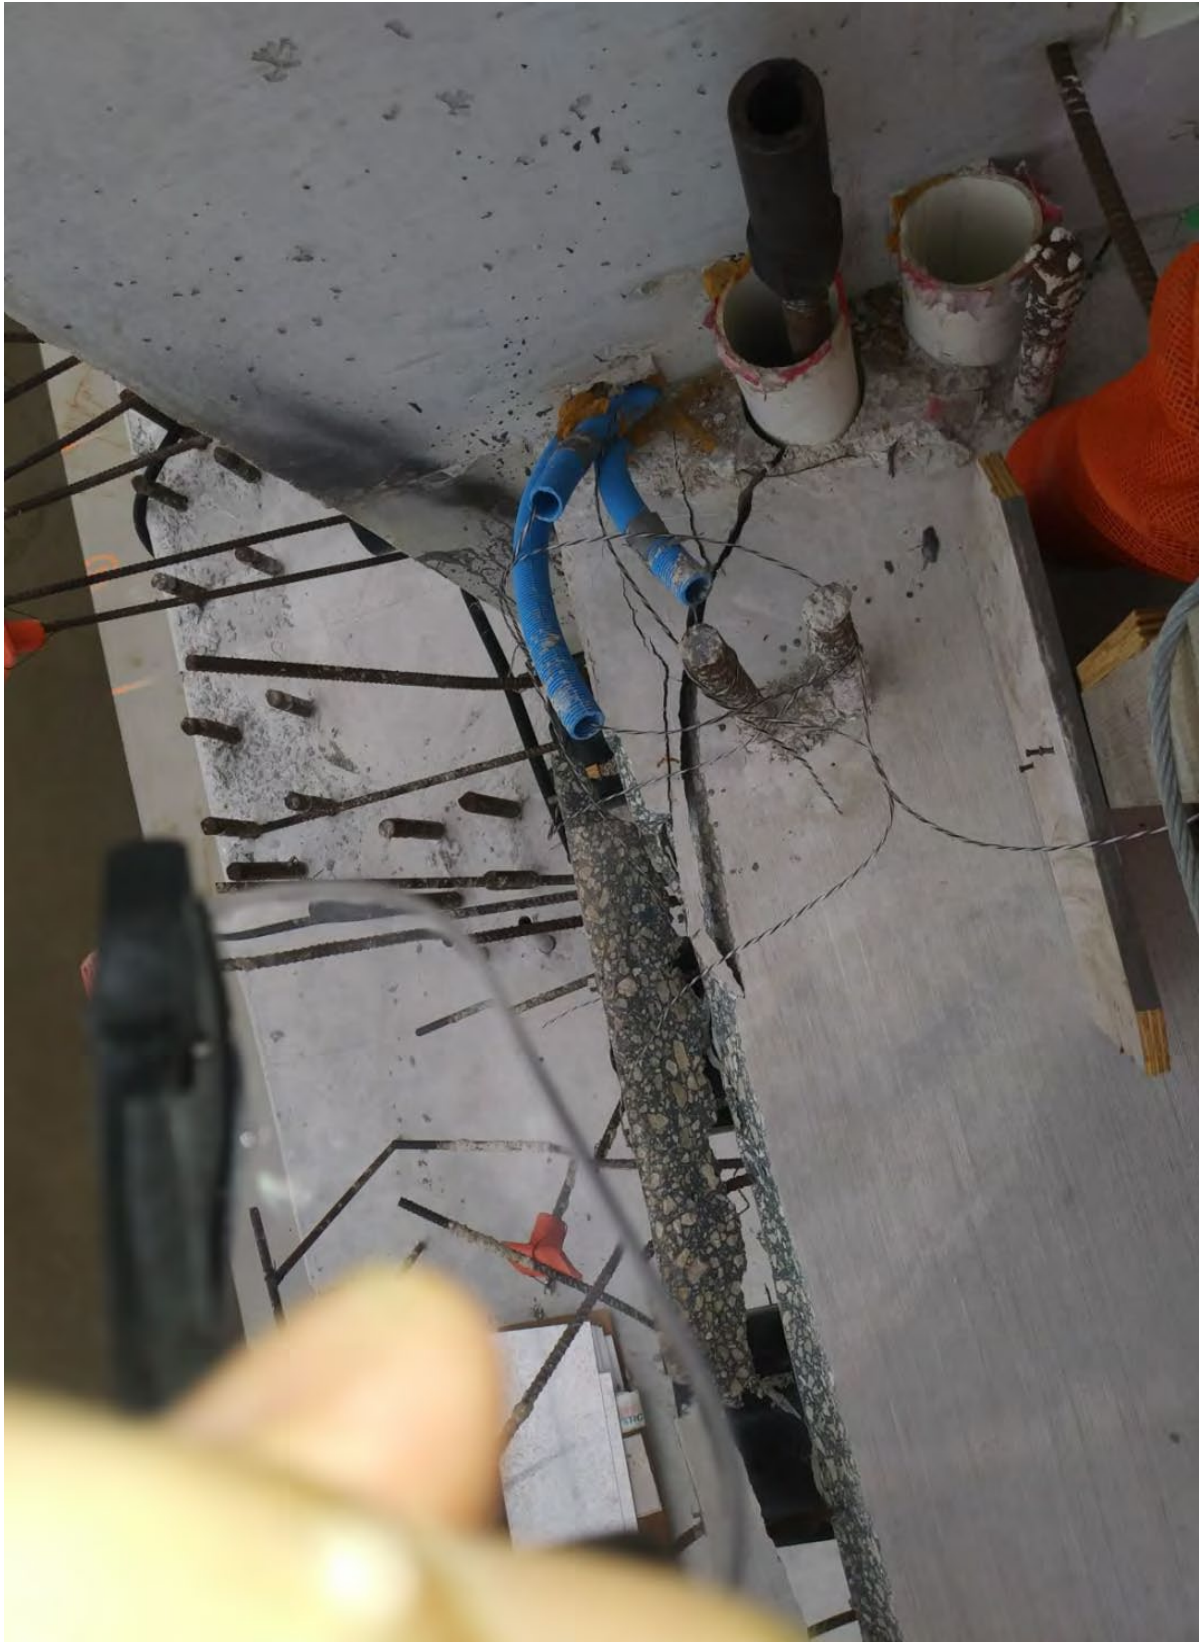
Figure 24 Cracks at the west side diaphragm II MCM email of 3/12/2018 – top face, by BPA.

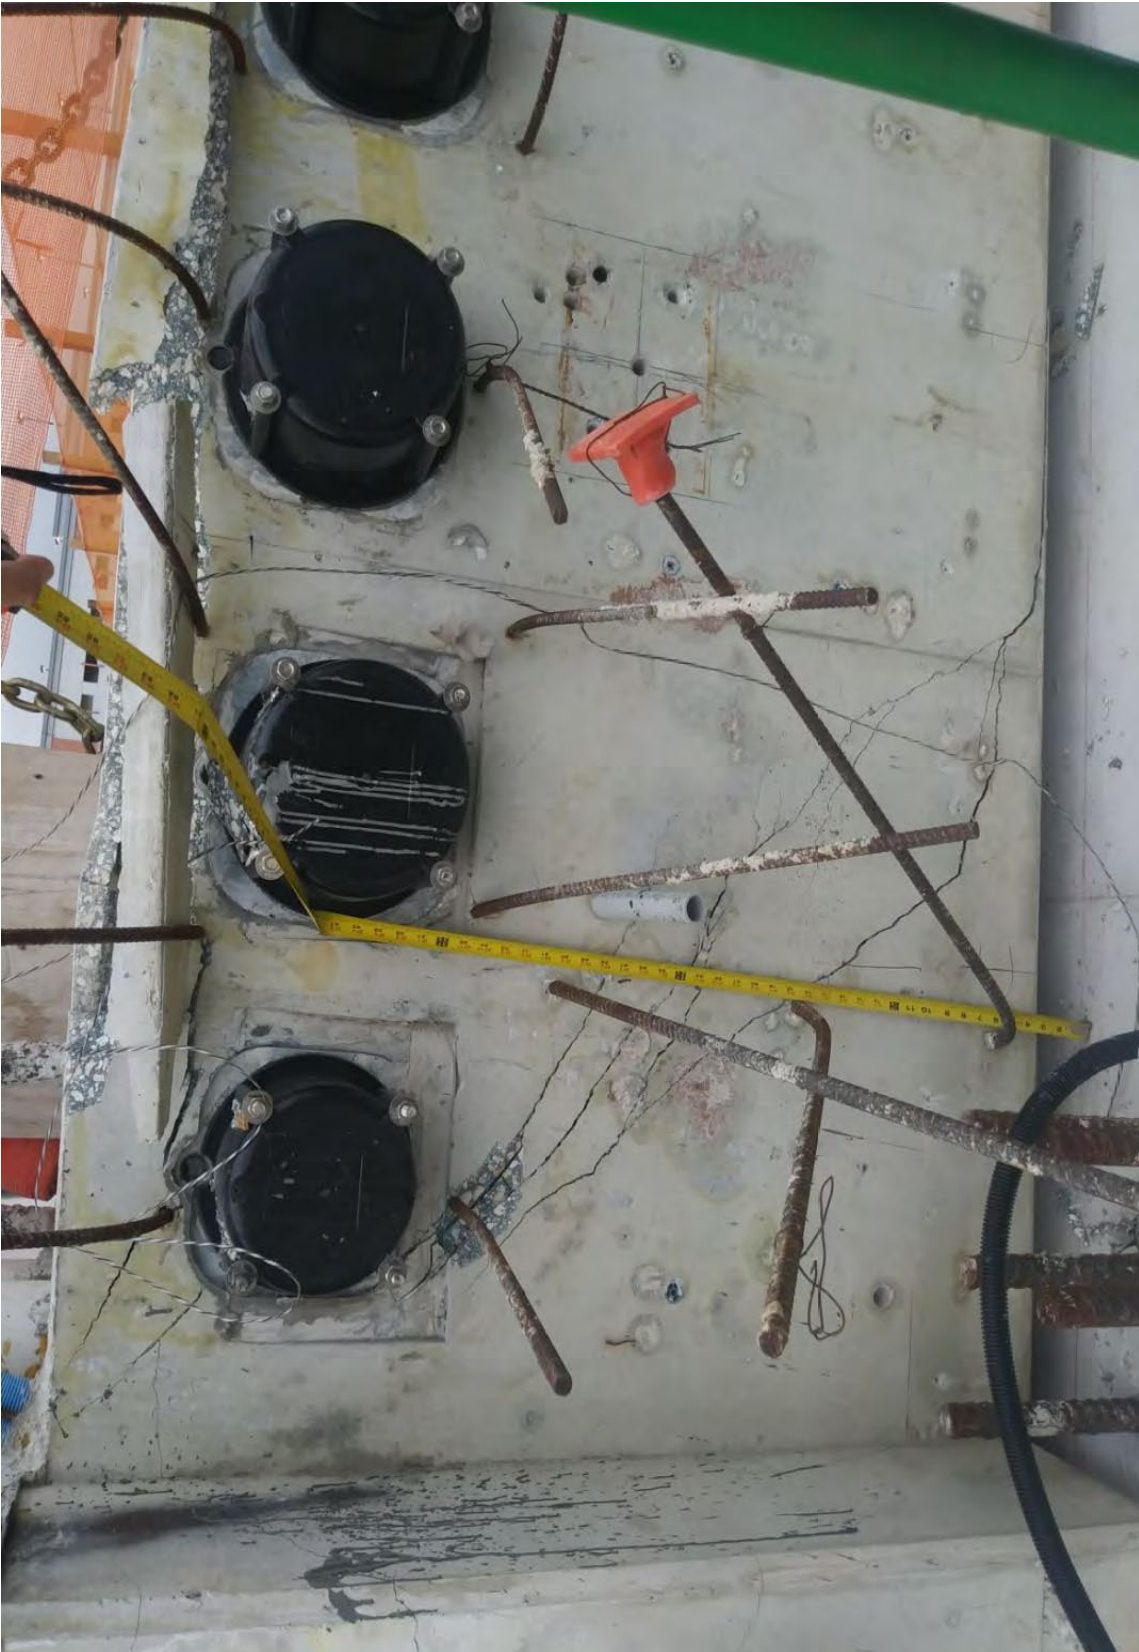
Figure 25 Cracks at the west side diaphragm II MCM email of 3/12/2018, by BPA – side face

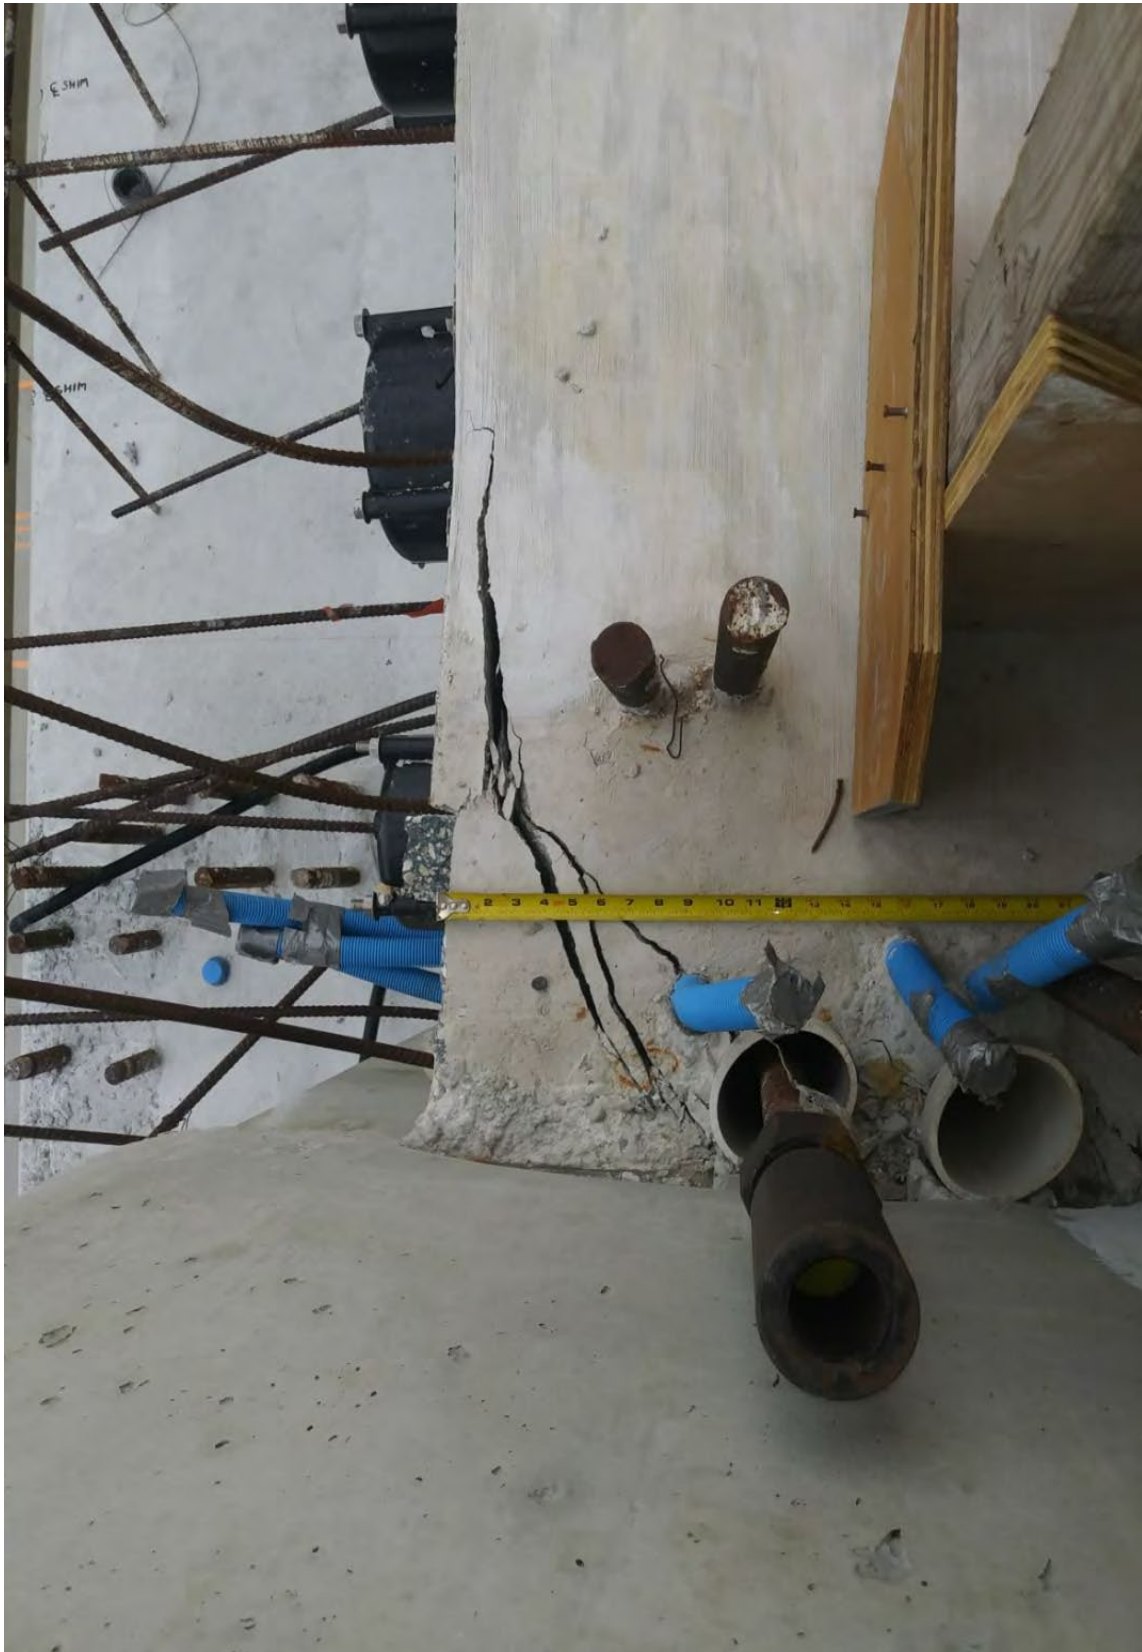
Figure 26 Cracks at the east side diaphragm II MCM email of 3/12/2018, by BPA – top face

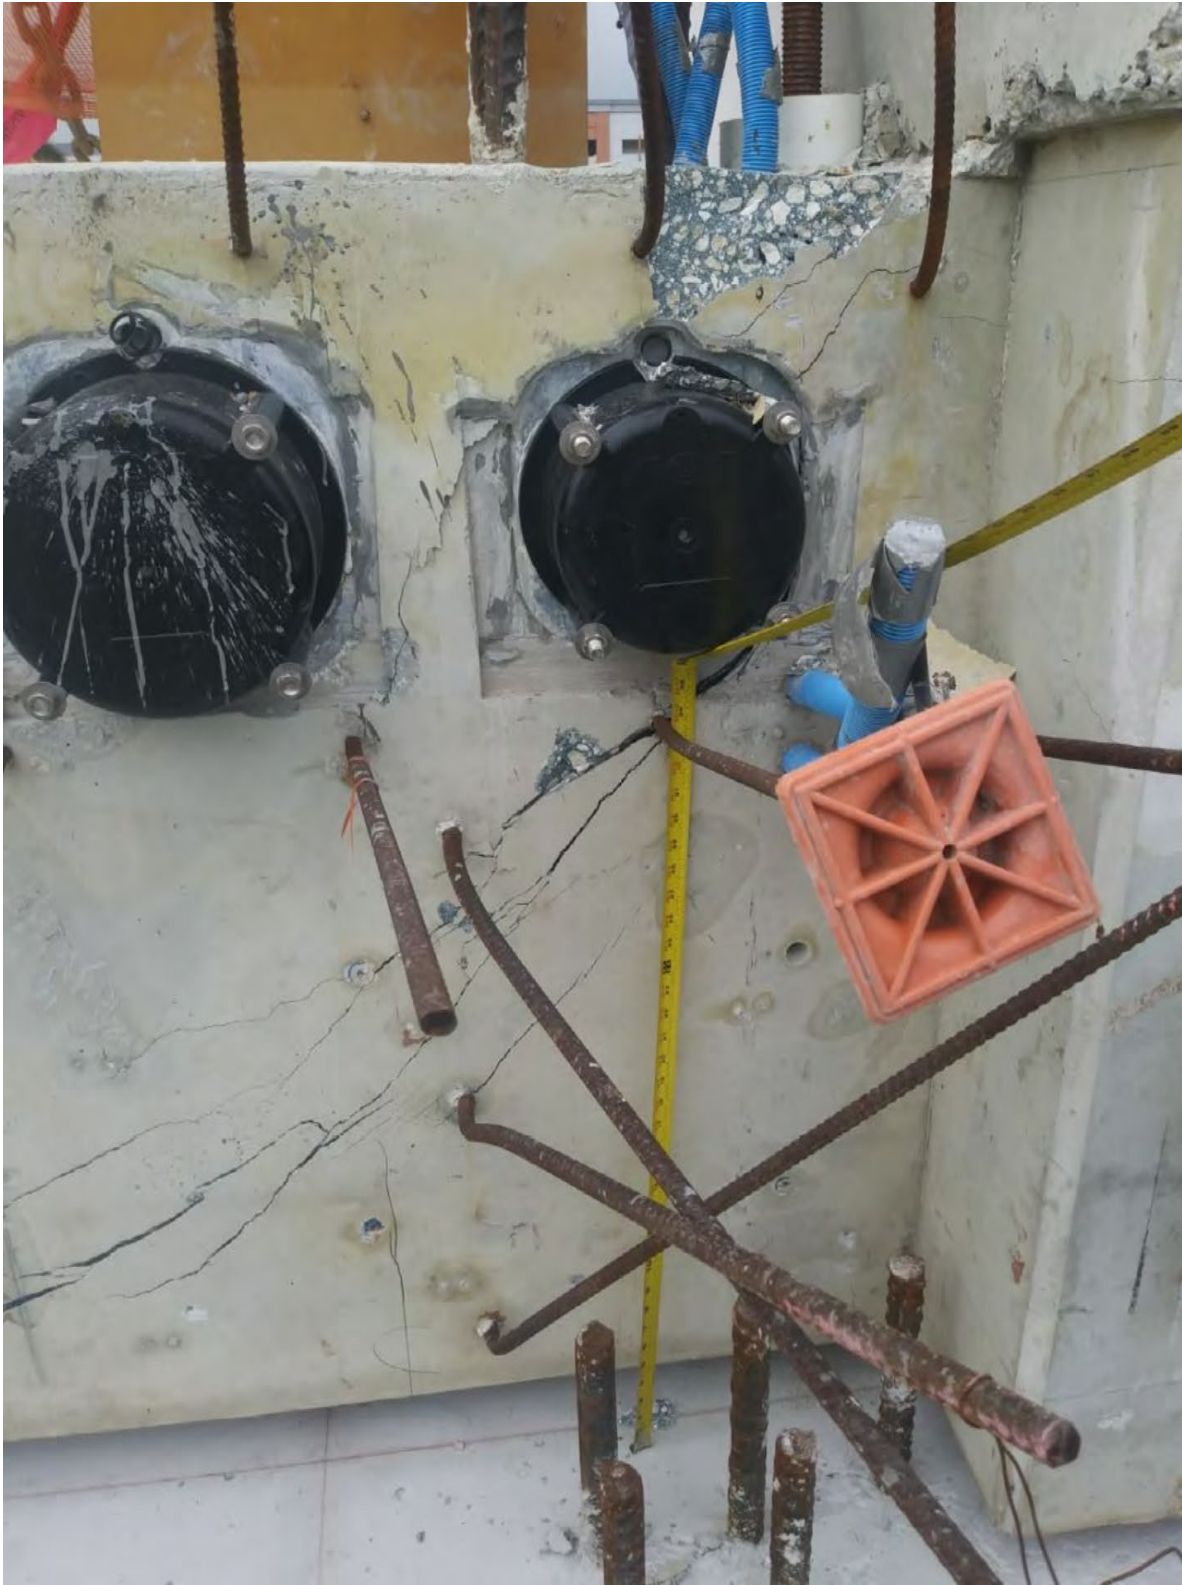
Figure 27 Cracks on the east side diaphragm II MCM email of 3/12/2018, by BPA – side face

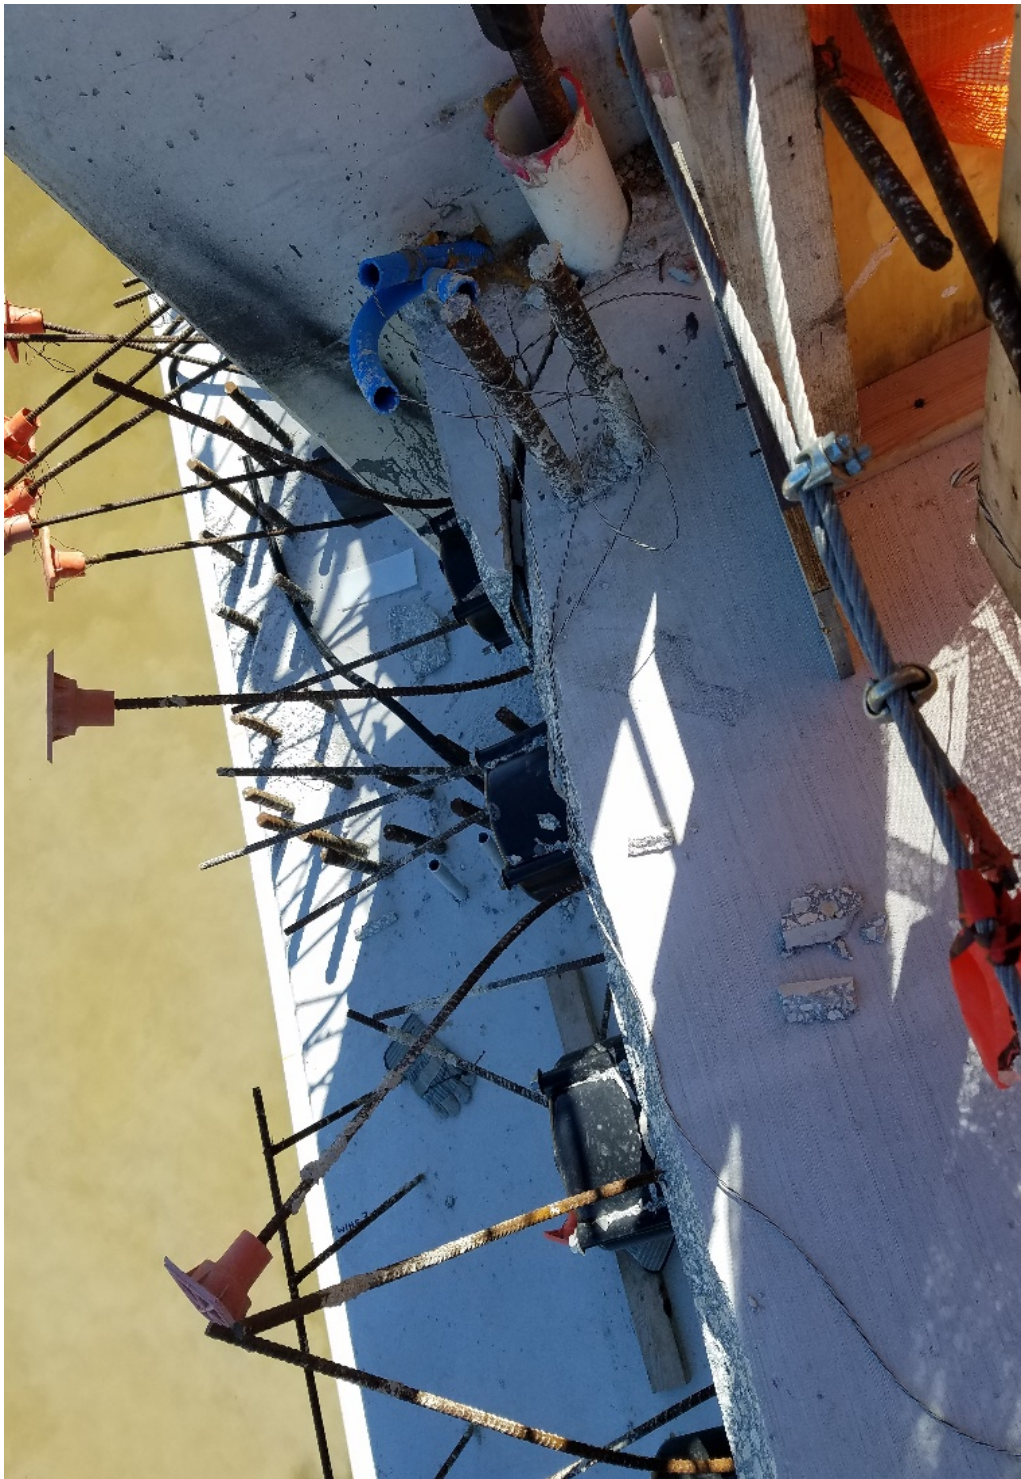
Figure 28 Diagonal cracks on the west side of diaphragm II on 3/13/2018, by BPA – top face

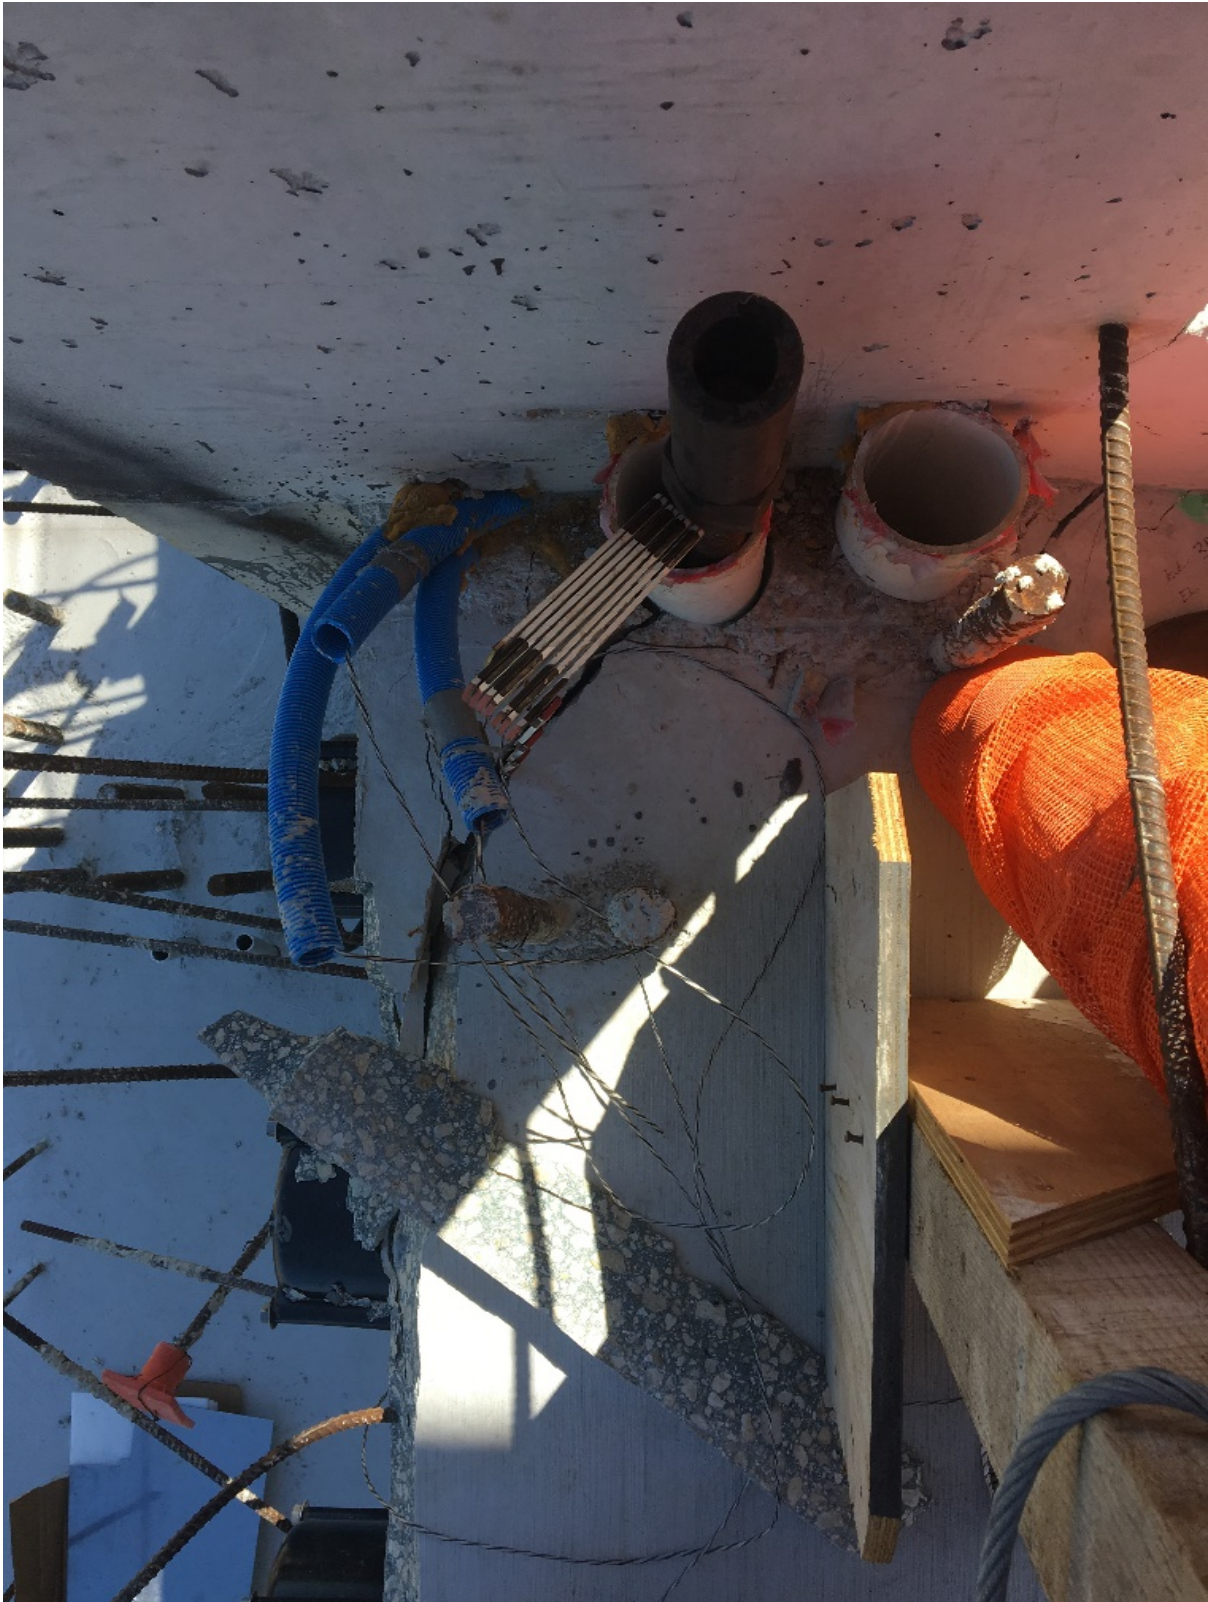
Figure 29 Close-up of cracks at the west side of diaphragm II on 3/13/2018, by BPA
