# Investigation of March 15, 2018 Pedestrian Bridge Collapse at Florida International University, Miami, FL

U.S Department of Labor  
Occupational Safety and Health Administration  
Directorate of Construction

June 2019

**Report prepared by**  
**Mohammad Ayub, PE, SE**  
Director, Office of Engineering Services  
Directorate of Construction  
OSHA National Office  
Washington, D.C.

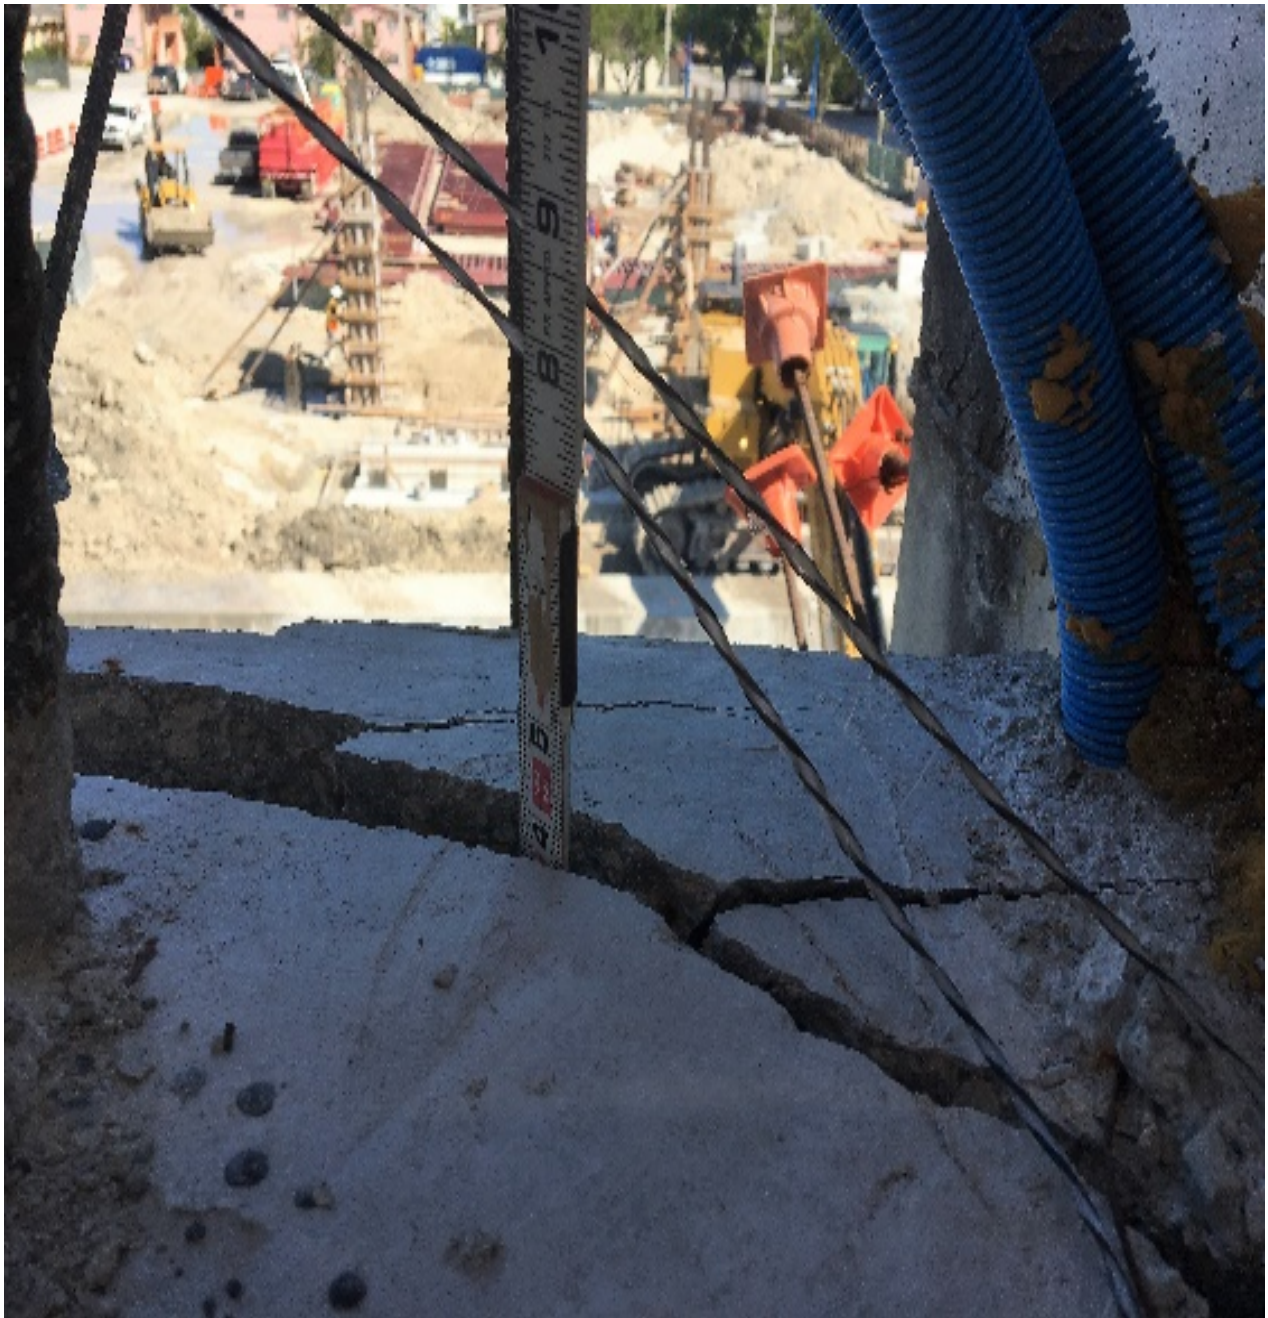
Figure 30 Notice the depth and width of diagonal cracks at the west side of diaphragm II on  
3/14/2018 by BPA

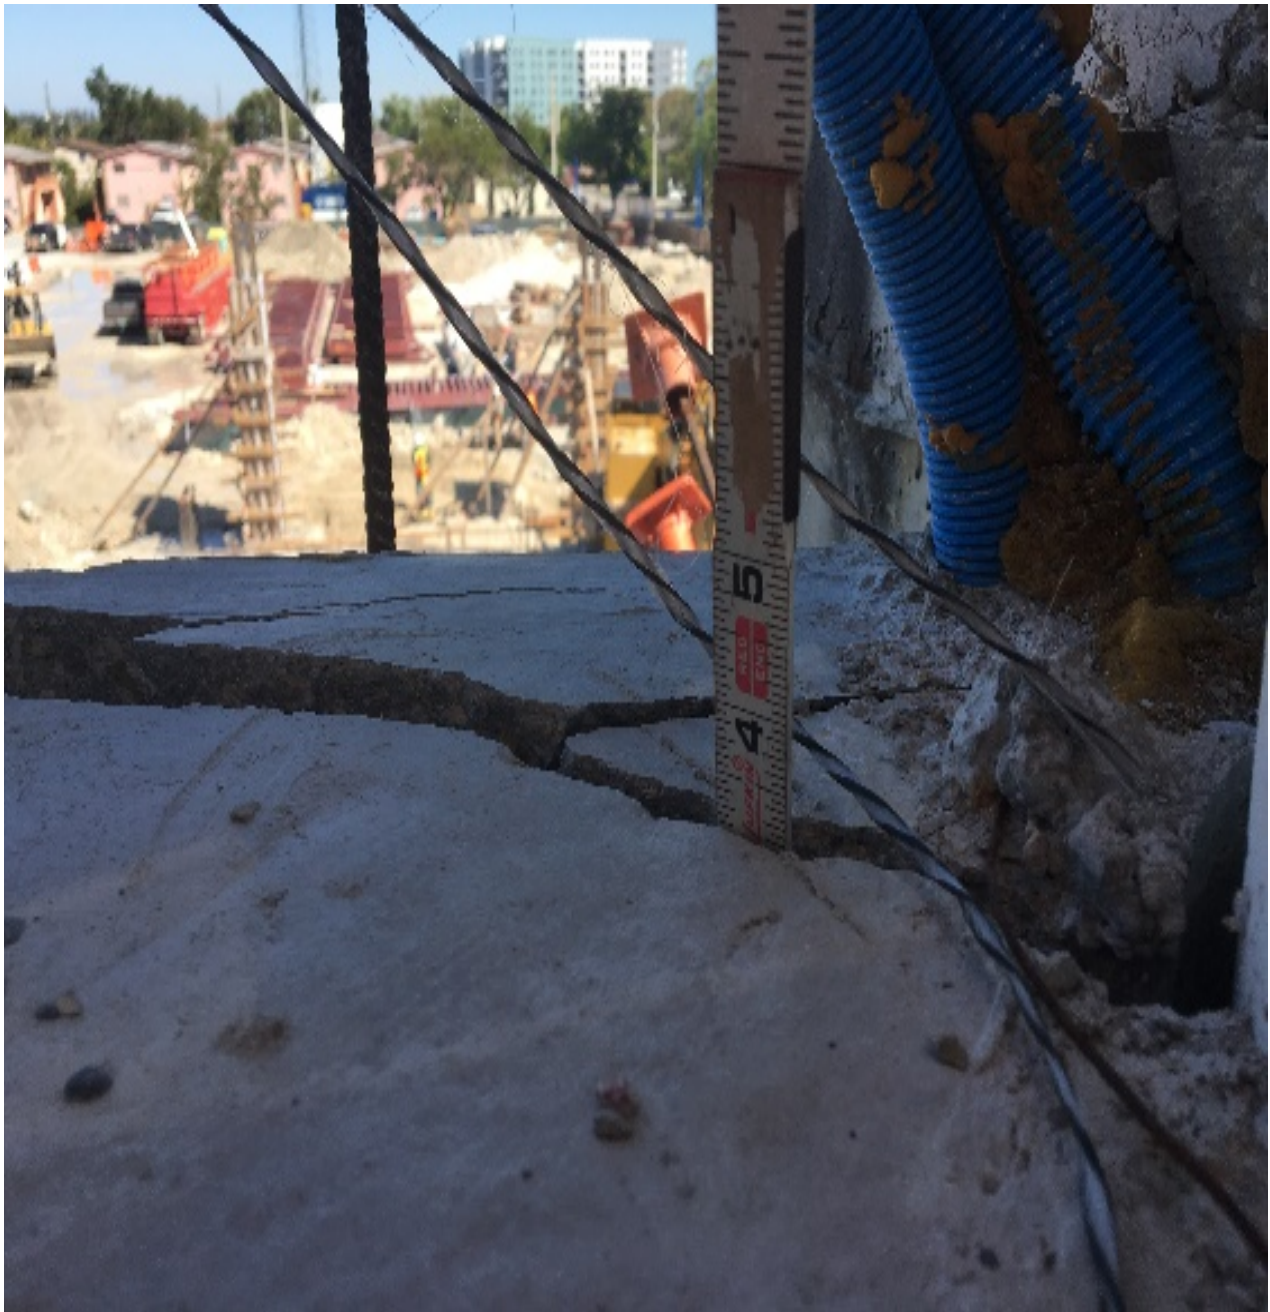
Figure 31 Notice the depth and width of cracks near column 12 at the west side of diaphragm II  
on 3/14/2018 by BPA

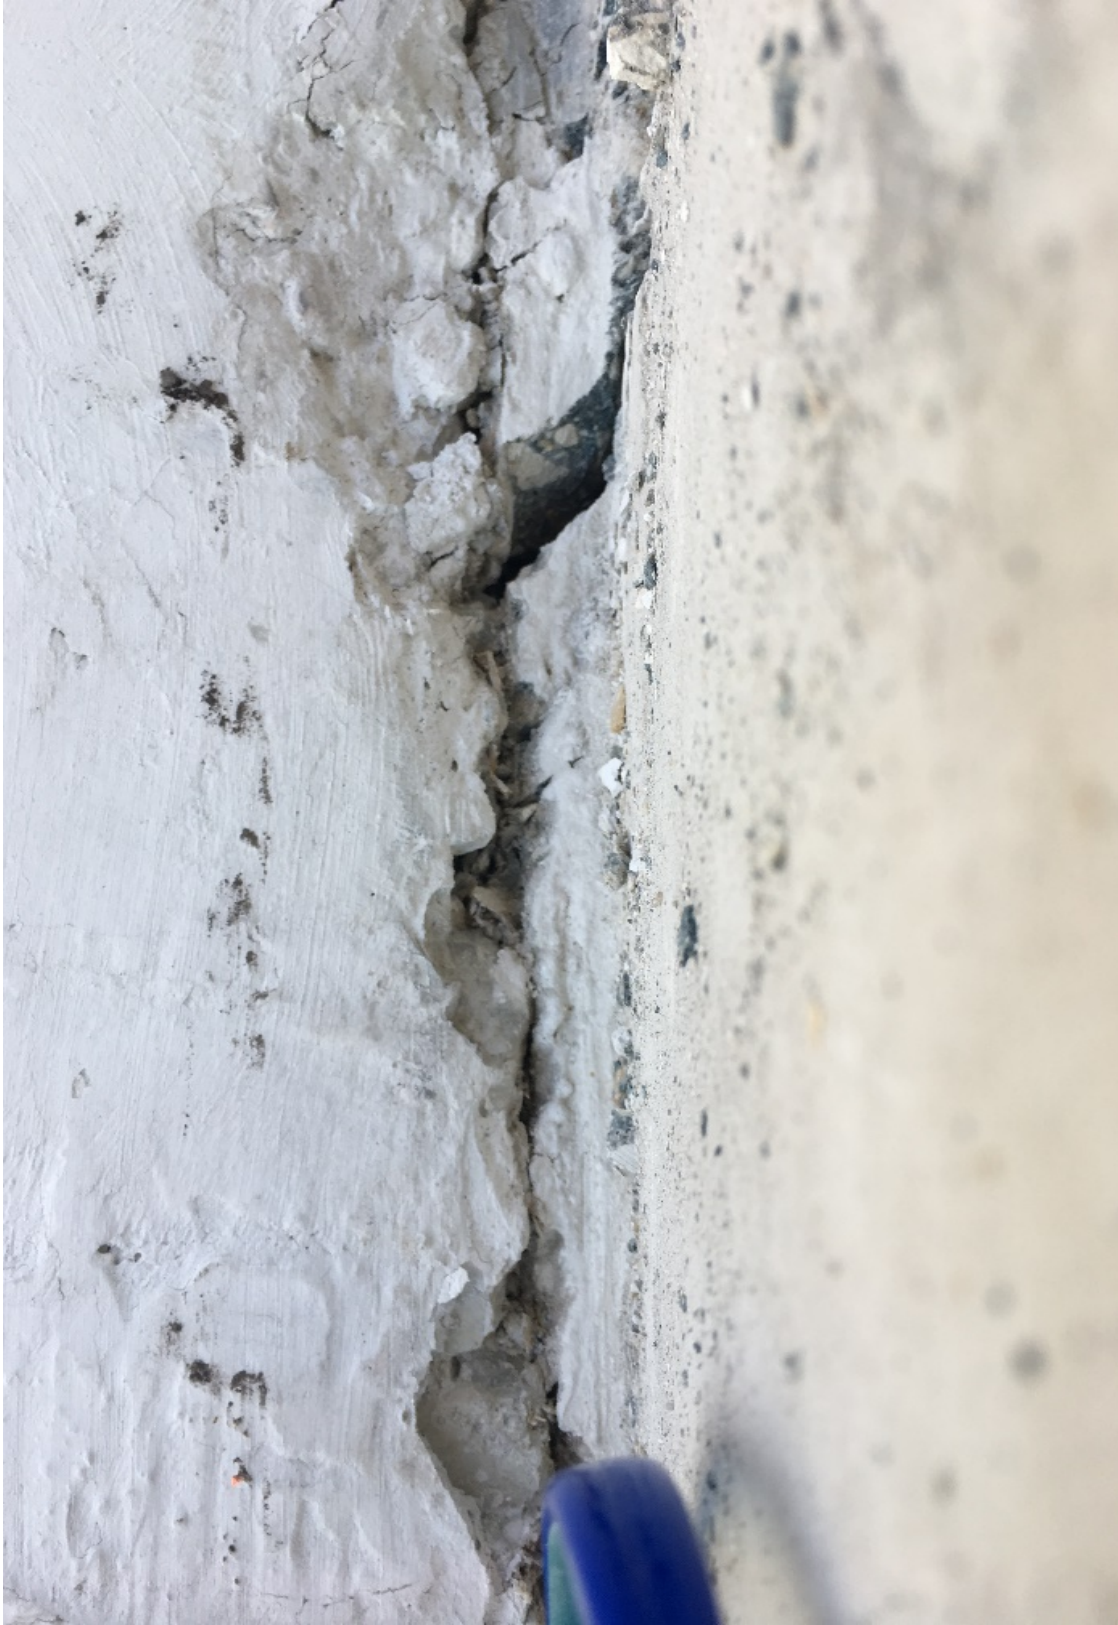
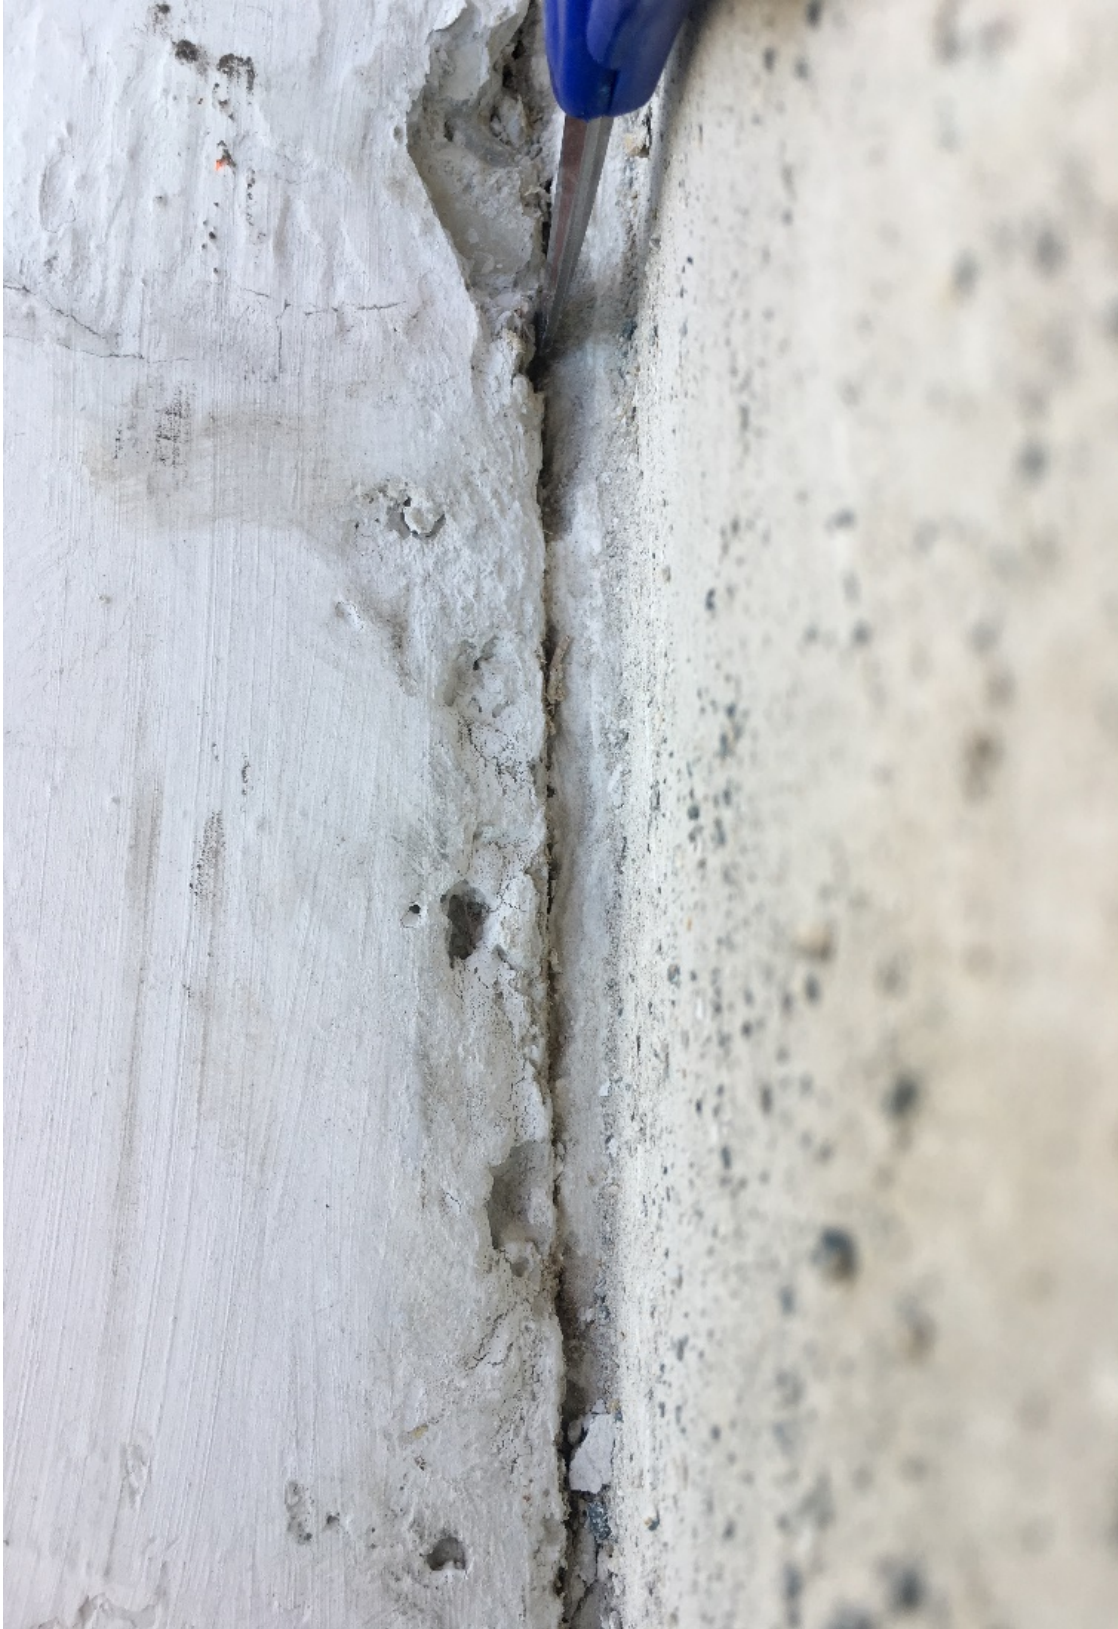
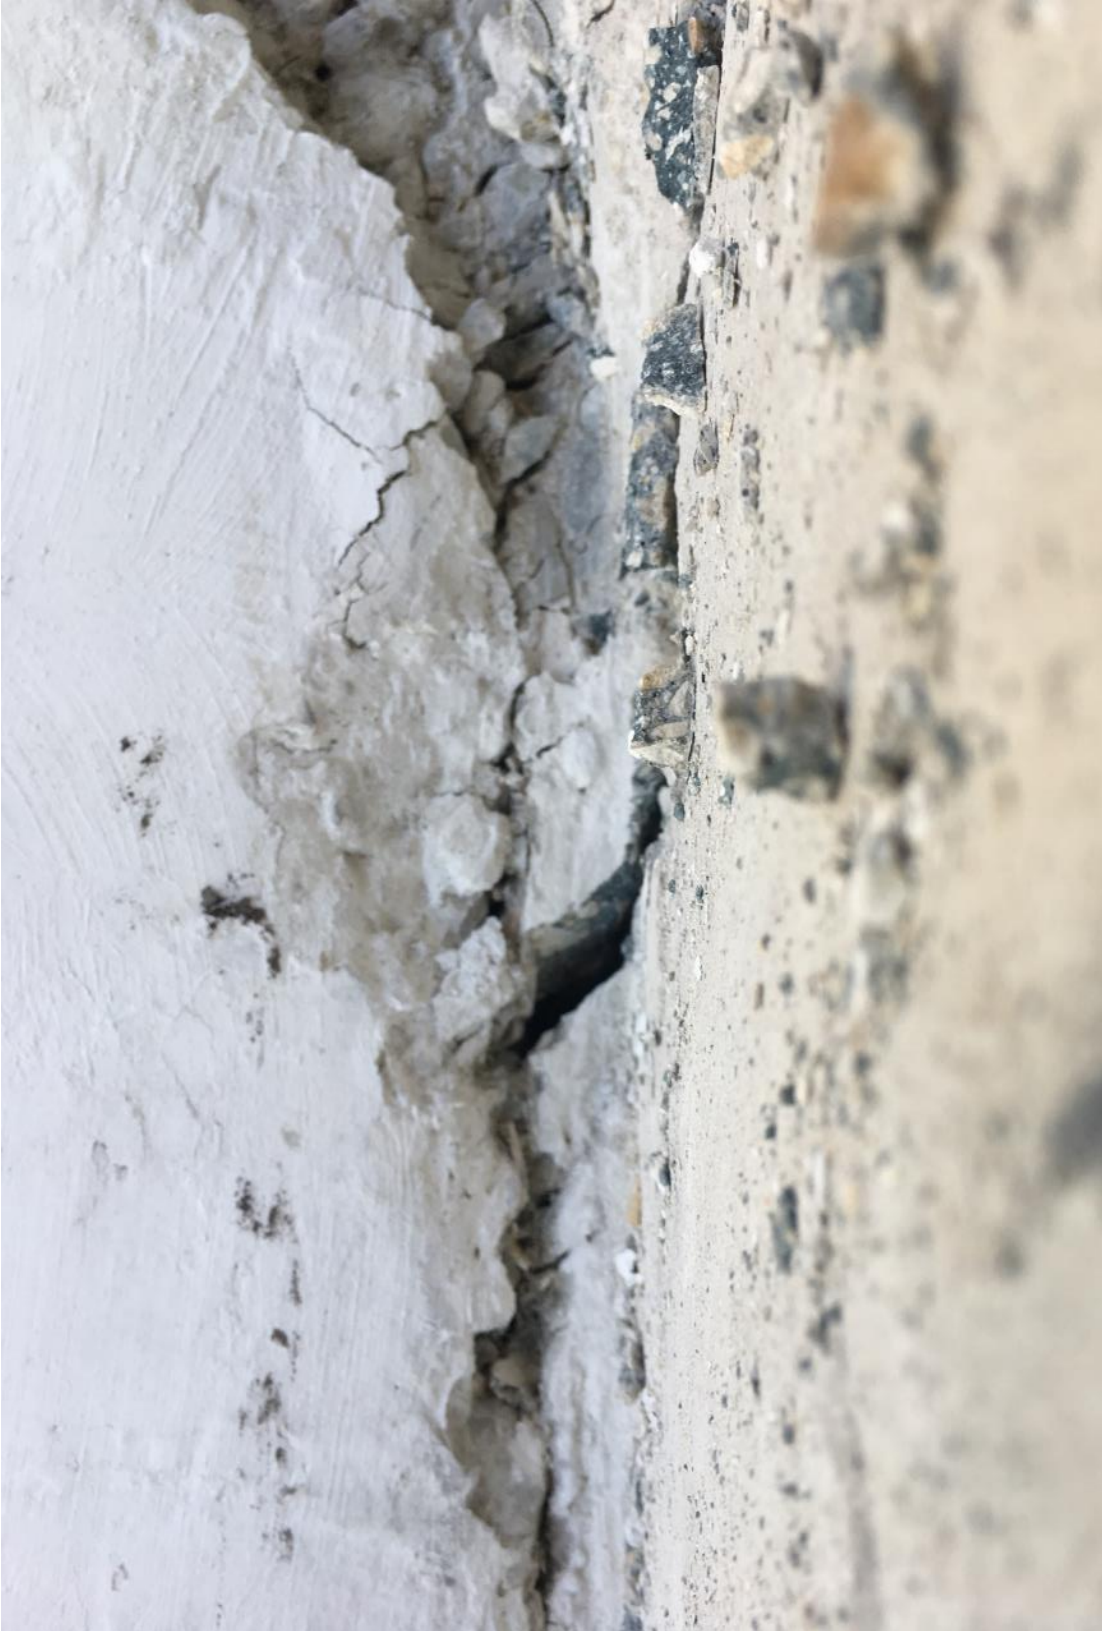
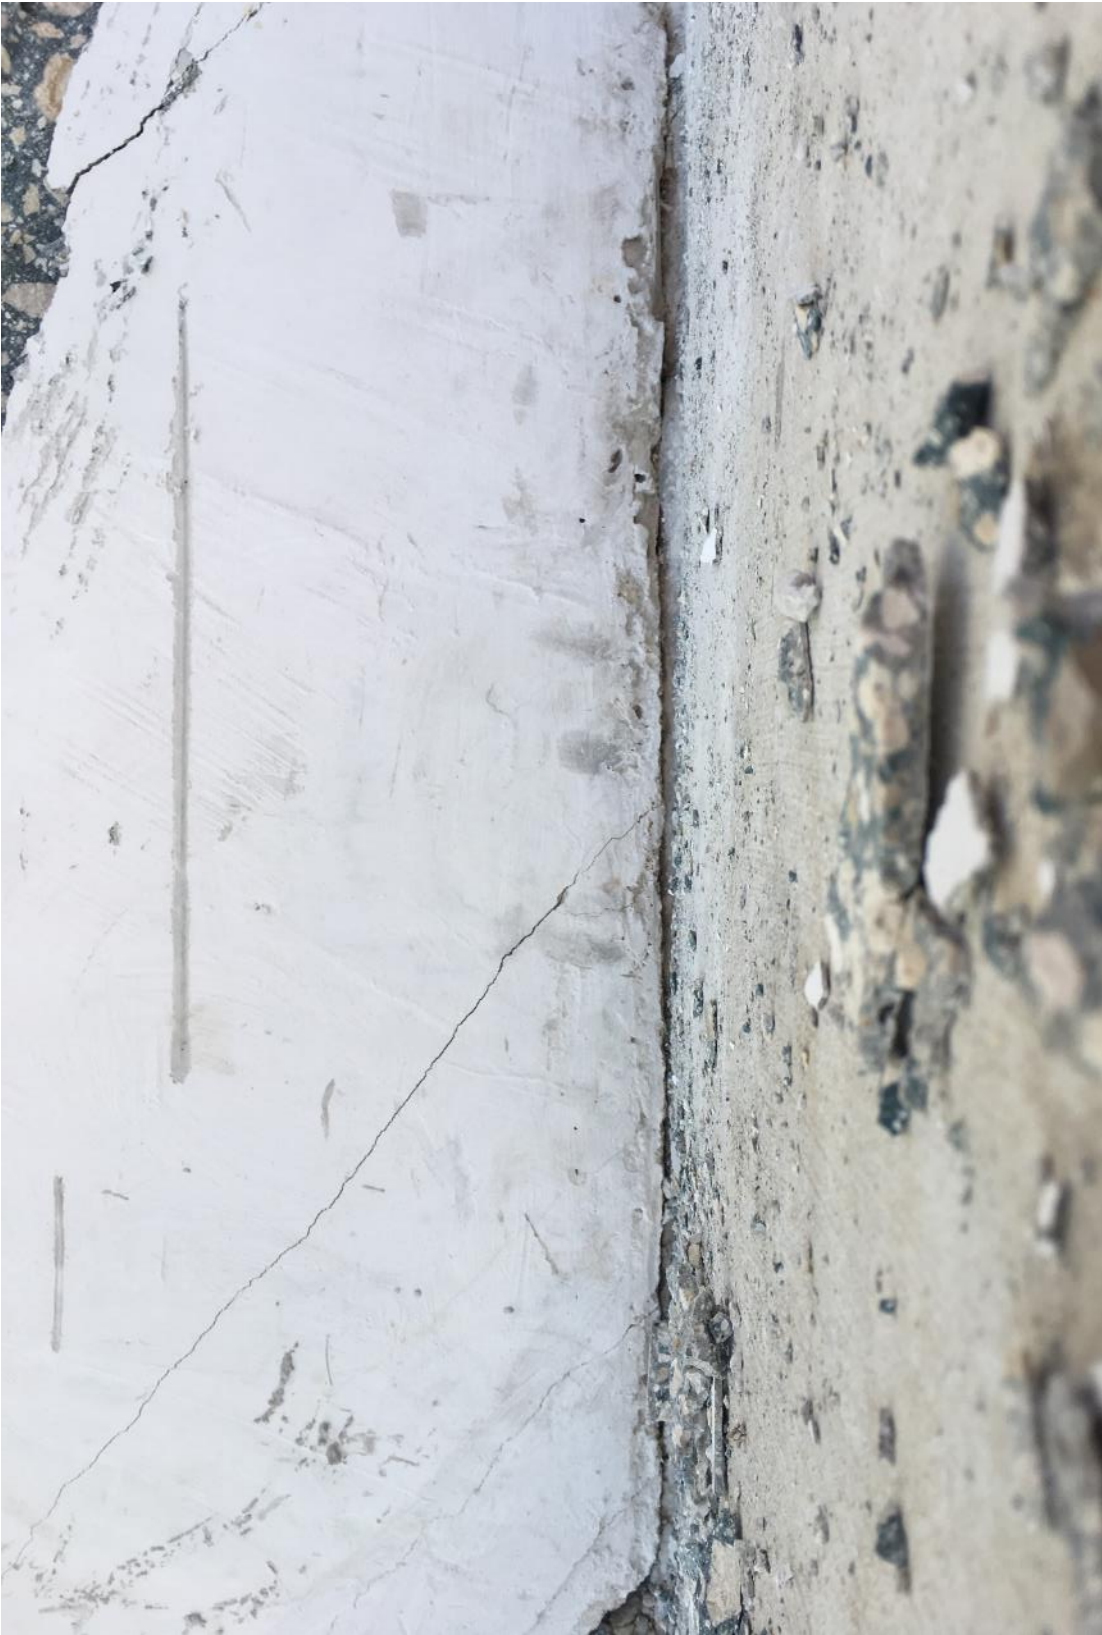
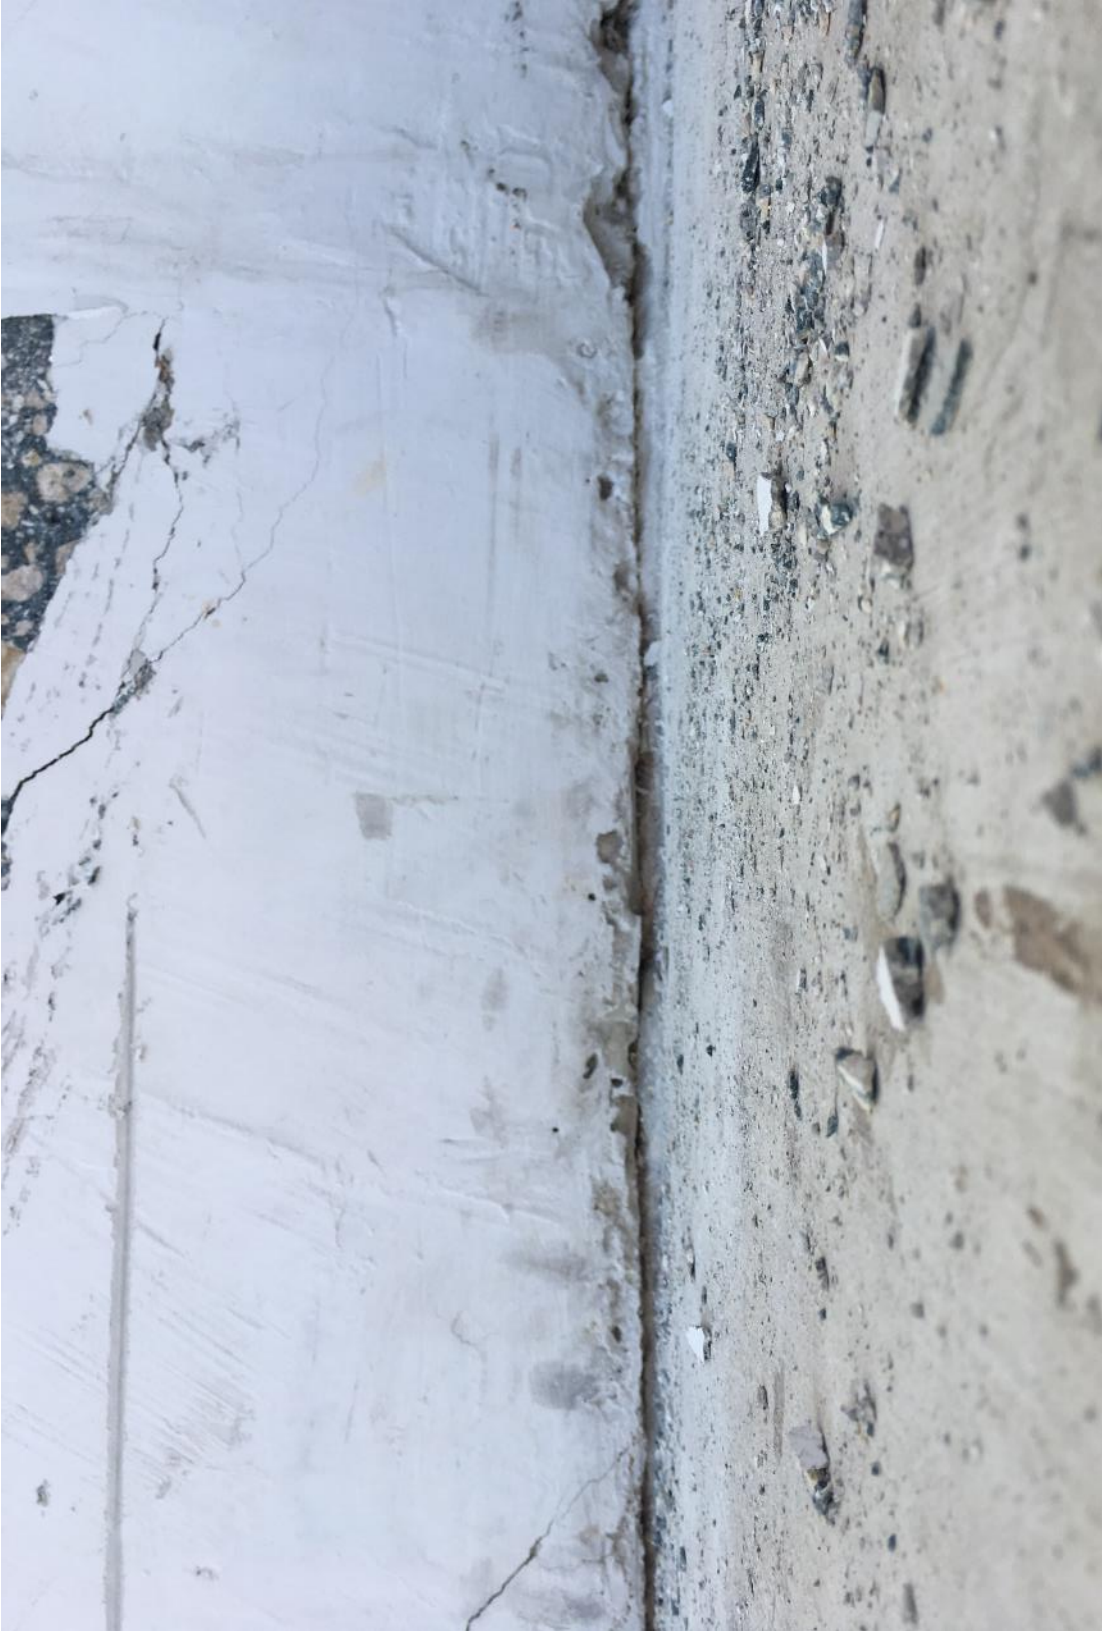
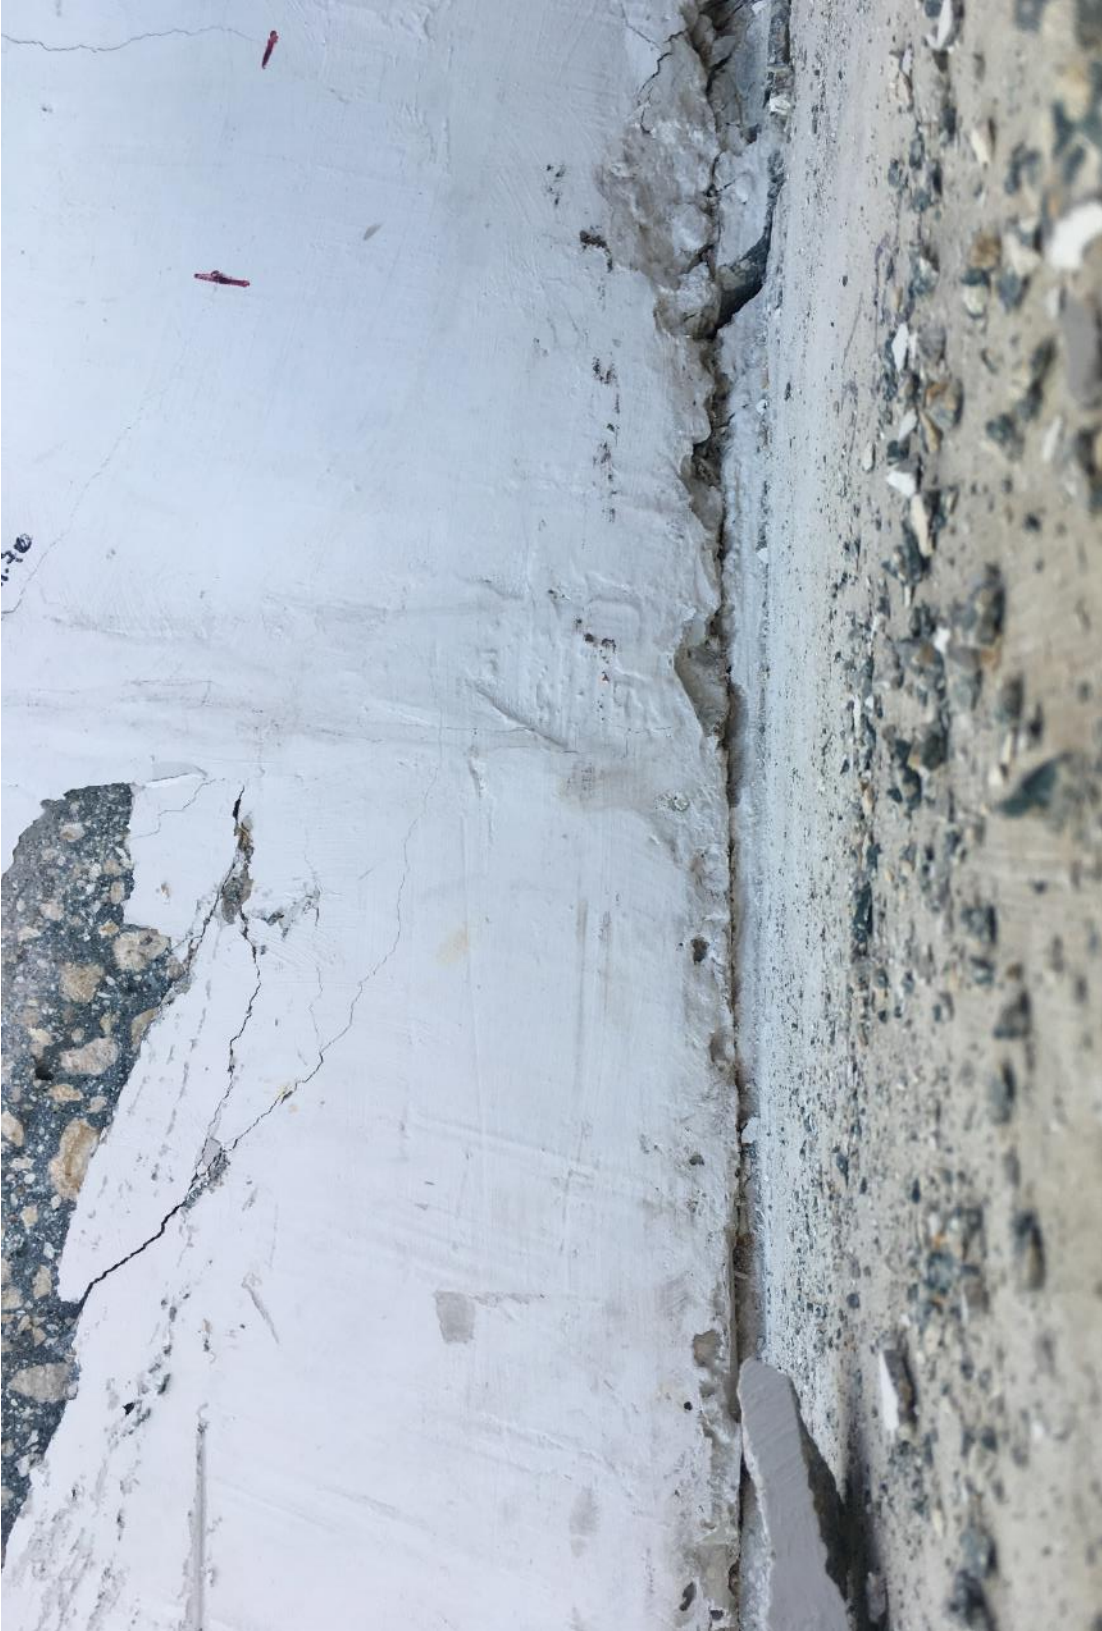
Figure 32 Cracks at the construction joint of the main span deck and diagonal 11 on 3/13/2018 by BPA

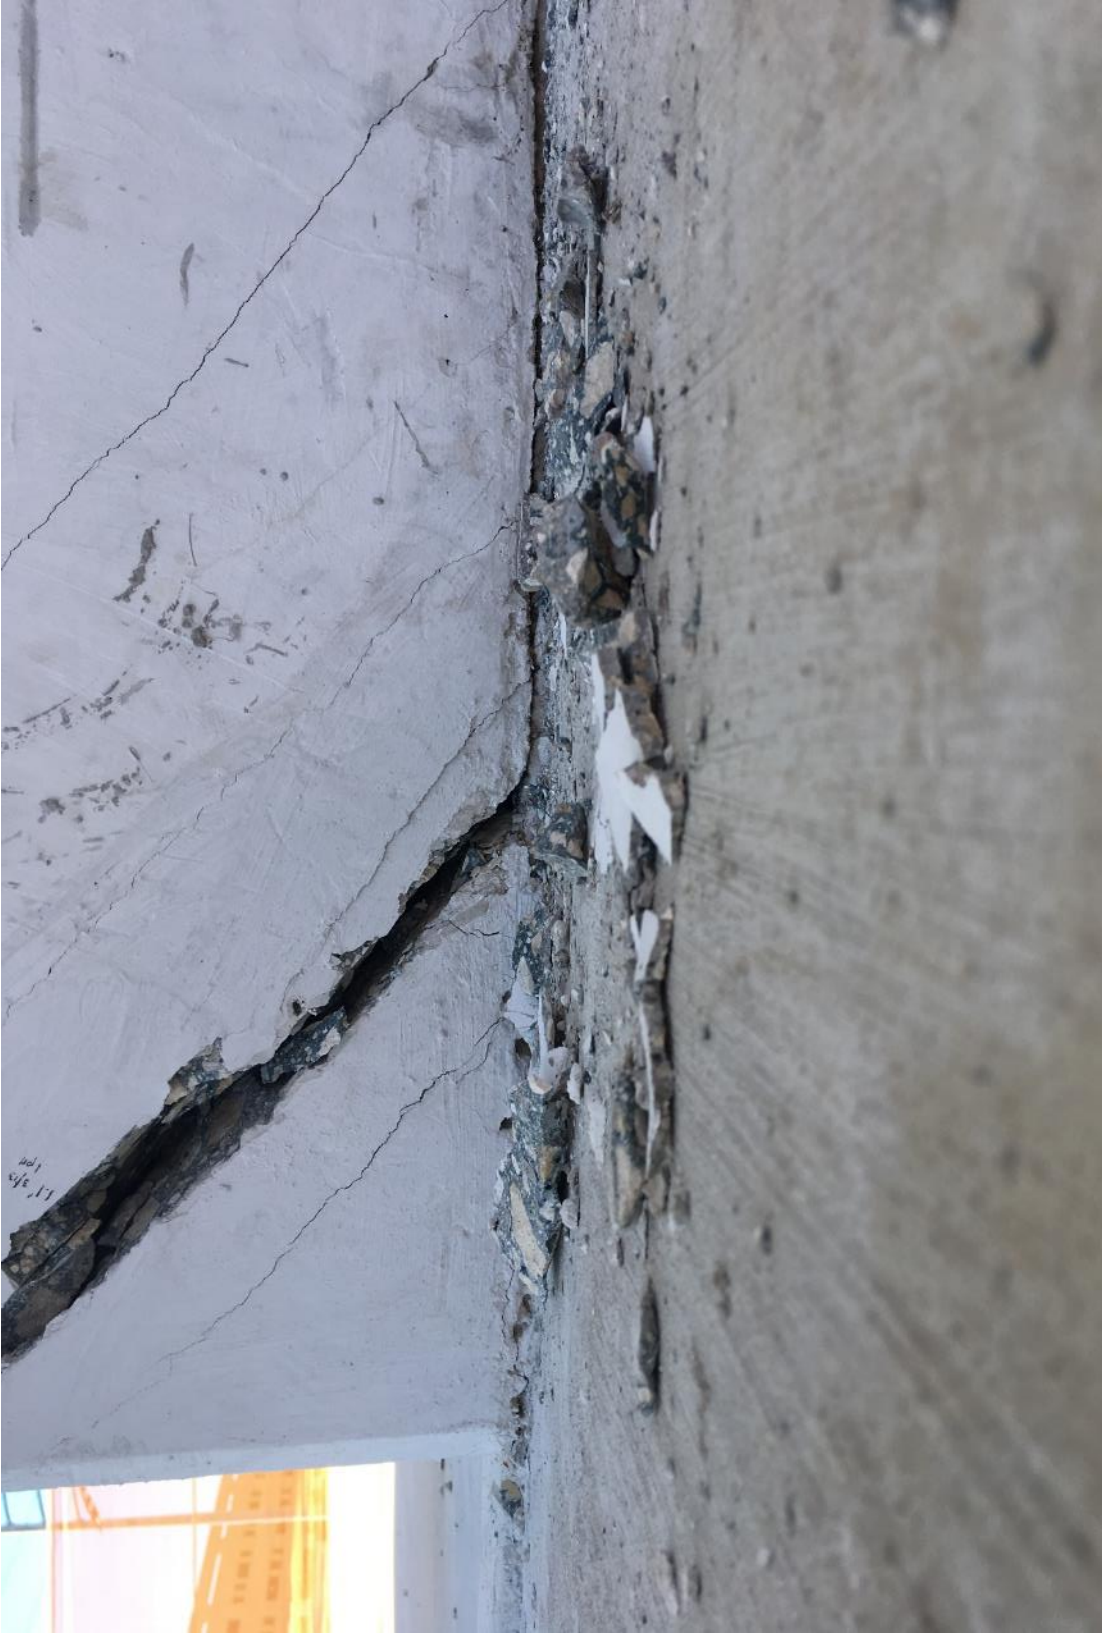
Figure 35 Cracks at the construction joint of the main span deck, diagonal 11 and the chamfer of diagonal 11 on  
3/13/2018 by BPA

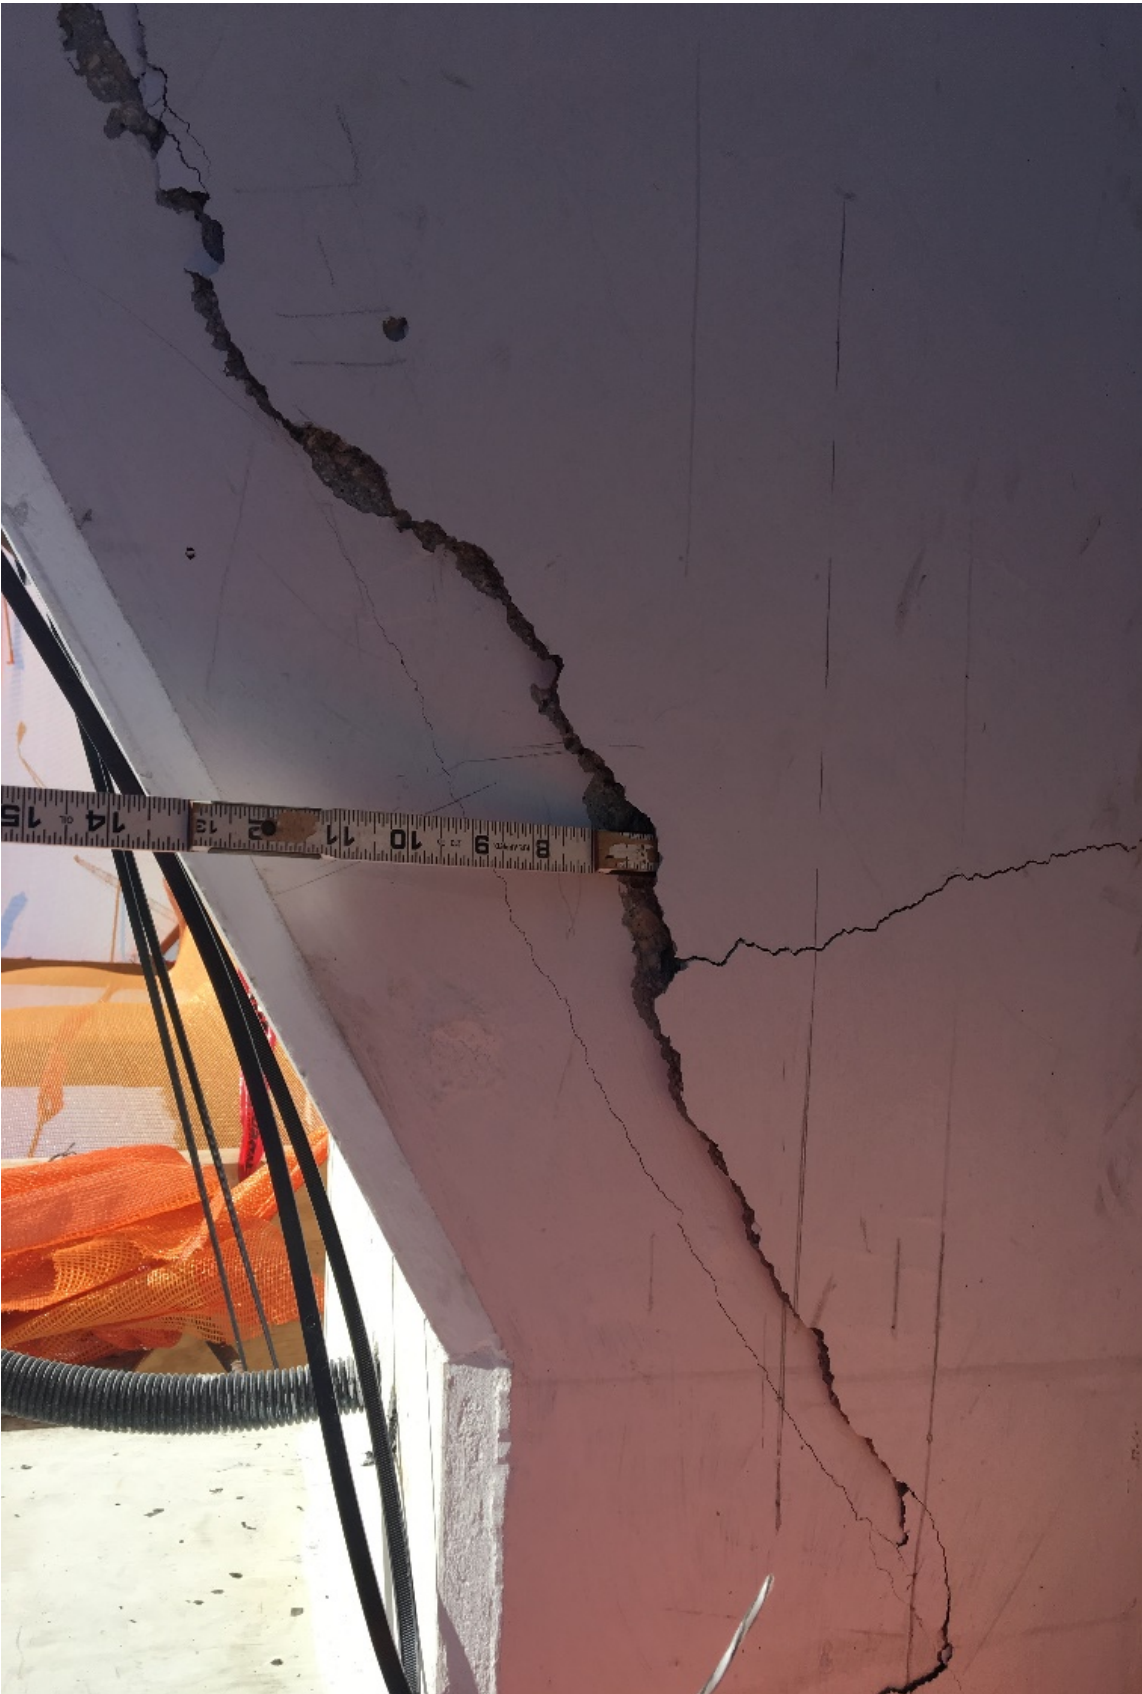
Figure 39 Close-up of longitudinal cracks in diagonal 11 on 3/14/2018 by BPA

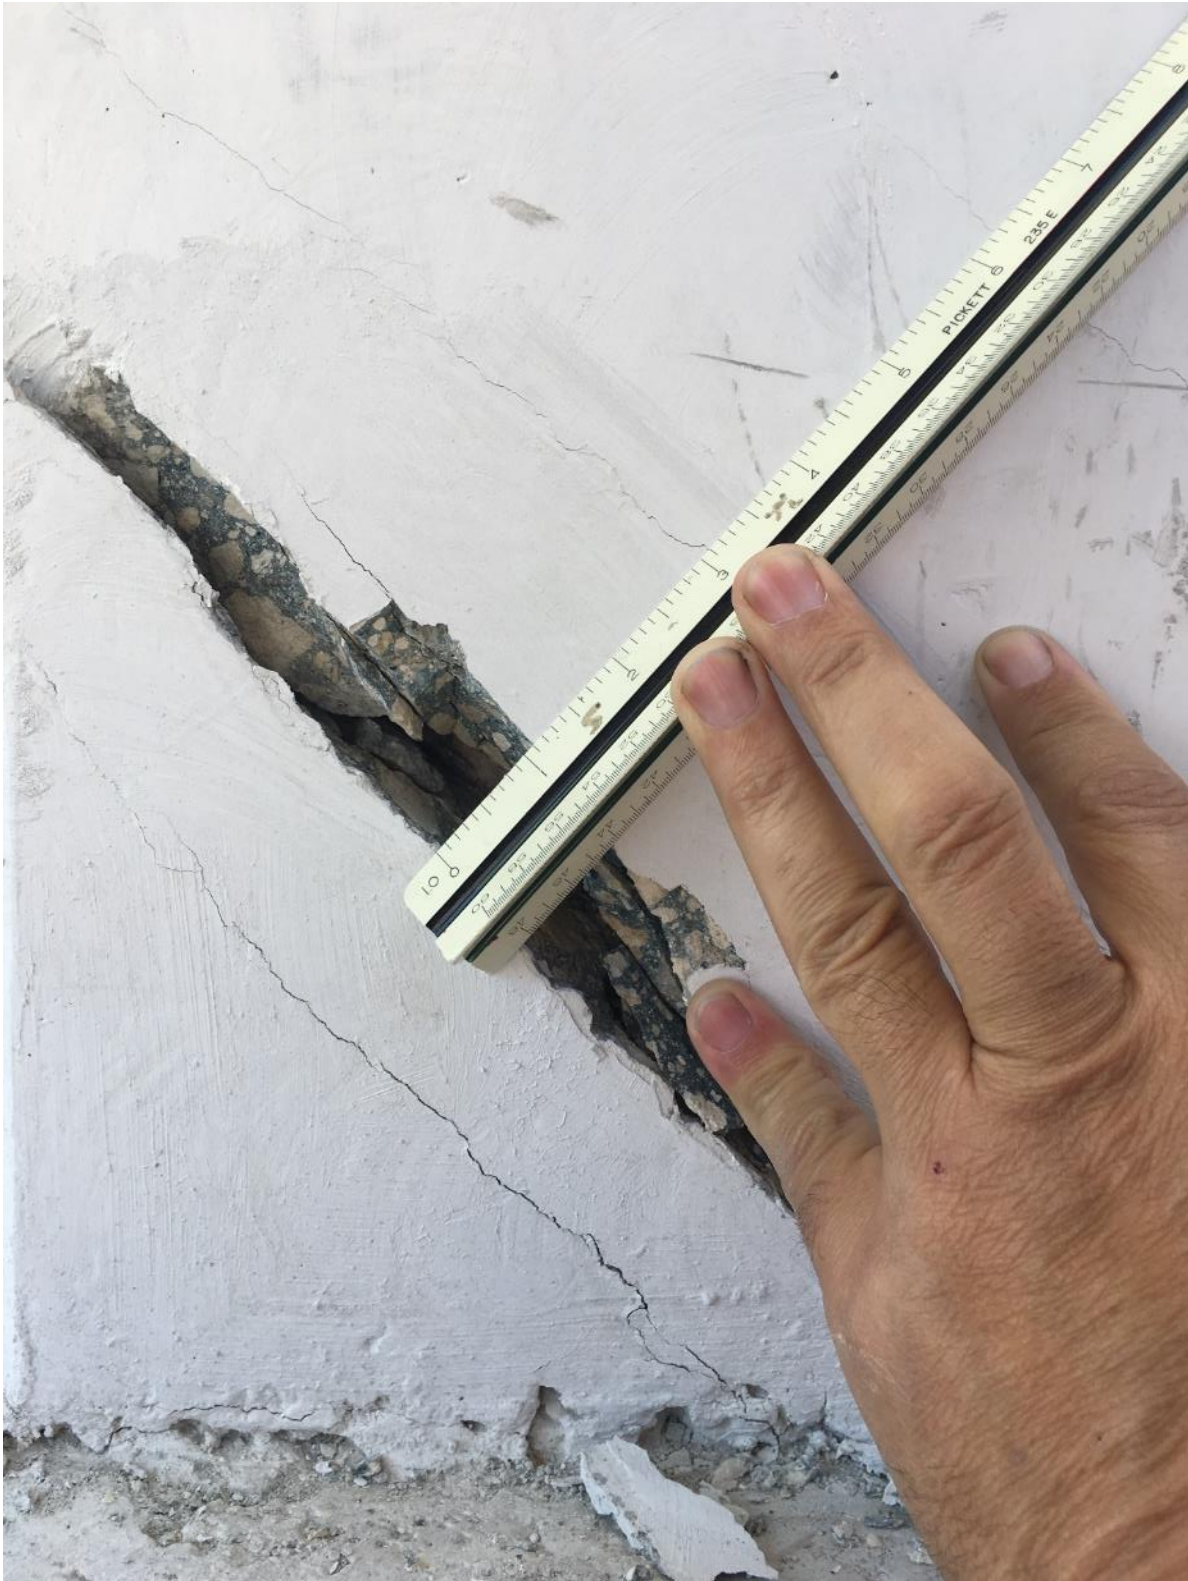
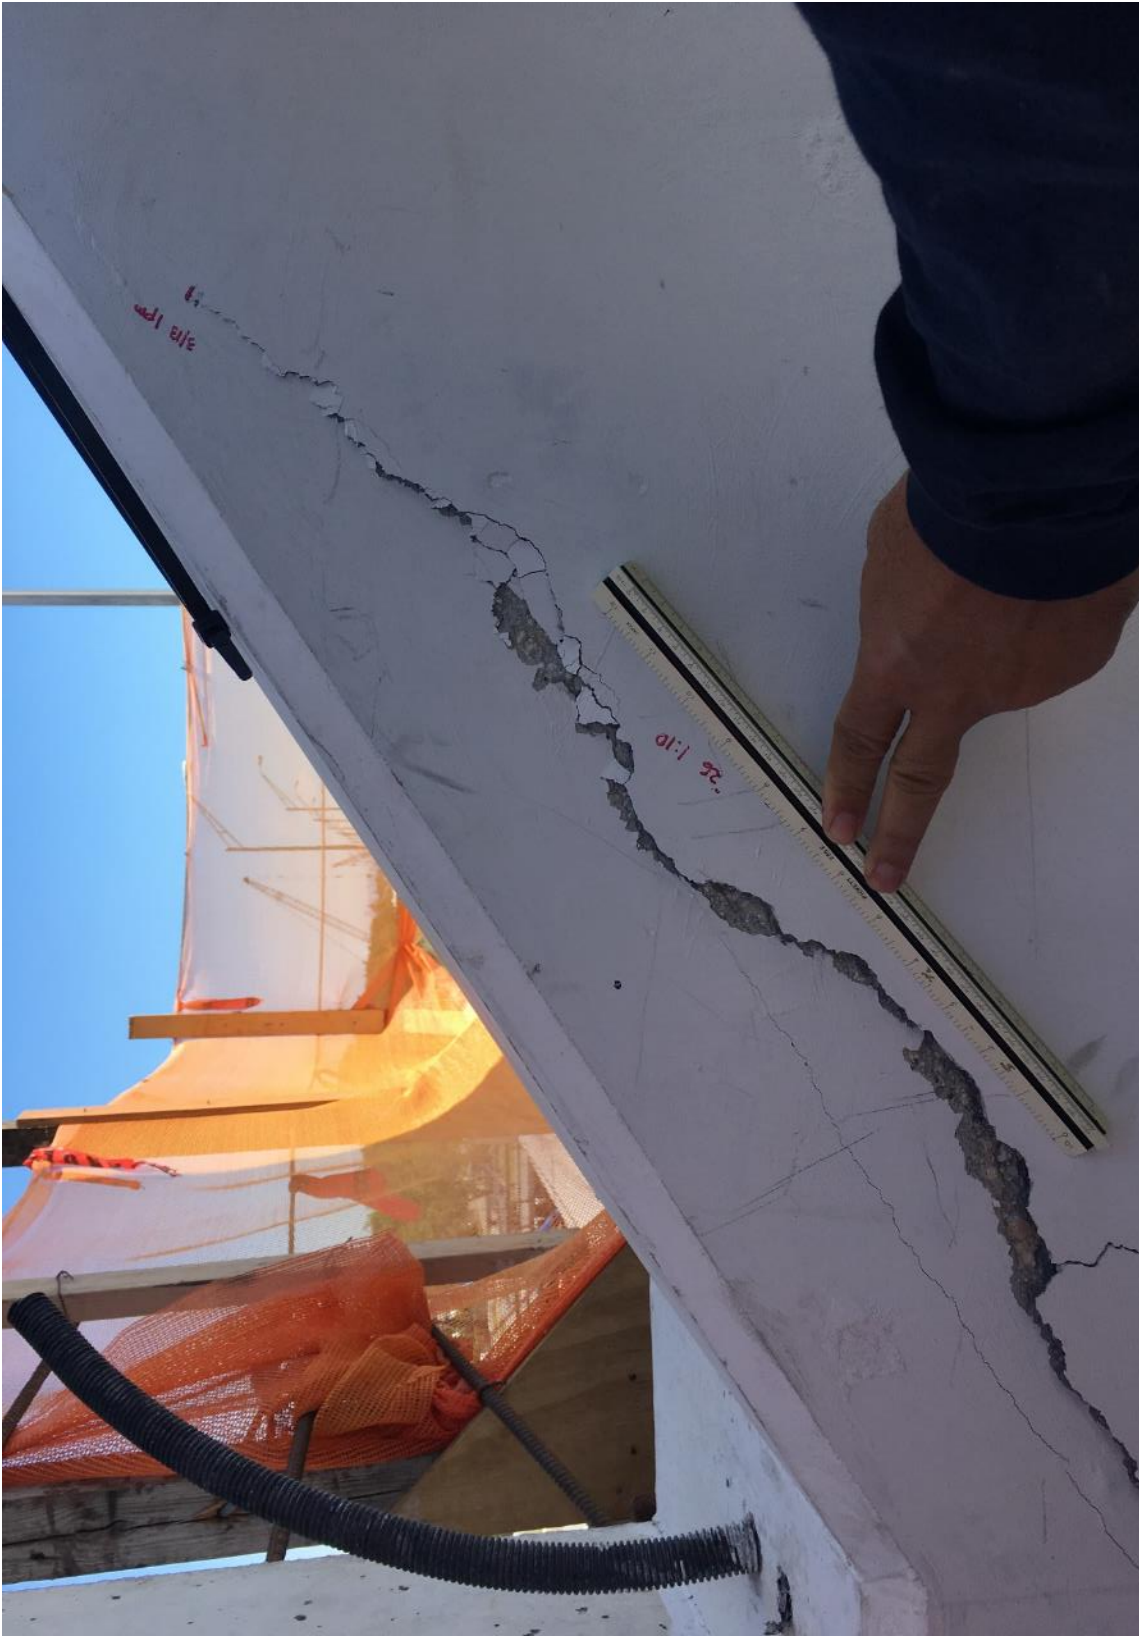
Figure 40 Close-up of longitudinal cracks in diagonal 11 on 3/13/2018 by BPA
