# Investigation of March 15, 2018 Pedestrian Bridge Collapse at Florida International University, Miami, FL

U.S Department of Labor  
Occupational Safety and Health Administration  
Directorate of Construction

June 2019

**Report prepared by**  
**Mohammad Ayub, PE, SE**  
Director, Office of Engineering Services  
Directorate of Construction  
OSHA National Office  
Washington, D.C.

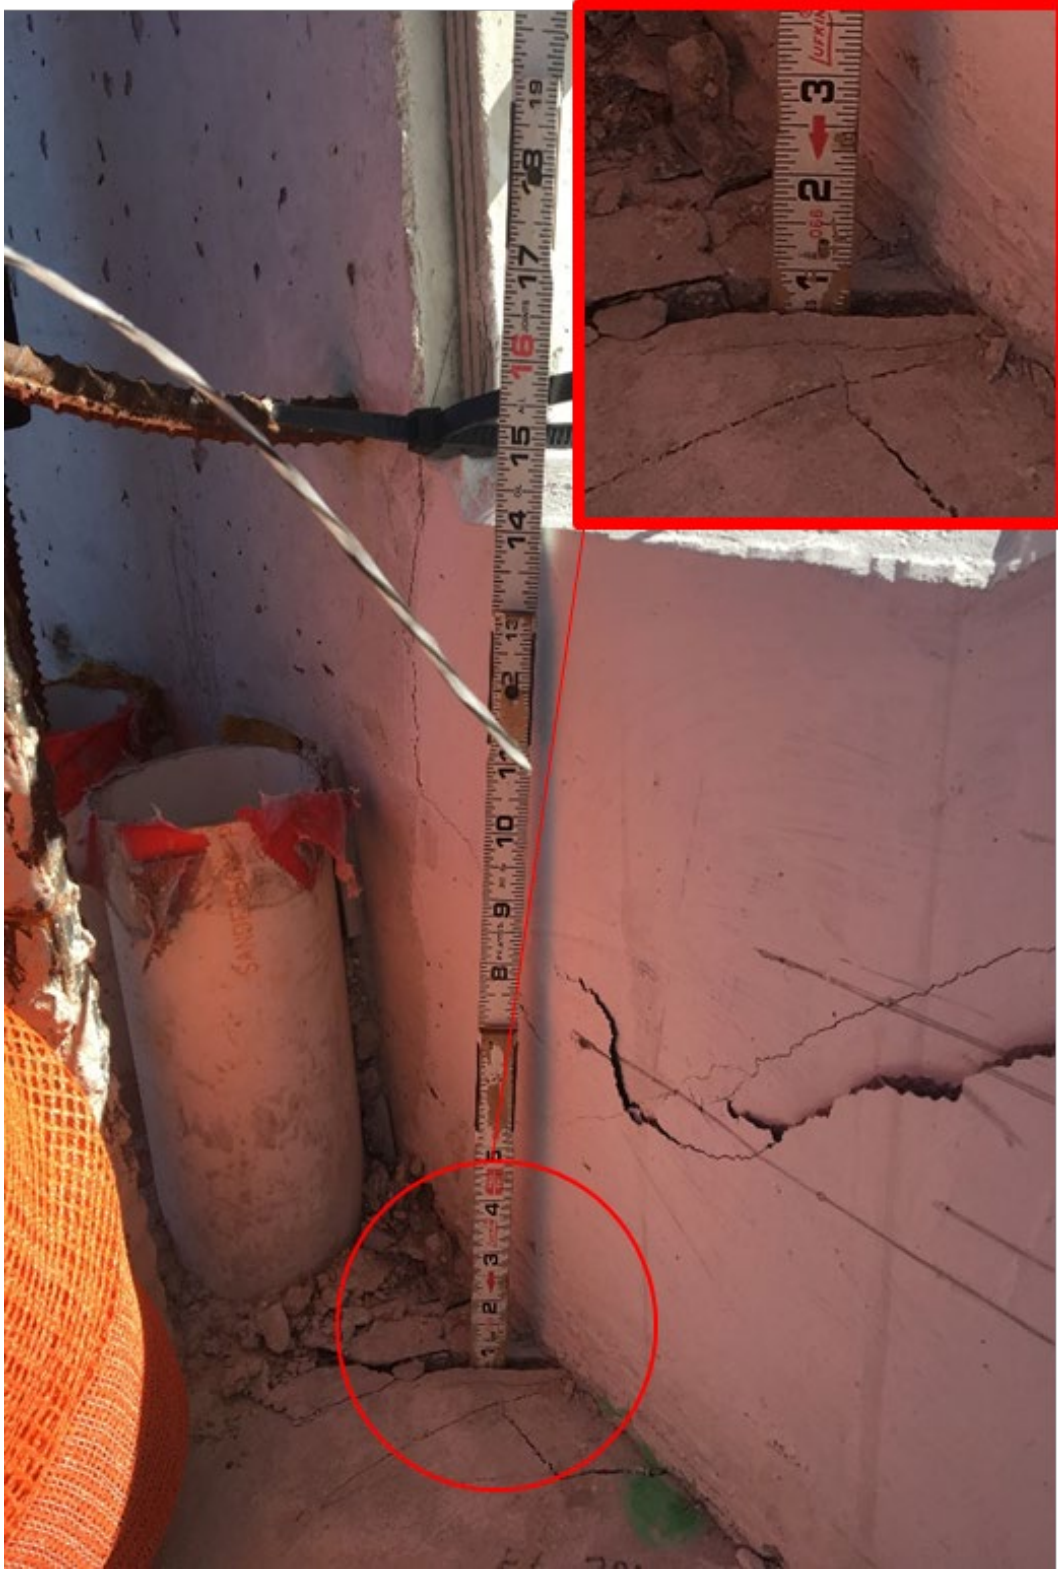
Figure 42 Cracks at the west side of diaphragm II on 3/14/2018 by BPA

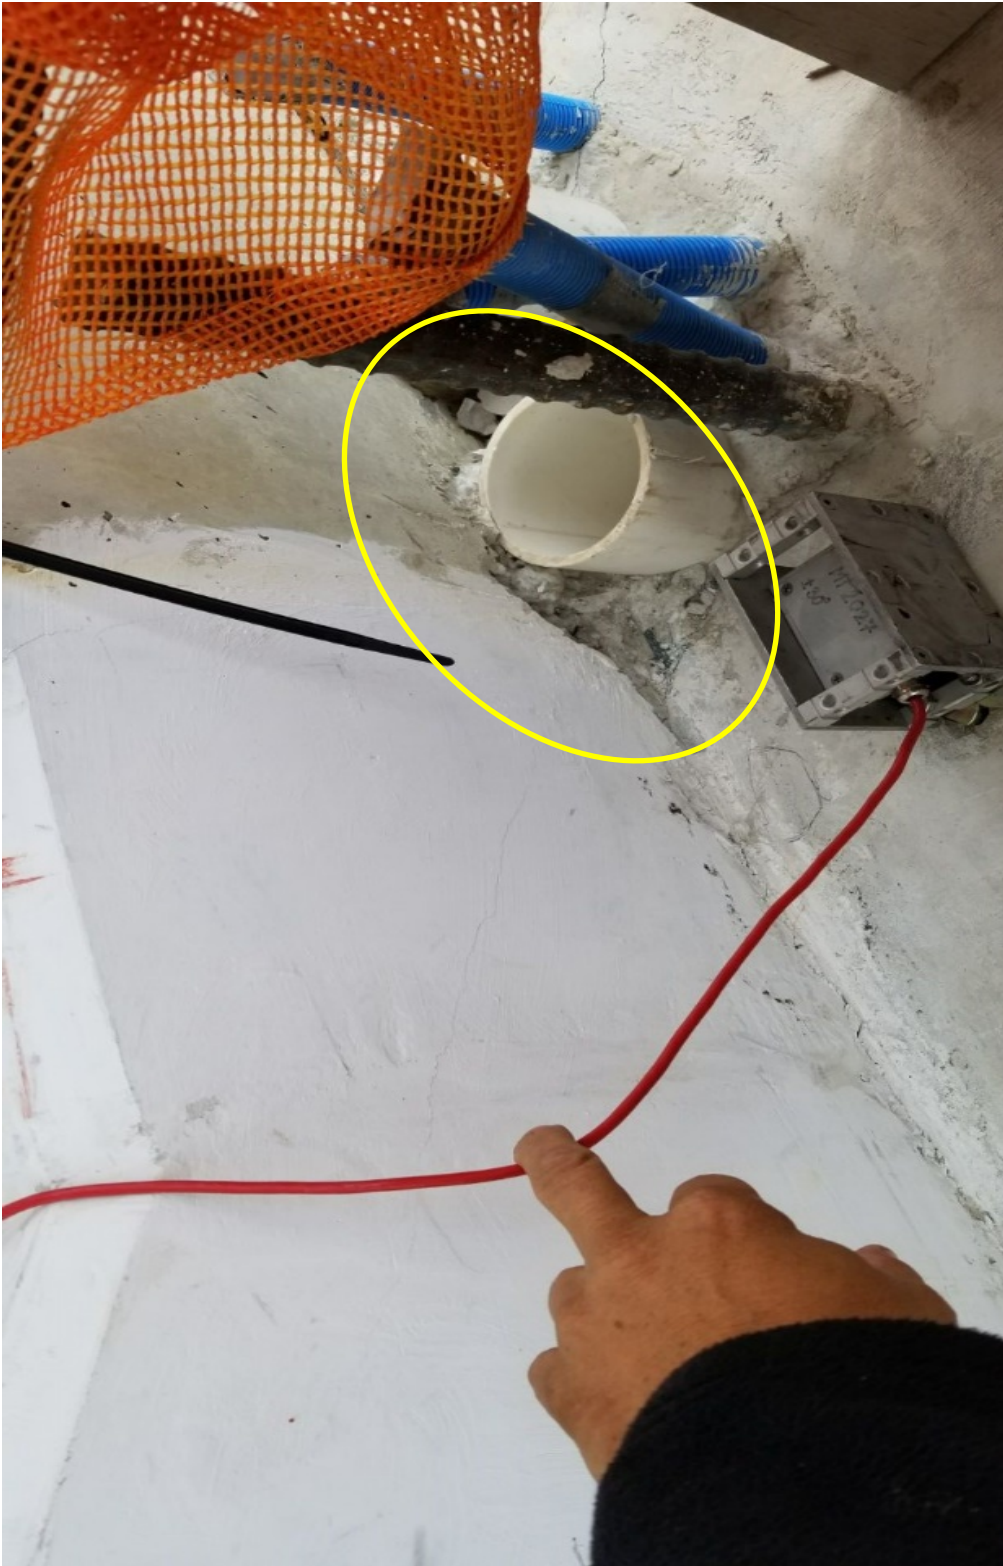
Figure 43 Cracks at the east side diaphragm II on 3/10/2018 – top face, by Corradino

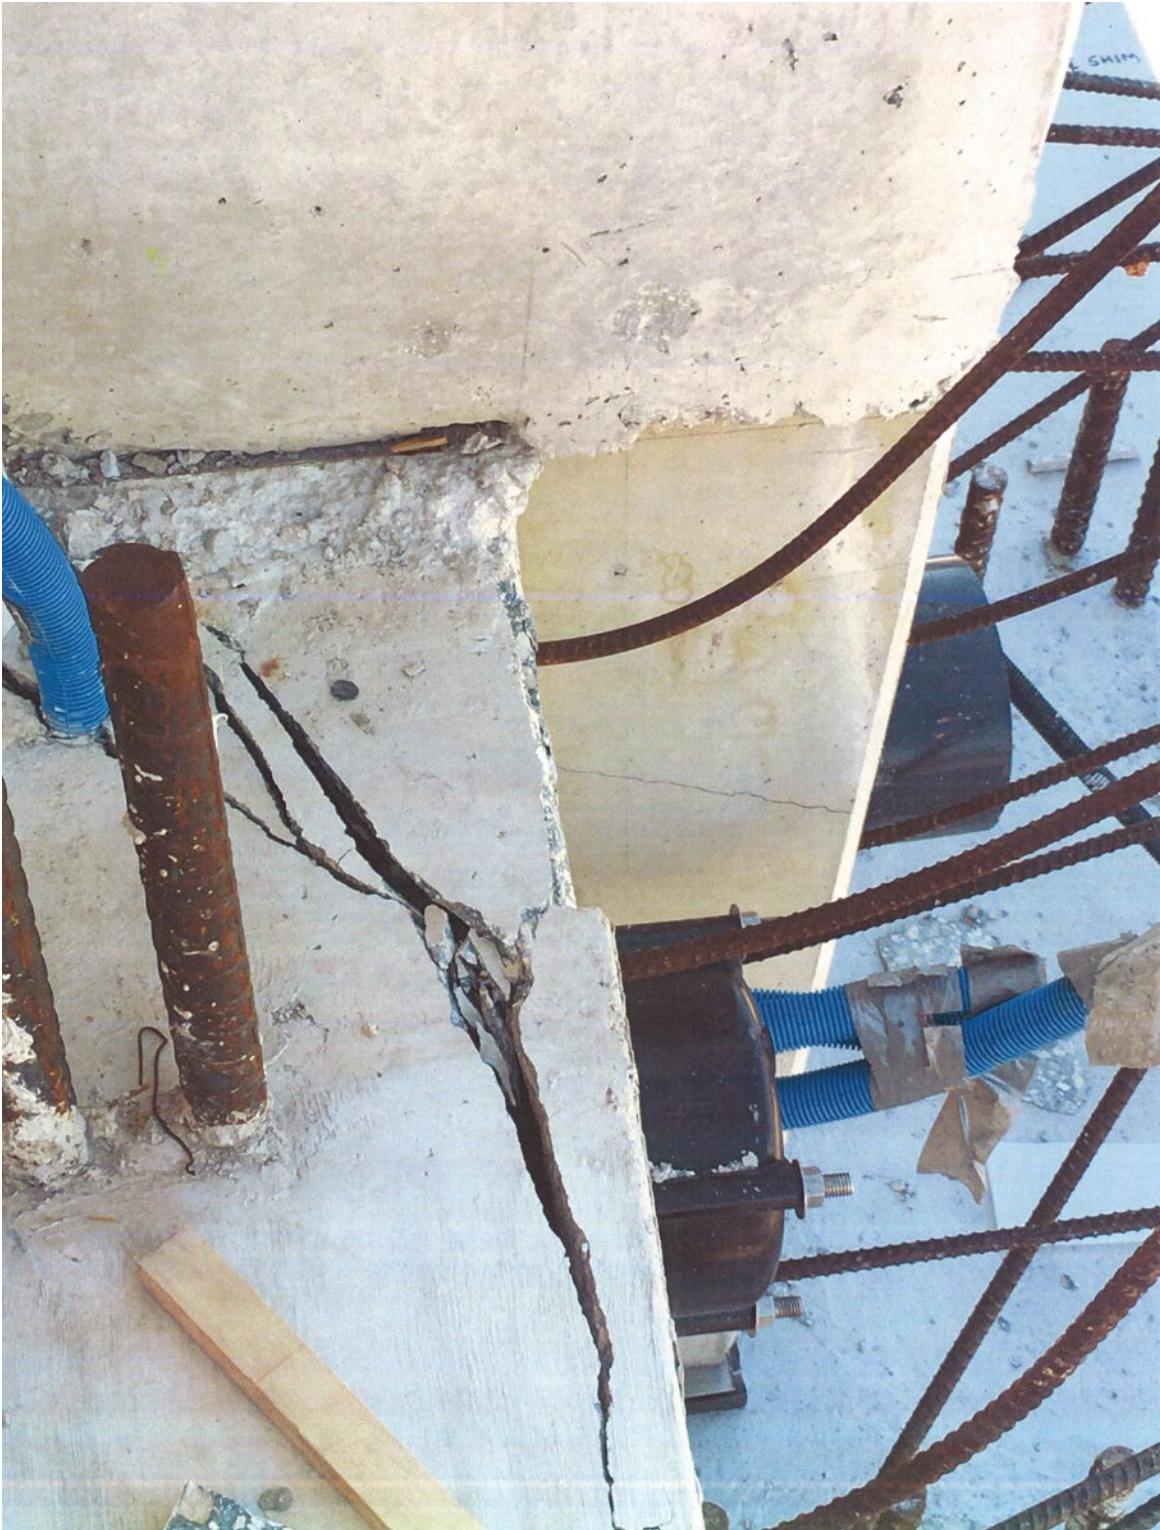
Figure 44 Cracks and movement of the column at the east side of diaphragm II on  
3/14/2018 by BPA

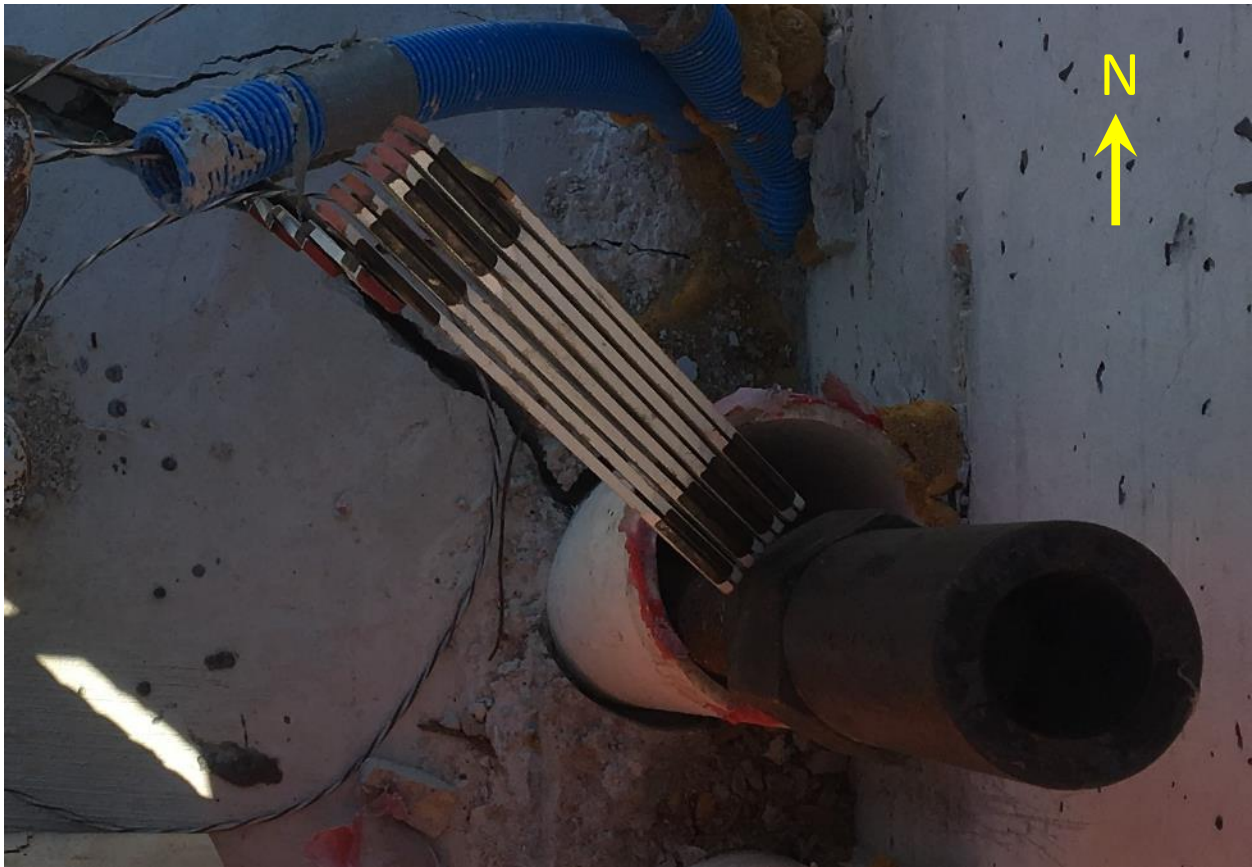
Figure 45 Note the gap indicative of movement between sleeve pipe and concrete, pictured on 3/13/2018 by BPA

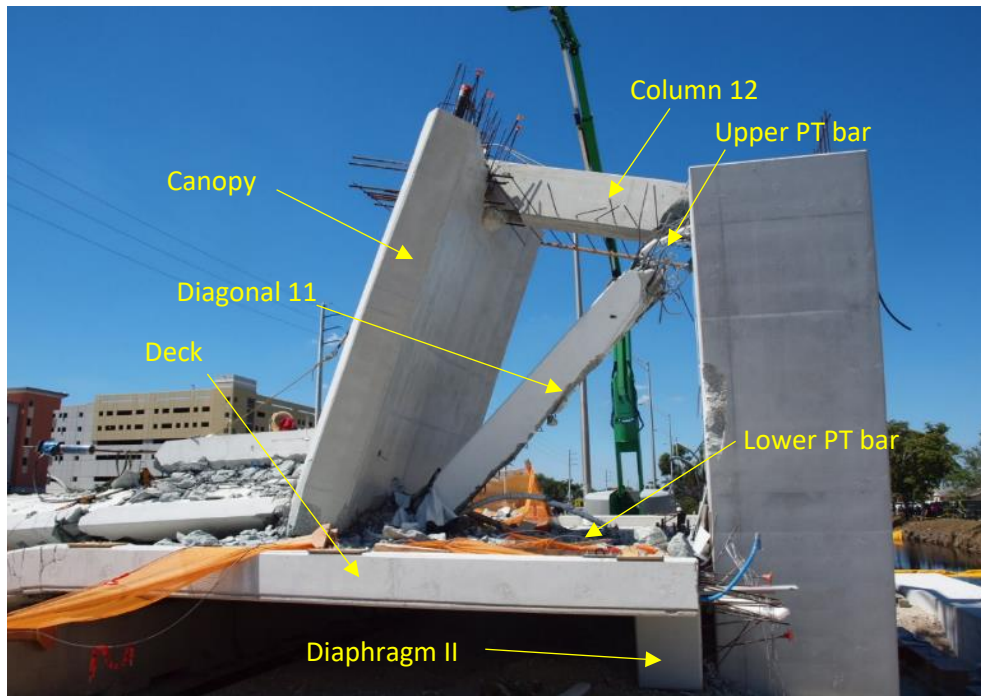
perilously attached to the bottom of the column 12 over the pylon with some rebar, and the other end remained connected to the canopy as shown in Figure 52. As a result of the blow-out, the lower end of the upper PT bar separated from the diaphragm II and rested on the top of the pylon. The lower PT bar of diagonal 11 peeled off from diagonal 11 but remained embedded in the diaphragm. The top ends of the upper and lower PT bars in diagonal 11 remained in the blister. The upper PT bar lost its tension completely and so did the lower PT bar which still carried the Jack used to re-tension the PT bars. The deck laid down approximately 140 feet flat on the ground covering all the four east bound lanes, and three west bound lanes, as shown in Figure 51. The south end of the deck and column 1 were still precariously on the top of the south pier, see Figure 52. The column 1 tilted approximately 15 degrees towards the north with canopy firmly attached. All diagonals other than diagonals 2, 3 and 4 were crushed. The canopy laid flat approximately 80 ft. over the fallen deck. Two blisters on the south side remained intact with the canopy but the rest of the blisters were badly damaged. The blisters at the junction of diagonal 11 and 10 were damaged with the bottom PT bar extending beyond the blister with the ram still attached to the PT bar. As a result of the blow-out, three #7 shear reinforcements at the construction joint of diagonal 11 and the deck were sheared but the southernmost shear reinforcement remained intact. The width of the blow-out was 2 ft. at the southern end gradually enlarging towards the north. The blow-out encompassed the two 4" pipes on either side of column 12, and was symmetrical to the center line of the deck.

Figure 52 Column 12, diagonal 11 and part of the canopy after bridge deck and diaphragm fell to the ground, March 17, 2018, by OSHA

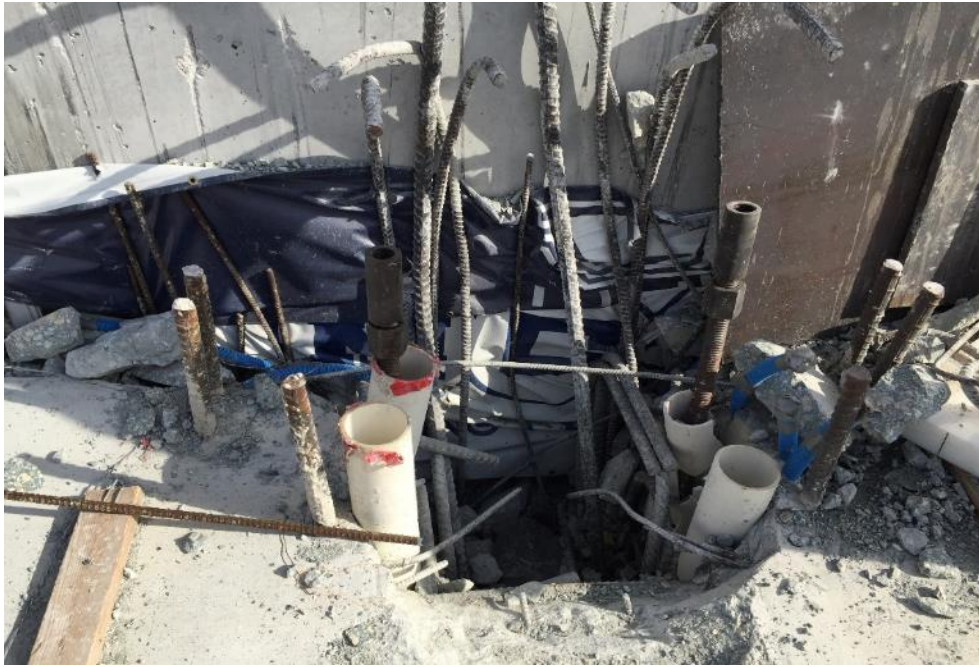
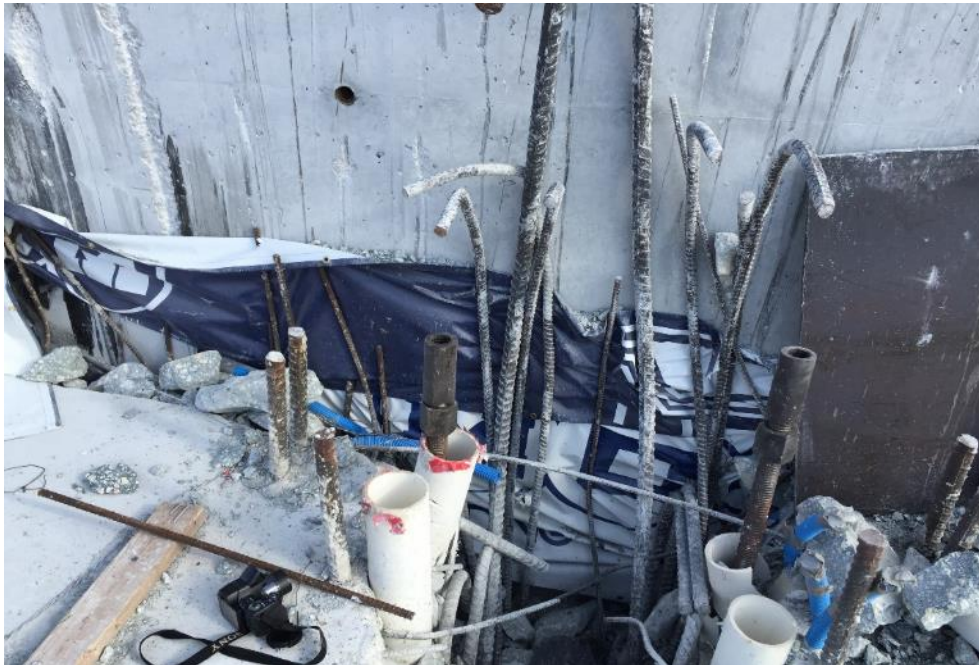
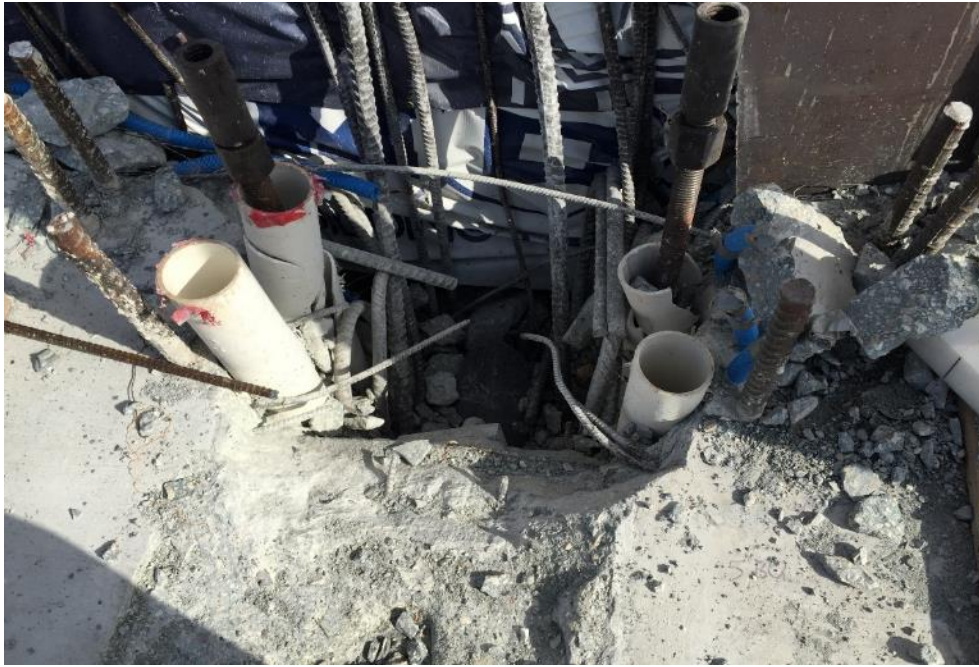
Figure 58 Concrete blow-out failure in Diaphragm II at the time of bridge collapse at the site looking north from south, March 21, 2018, by OSHA

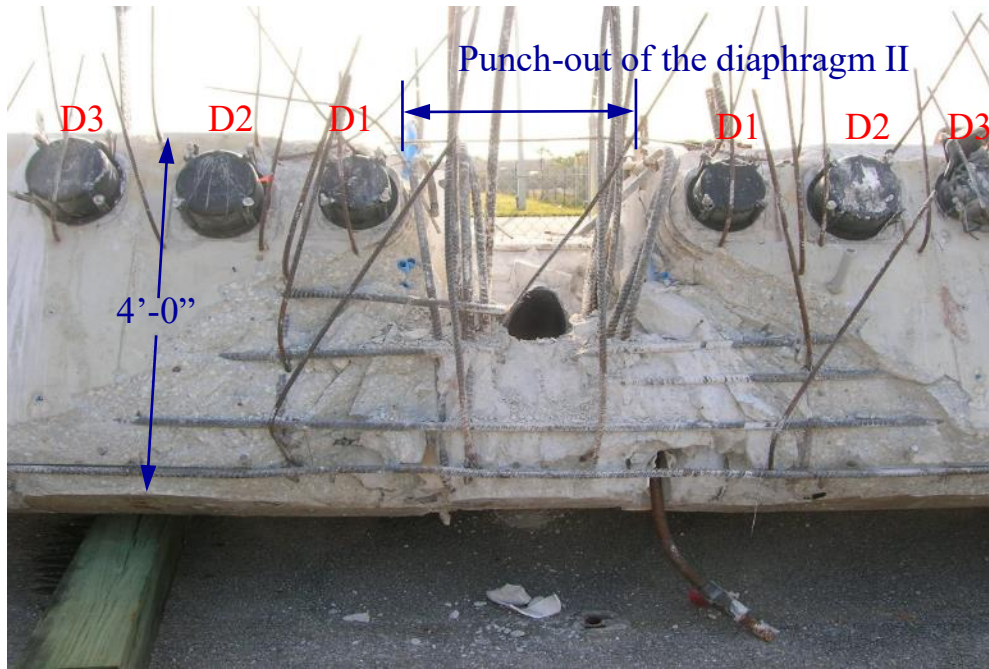
Figure 62 Concrete blow-out failure in Diaphragm II at the time of bridge collapse in the storage yard looking north from south, April 9, 2018, by OSHA

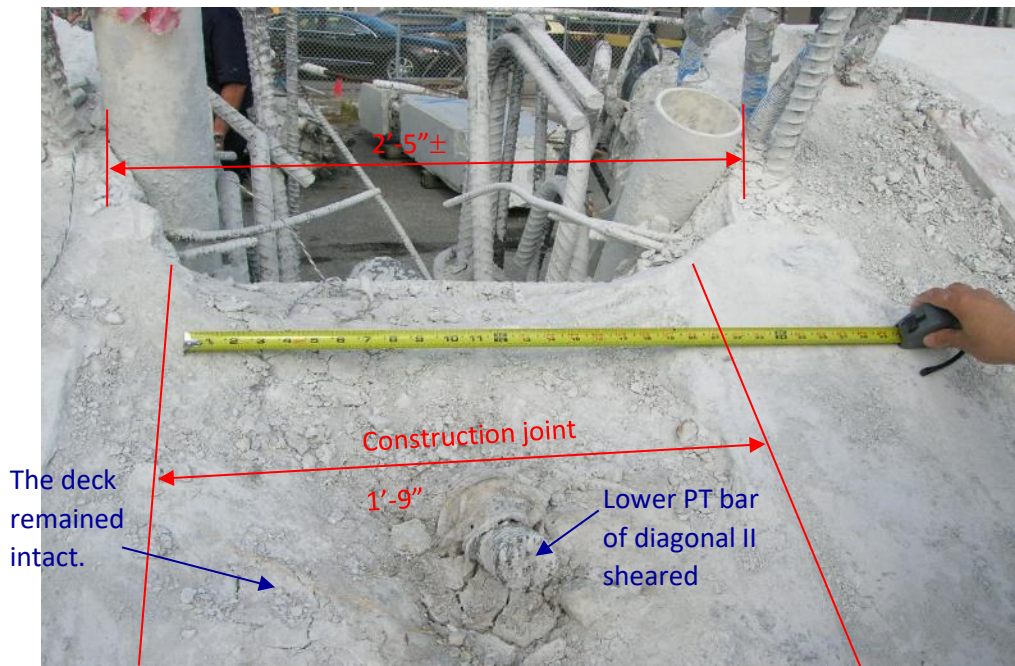
Figure 63 Blow-out hole in Diaphragm II at the time of the bridge collapse in the storage yard looking north from south, April 9, 2018, by OSHA

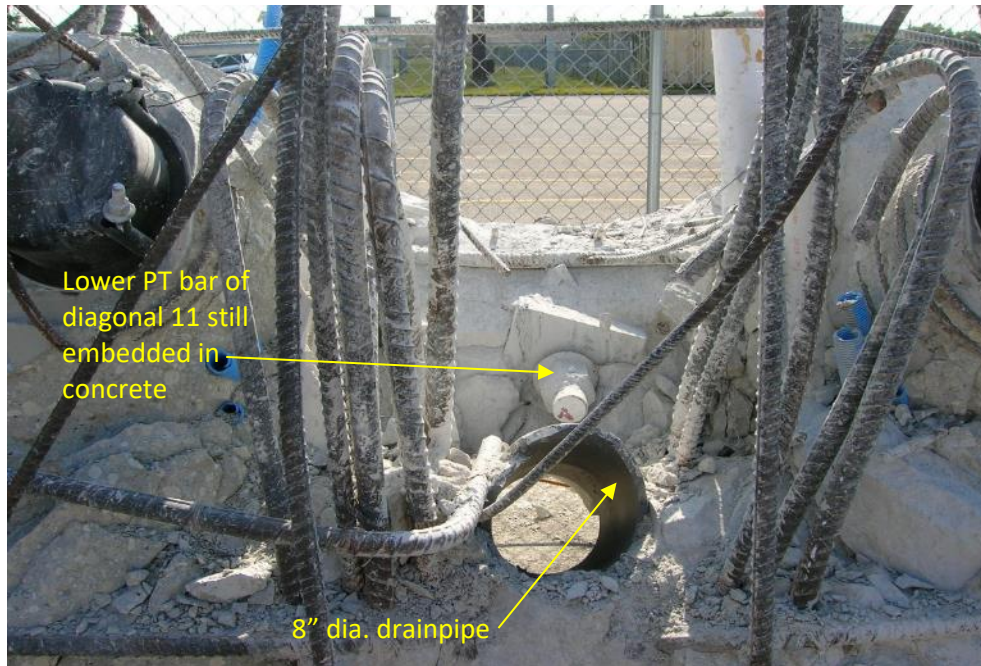
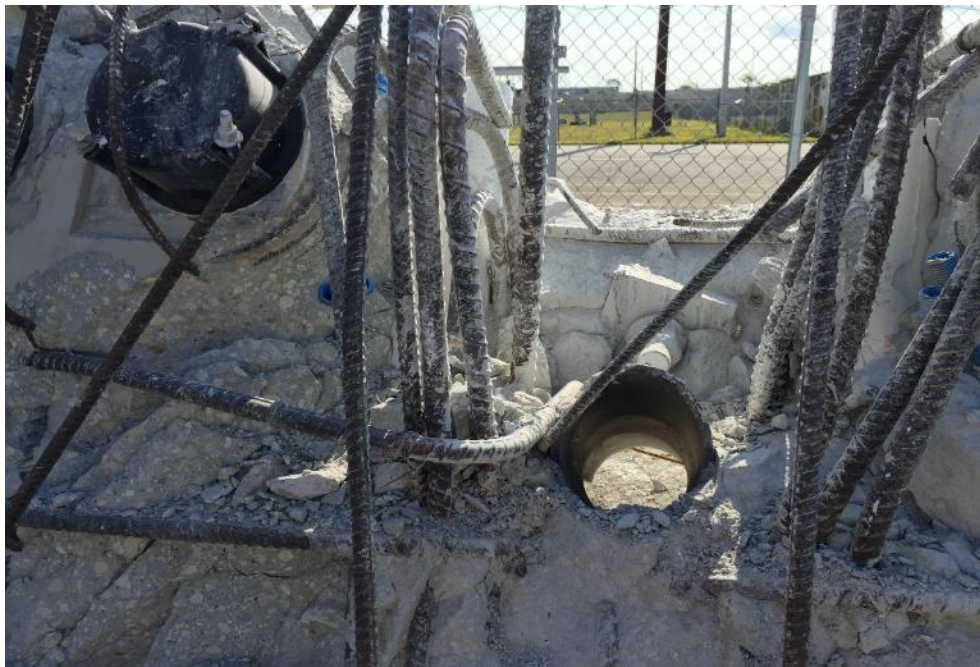
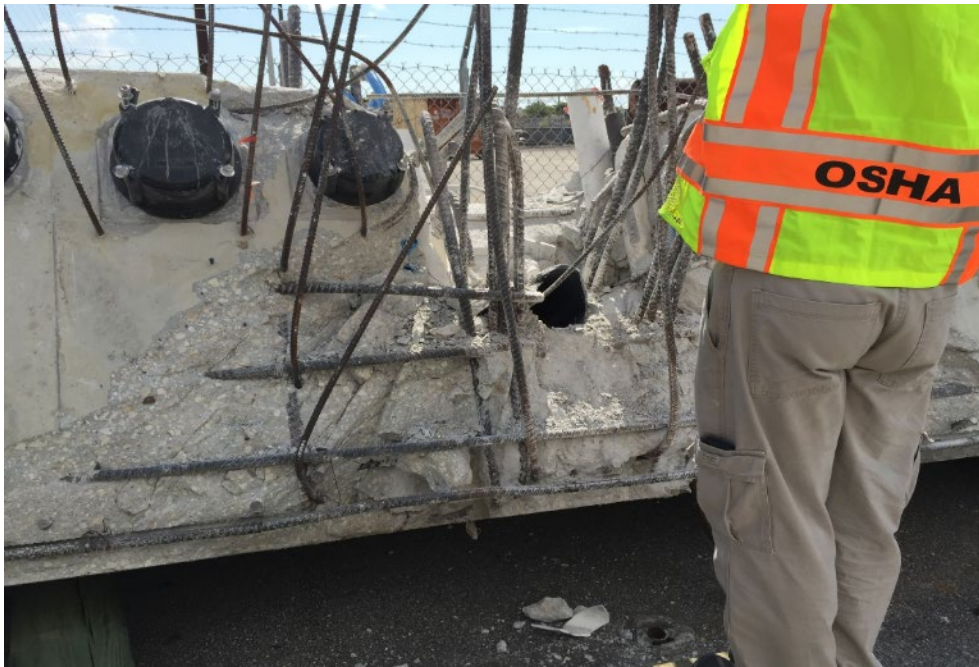
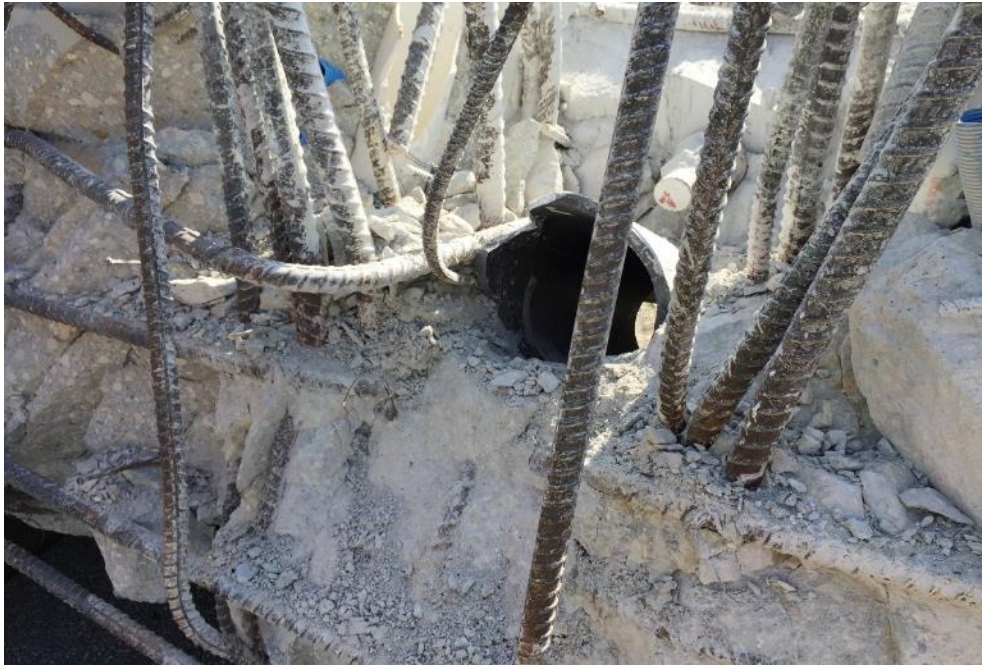
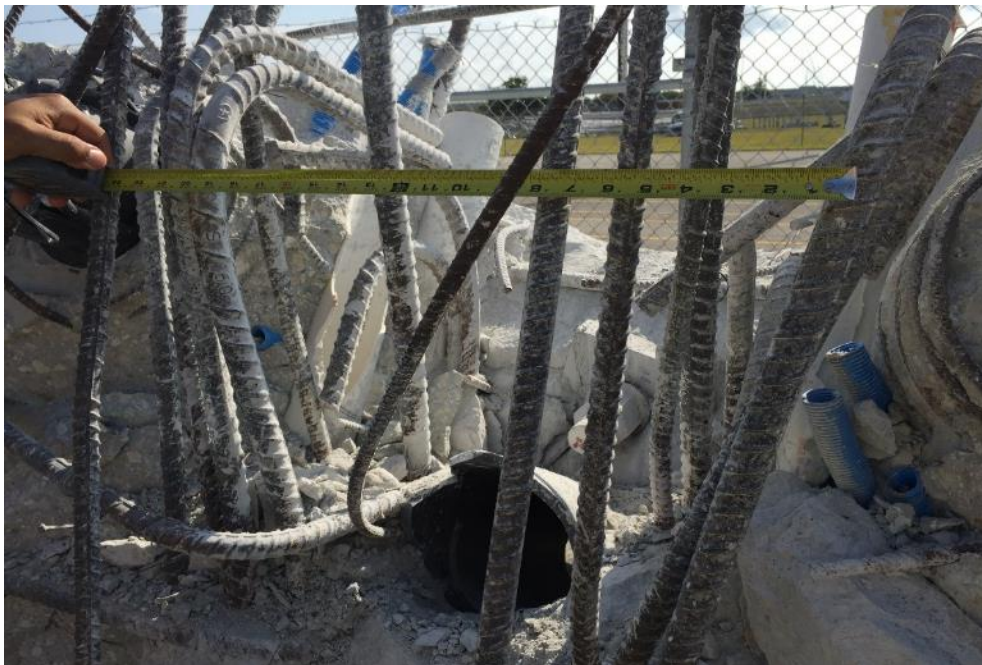
Figure 64 Punched hole in Diaphragm II at the time of the bridge collapse – from south looking towards north, April 9, 2018, by OSHA

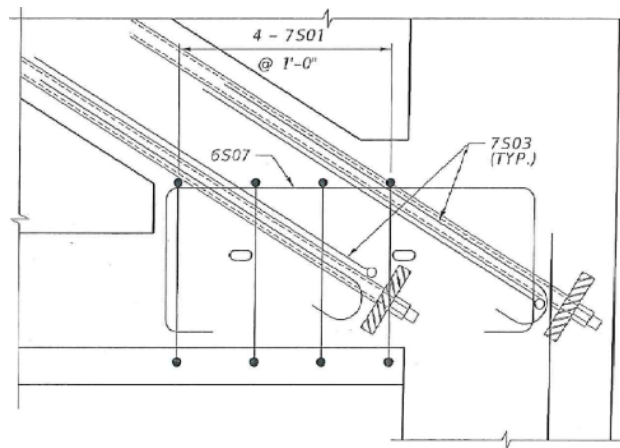
Figure 77 Construction joint detail at diagonal 11 and deck.

Reproduced below in Figure 77 is the detail entitled “Truss members 11 & 12 connection detail” from drawing B-61 with construction joint identified. Industry standard is to “consider shear transfer across a given plane, such as an existing or potential crack, an interface between dissimilar materials or an interface between two concrete cast at different times.” The construction joint at the bottom of the diagonal 11, therefore, qualifies for evaluation of the shear friction. This bridge is a concrete truss bridge weighing approximately 1,900 kips. Therefore the forces in the truss members are high. We will analyze the construction joint for shear friction by LRFD Bridge Design Specifications by AASHTO, seventh edition.

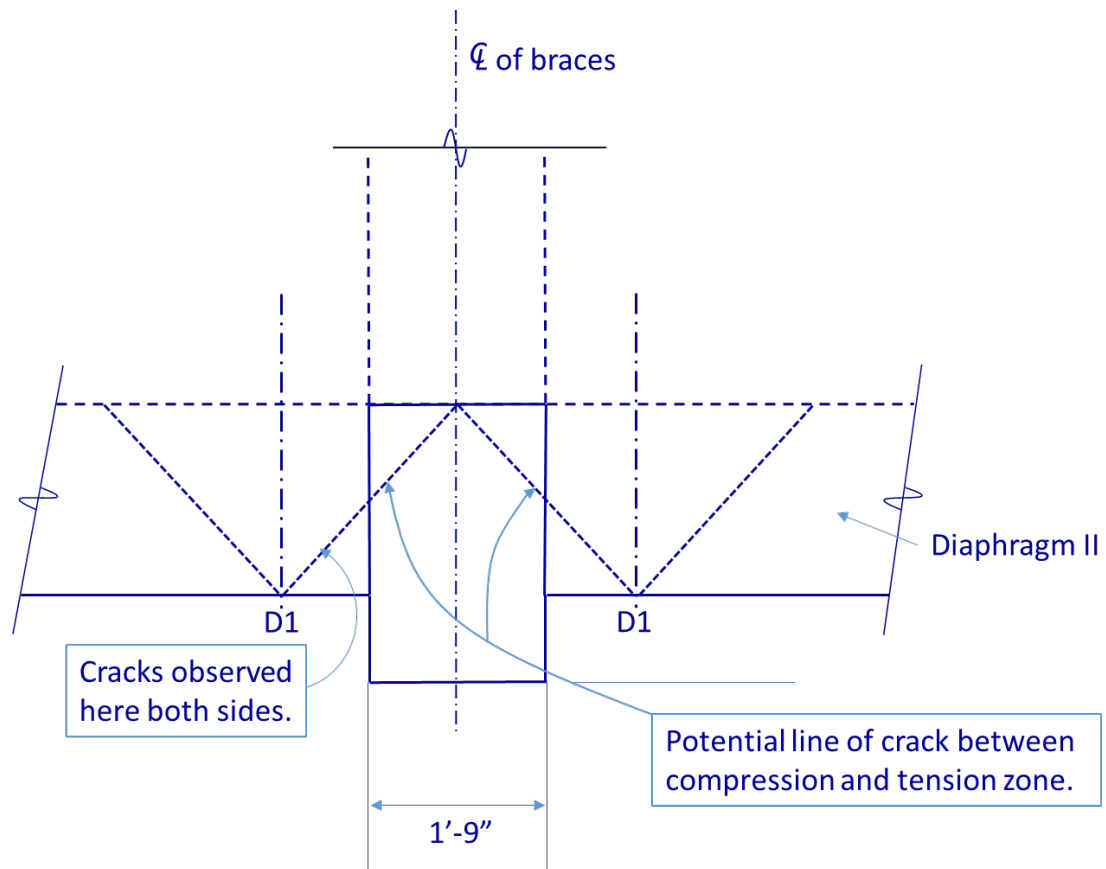
A 12" dia. semicircular cut was made in the center of the deck to accommodate an 8" round drain pipe. This not only reduced the cross sectional area of the deck at the key location but prevented the placement of any PT tendons or heavy mild reinforcement to capture the horizontal force from the deck. There was a 4" and 4½" diameter plastic pipe placed right against the columns in diaphragm II. Such locations often act as a crack initiator.

Figure 78 Potential line of crack – plan view

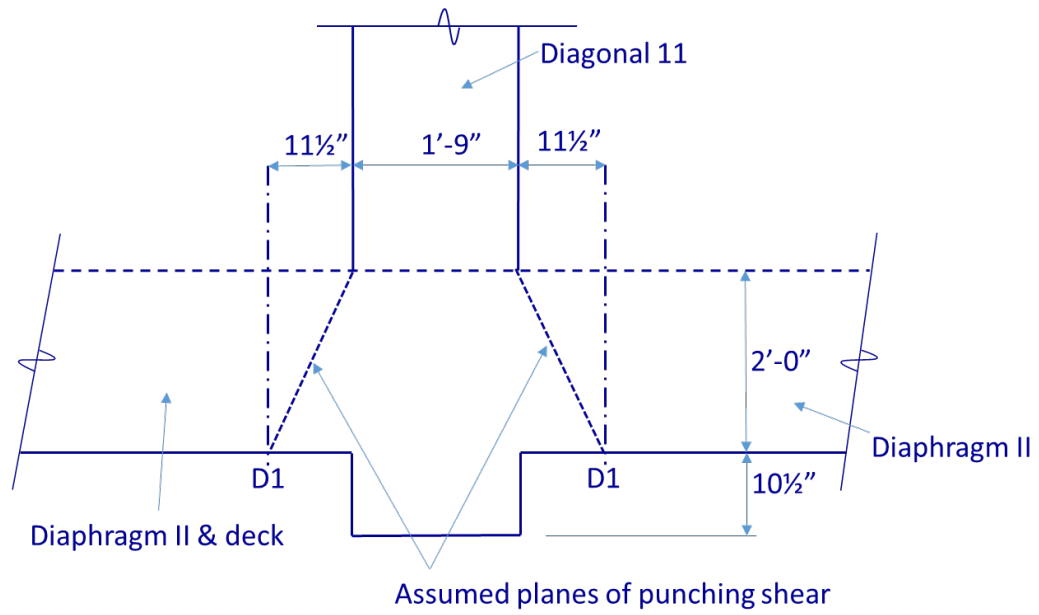
Figure 79 Potential Punching shear failure at north end – plan view
