# Investigation of March 15, 2018 Pedestrian Bridge Collapse at Florida International University, Miami, FL

U.S Department of Labor  
Occupational Safety and Health Administration  
Directorate of Construction

June 2019

**Report prepared by**  
**Mohammad Ayub, PE, SE**  
Director, Office of Engineering Services  
Directorate of Construction  
OSHA National Office  
Washington, D.C.

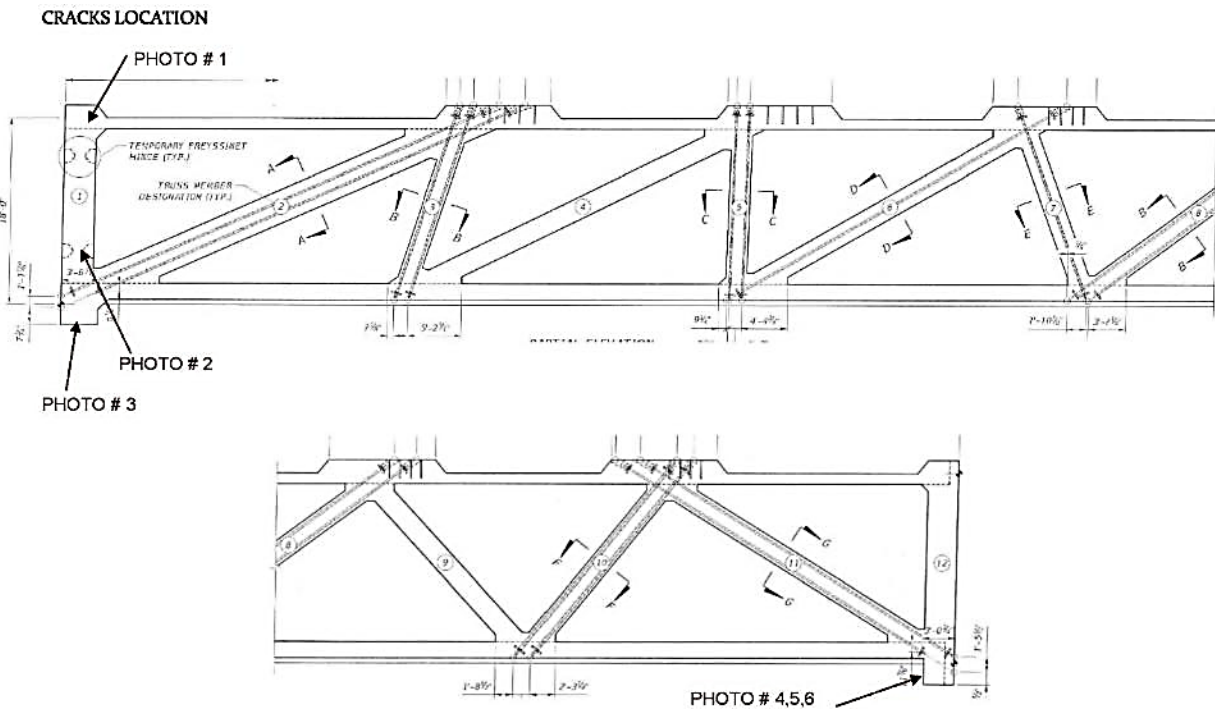
Figure 21 Location of cracks in 2/28/2018 E-mail from MCM to FIGG as per BPA

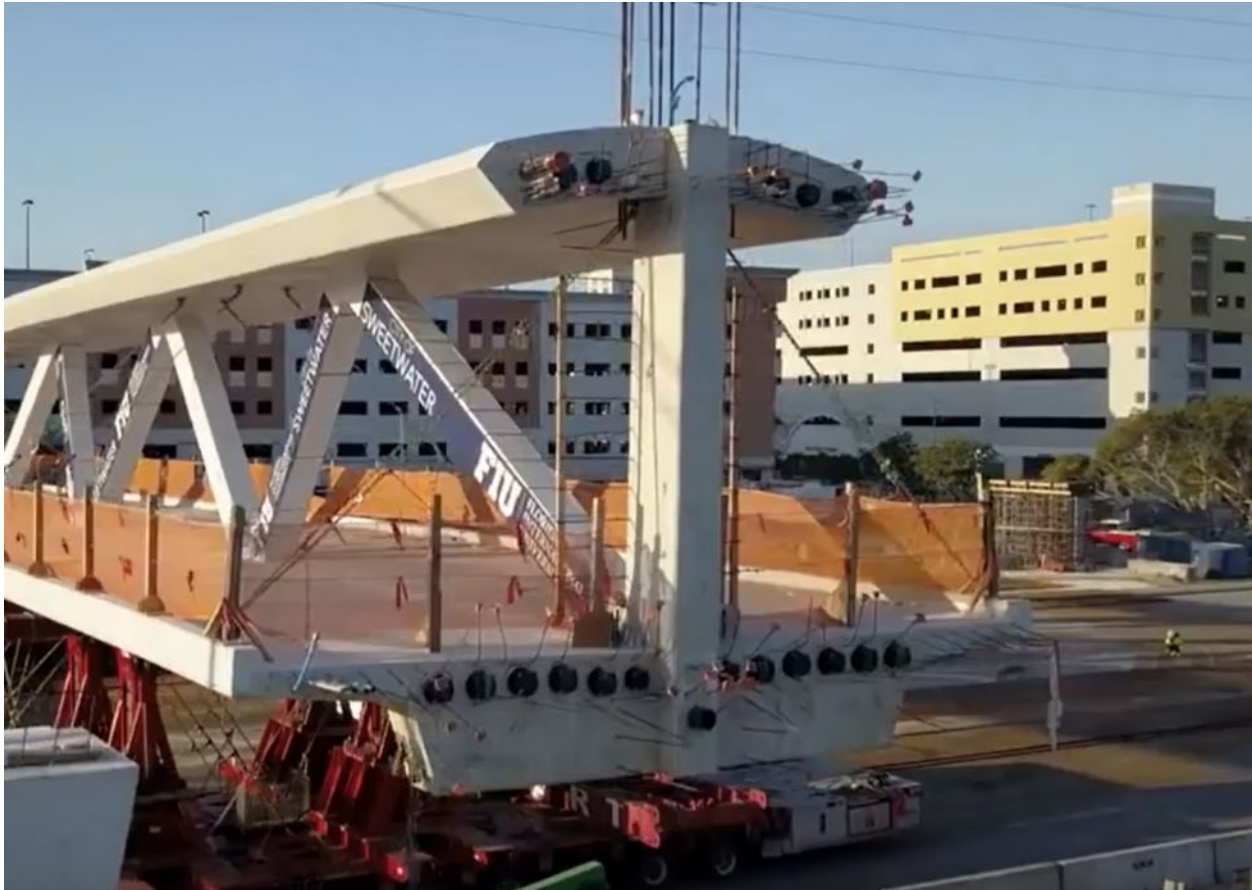
March 10, 2018 Truss was transported by SPMT and placed on the pier and the pylon, and were generally free of cracks other than those mentioned above, and as shown in the following pictures.

Figure 22 North end of the main span truss during transportation, generally free of cracks

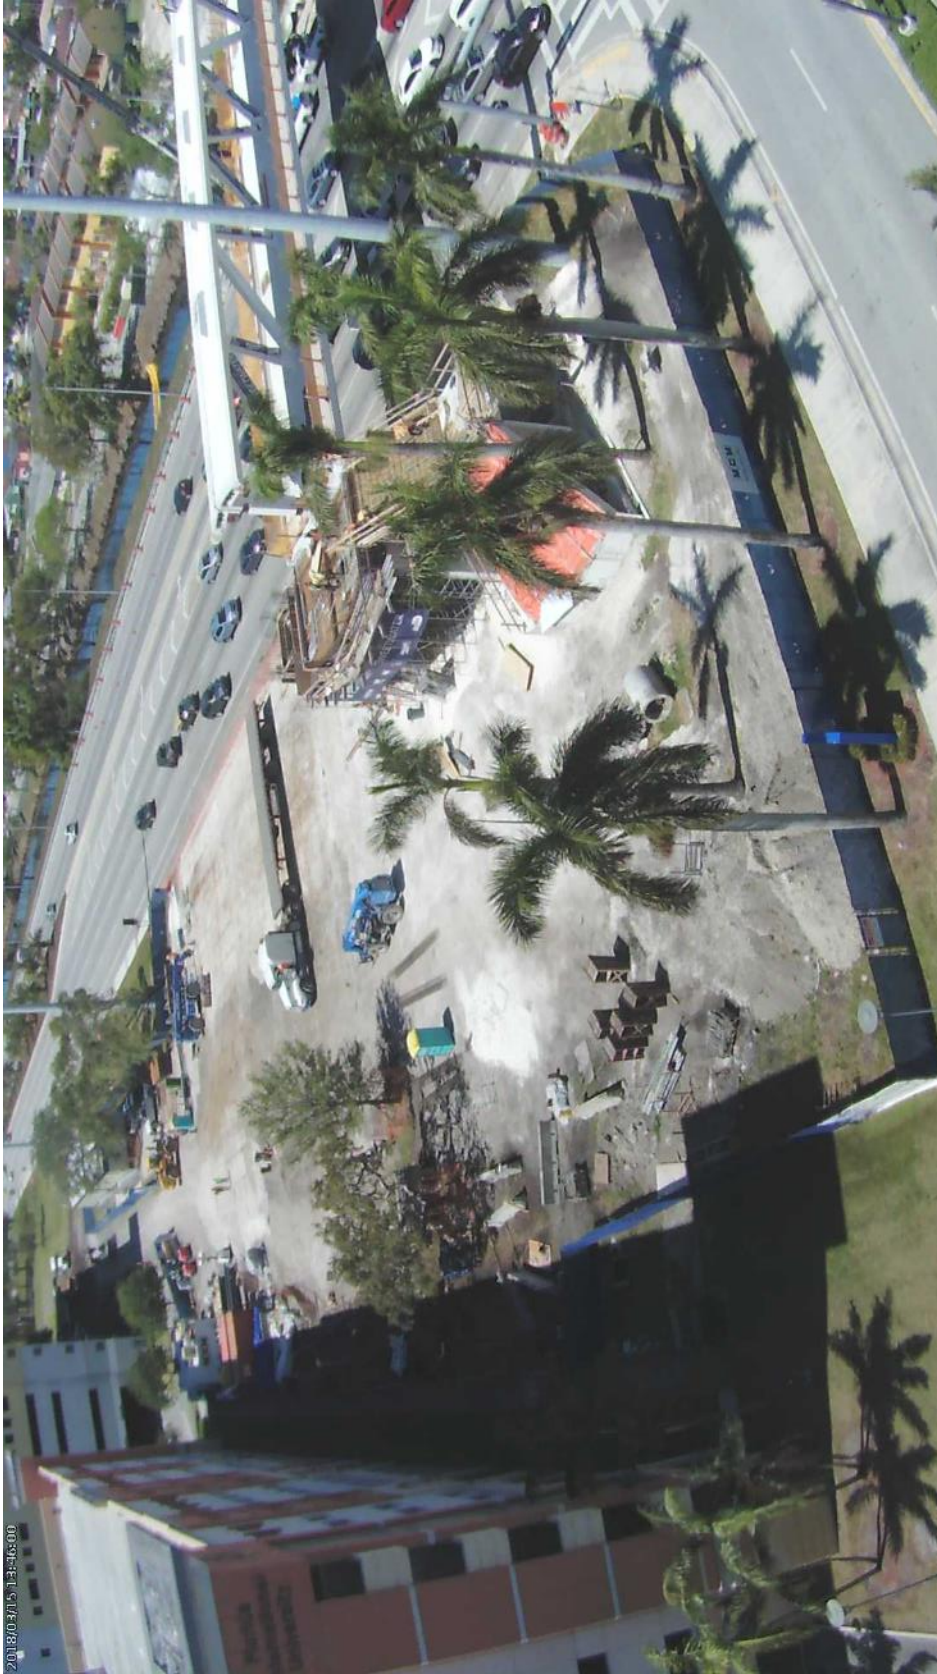
Figure 46 Bridge immediately prior to the collapse, March 15, 2018 – camera #1

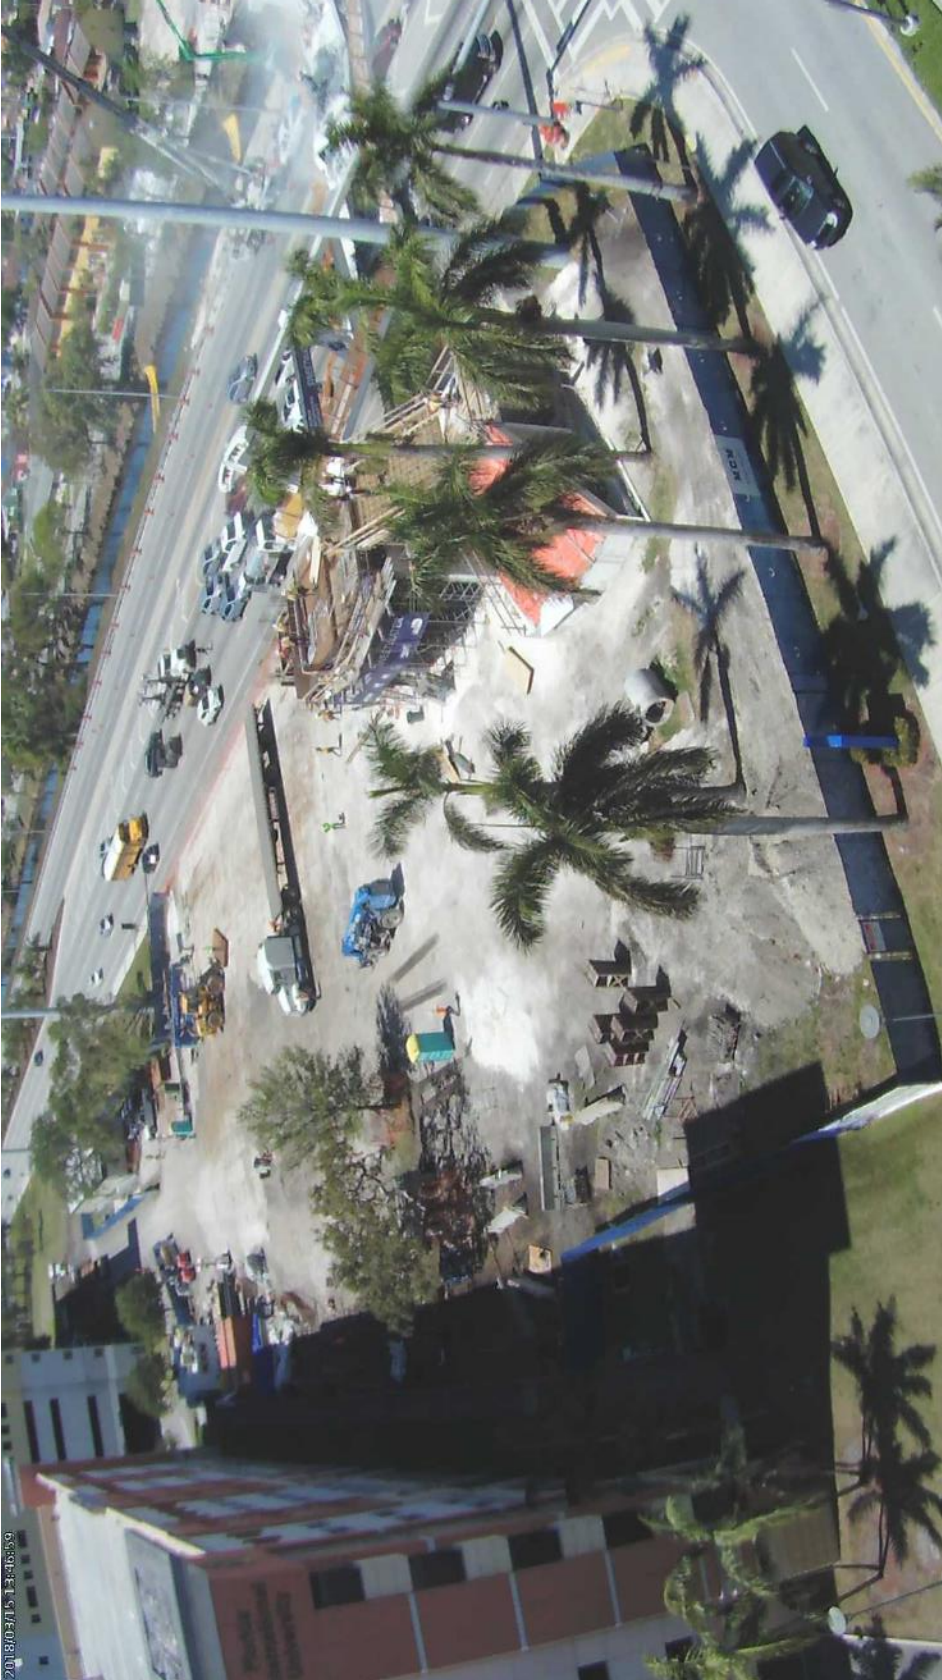
Figure 47 Bridge immediately after the collapse, March 15, 2018 – camera #1

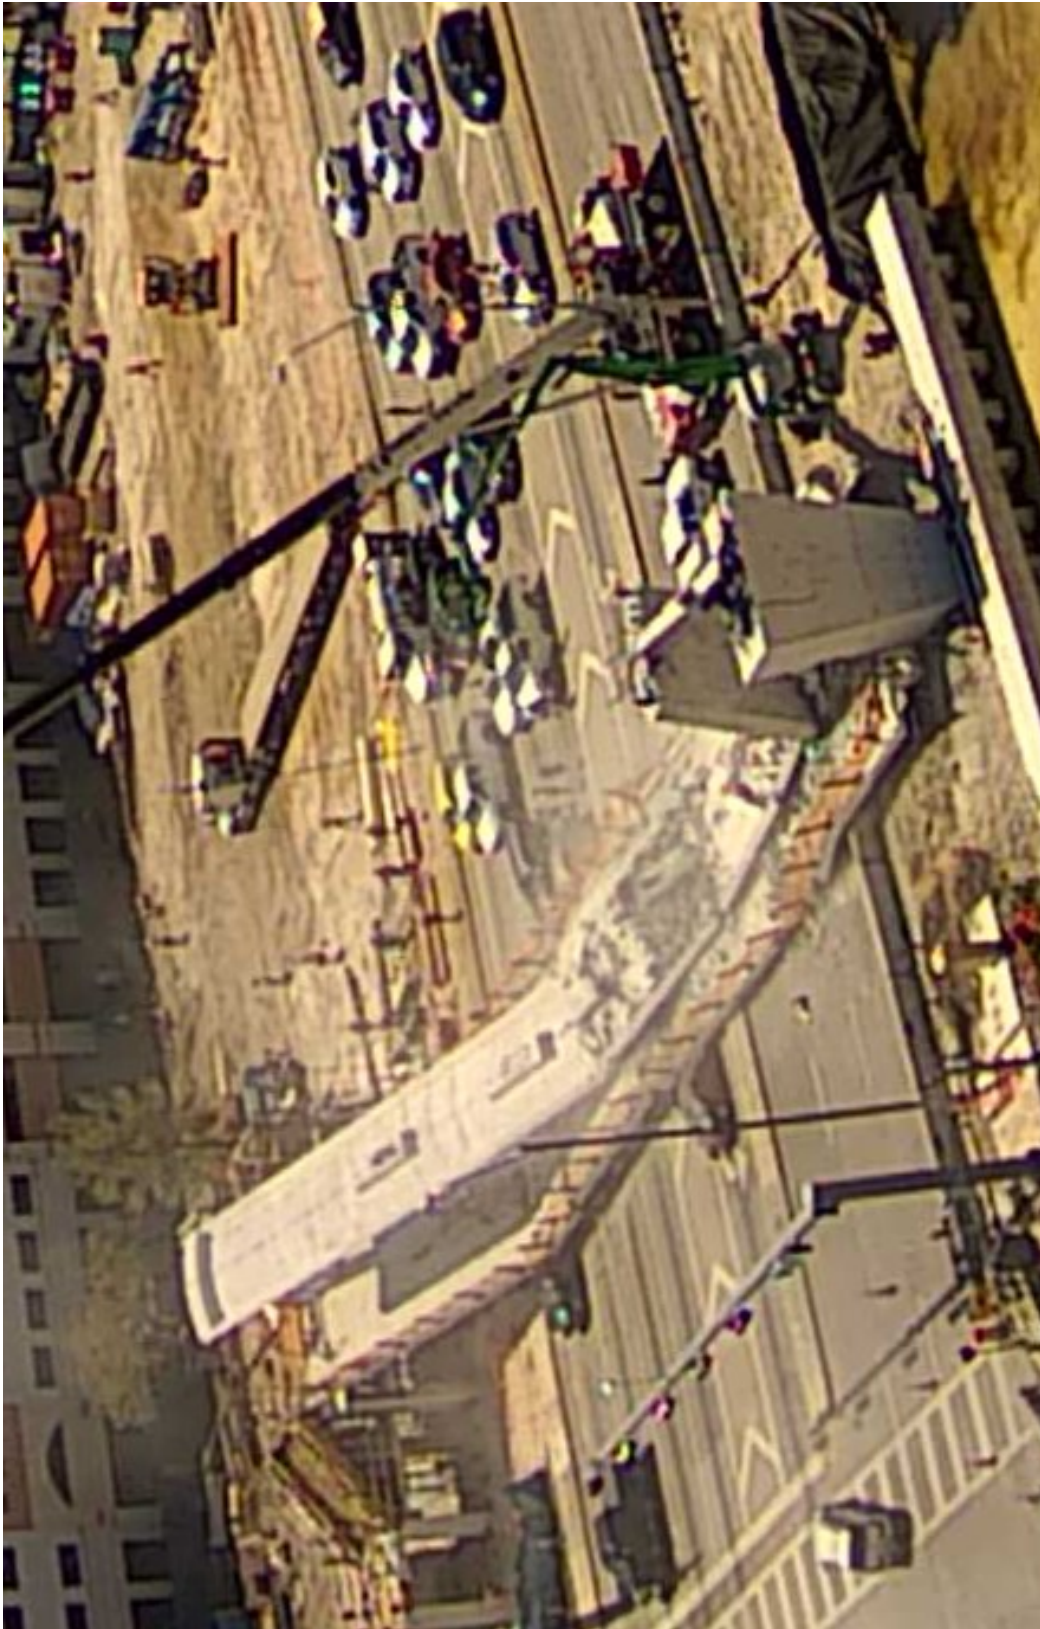
Figure 49 Bridge immediately after the collapse, March 15, 2018 – camera #2  
Employees engaged in re-tensioning the PT bars in diagonal 11

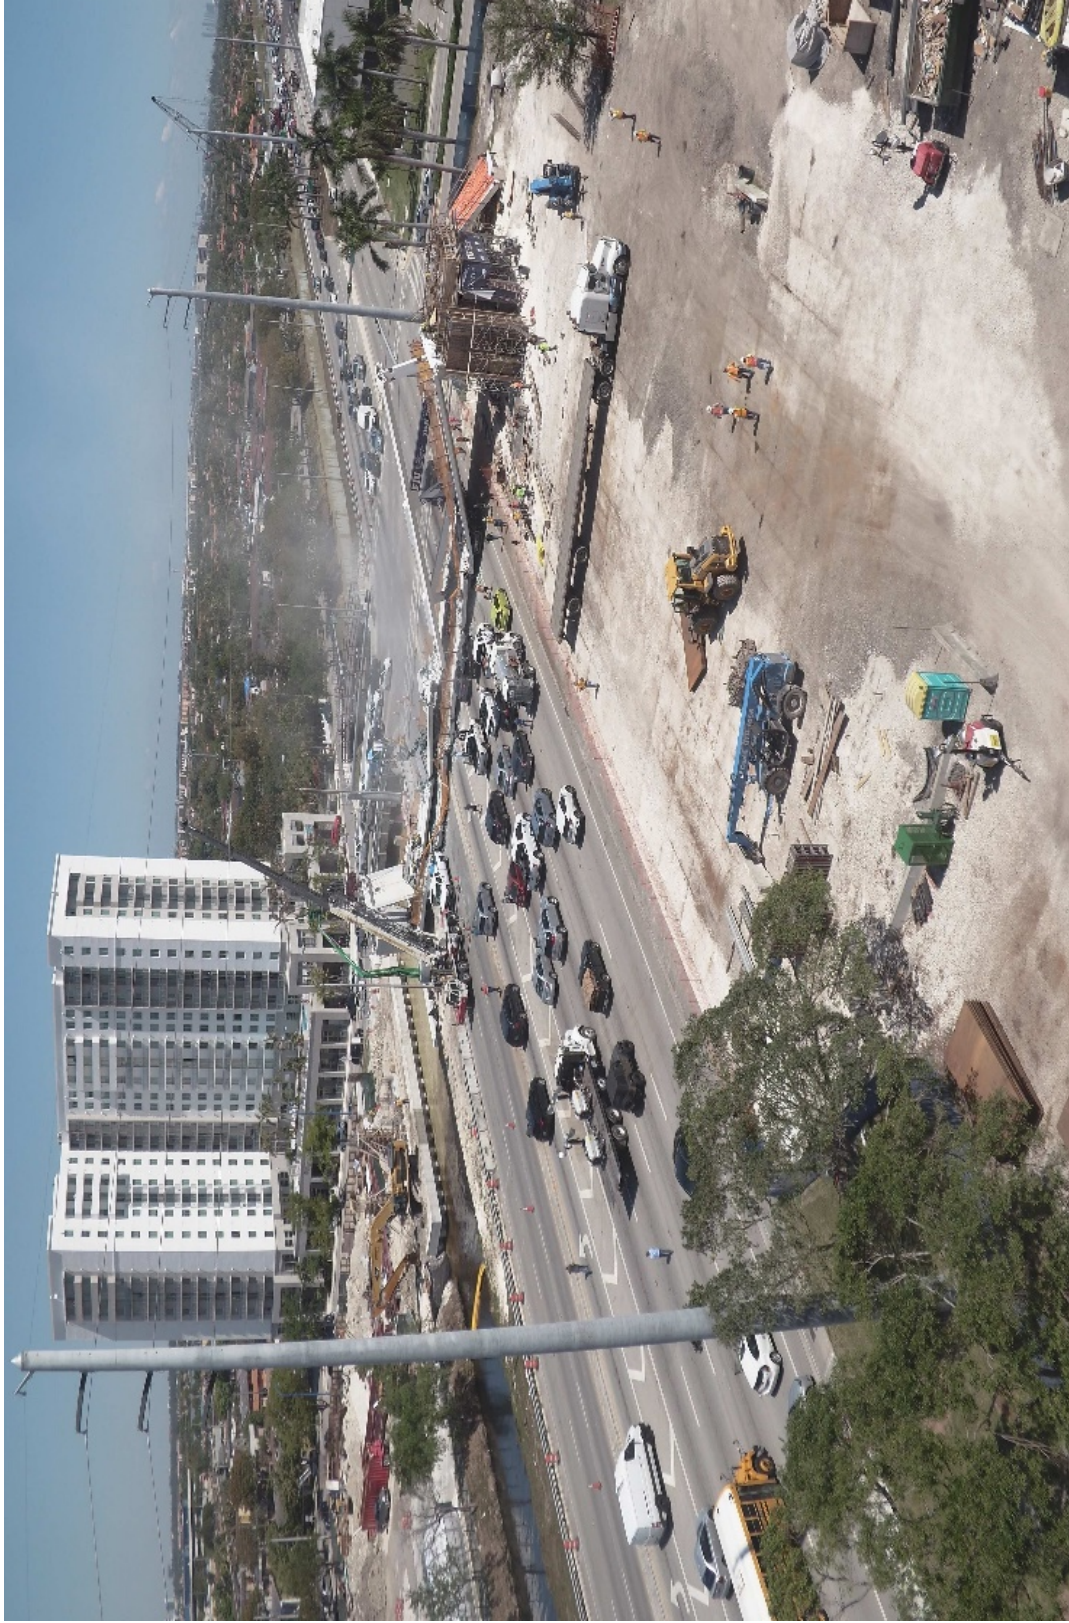
Figure 51 Bridge immediately after the collapse, March 15, 2018 – camera #3  
(north on the left and south on the right)

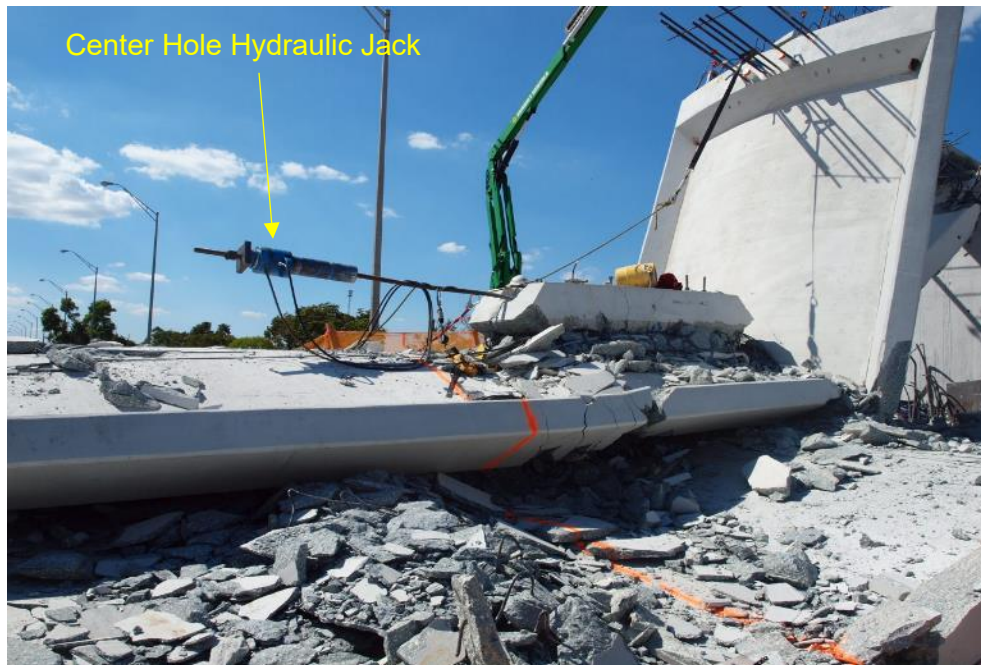
Figure 53 Northernmost blister and hydraulic jack attached to the lower PT bar of diagonal 11 after bridge collapse – side view, March 17, 2018 by OSHA

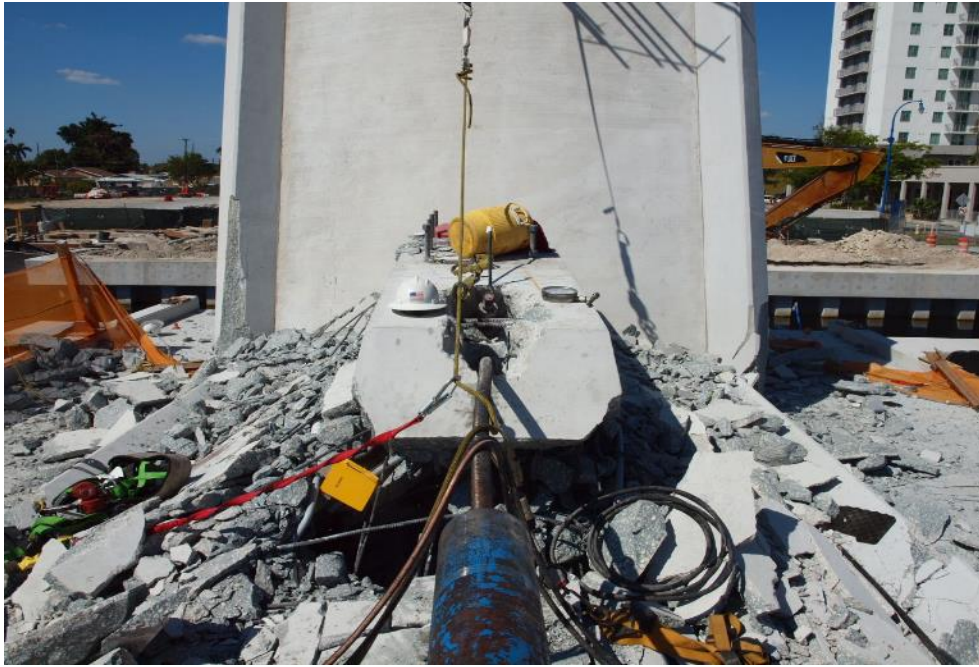
Figure 54 Northernmost blister and hydraulic jack attached to the lower PT bar of diagonal 11 after bridge collapse – front view, March 17, 2018 by OSHA

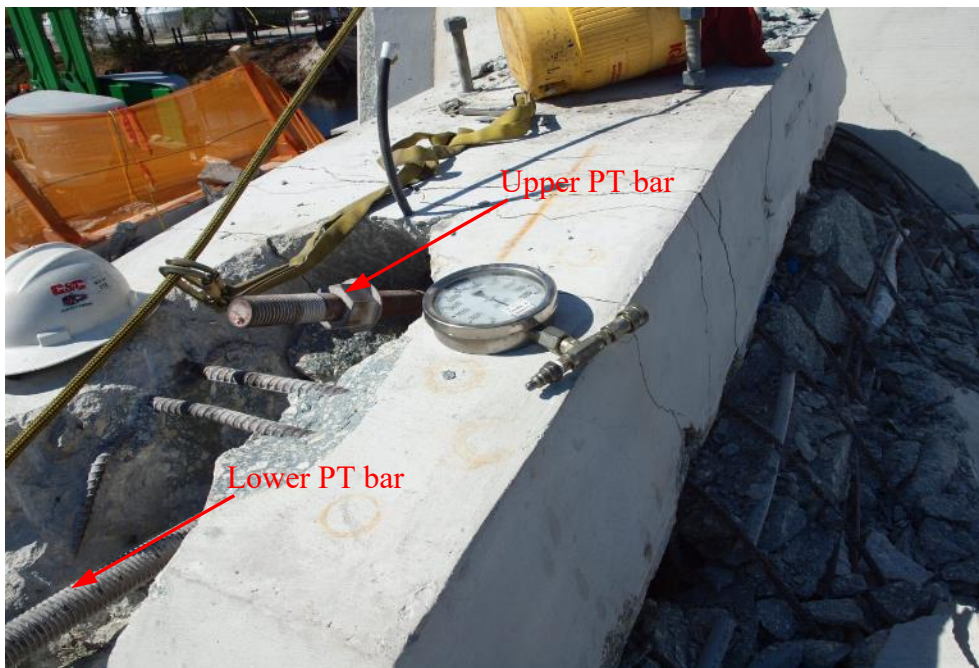
Figure 55 Northernmost blister and pressure gauge, March 17, 2018 by OSHA

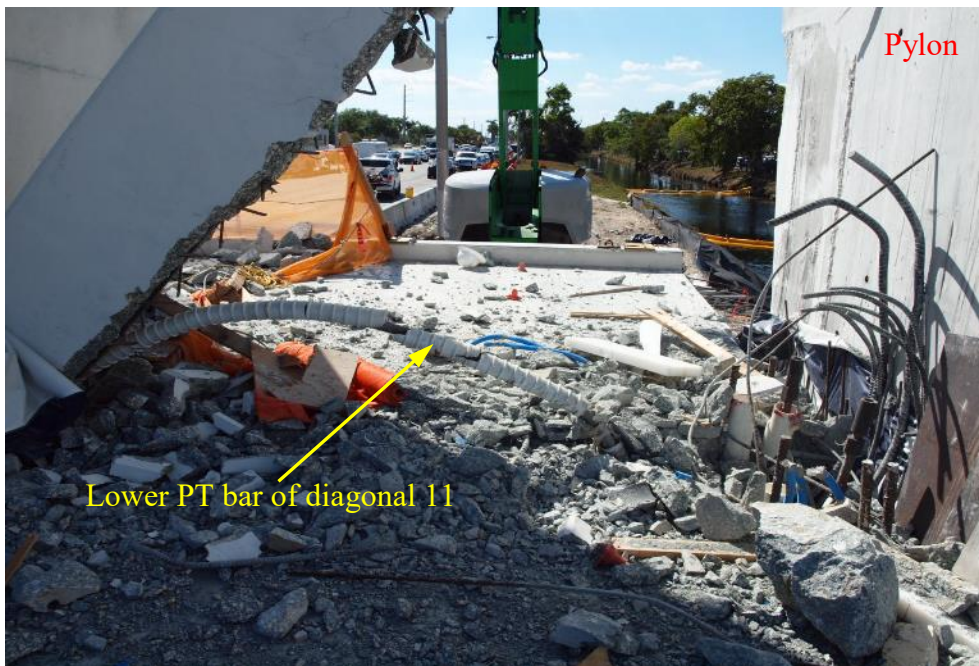
perilously attached to the bottom of the column 12 over the pylon with some rebar, and the other end remained connected to the canopy as shown in Figure 52. As a result of the blow-out, the lower end of the upper PT bar separated from the diaphragm II and rested on the top of the pylon. The lower PT bar of diagonal 11 peeled off from diagonal 11 but remained embedded in the diaphragm. The top ends of the upper and lower PT bars in diagonal 11 remained in the blister. The upper PT bar lost its tension completely and so did the lower PT bar which still carried the Jack used to re-tension the PT bars. The deck laid down approximately 140 feet flat on the ground covering all the four east bound lanes, and three west bound lanes, as shown in Figure 51. The south end of the deck and column 1 were still precariously on the top of the south pier, see Figure 52. The column 1 tilted approximately 15 degrees towards the north with canopy firmly attached. All diagonals other than diagonals 2, 3 and 4 were crushed. The canopy laid flat approximately 80 ft. over the fallen deck. Two blisters on the south side remained intact with the canopy but the rest of the blisters were badly damaged. The blisters at the junction of diagonal 11 and 10 were damaged with the bottom PT bar extending beyond the blister with the ram still attached to the PT bar. As a result of the blow-out, three #7 shear reinforcements at the construction joint of diagonal 11 and the deck were sheared but the southernmost shear reinforcement remained intact. The width of the blow-out was 2 ft. at the southern end gradually enlarging towards the north. The blow-out encompassed the two 4" pipes on either side of column 12, and was symmetrical to the center line of the deck.

Figure 57 Lower PT separated from the diagonal 11 still embedded in diaphragm after bridge collapse, March 17, 2018 by OSHA

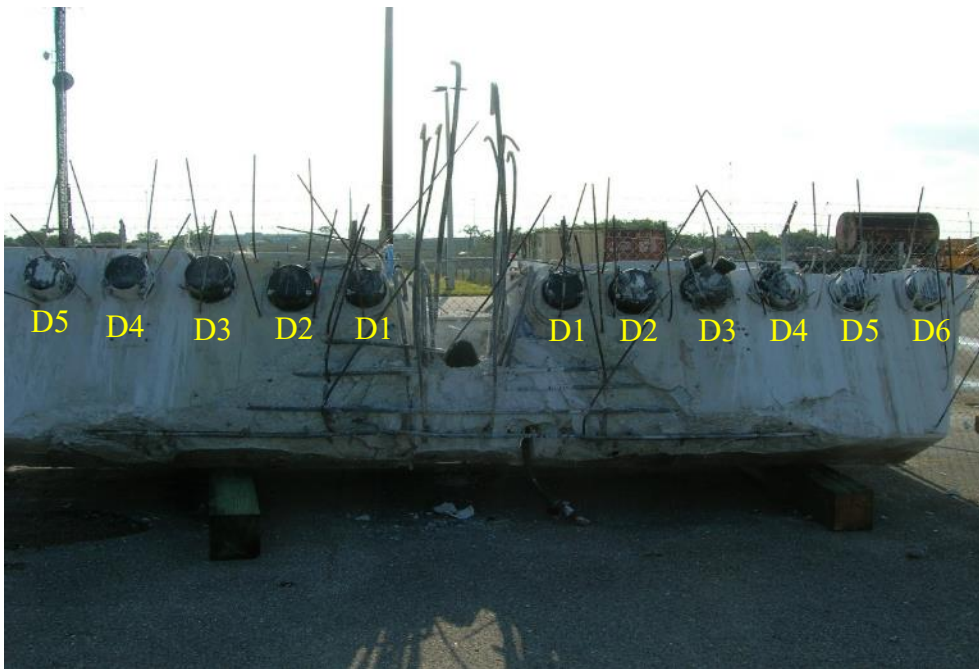
Figure 61 Remnants of diaphragm II at the time of the bridge collapse in the storage yard – looking north from south, April 9, 2018, by OSHA

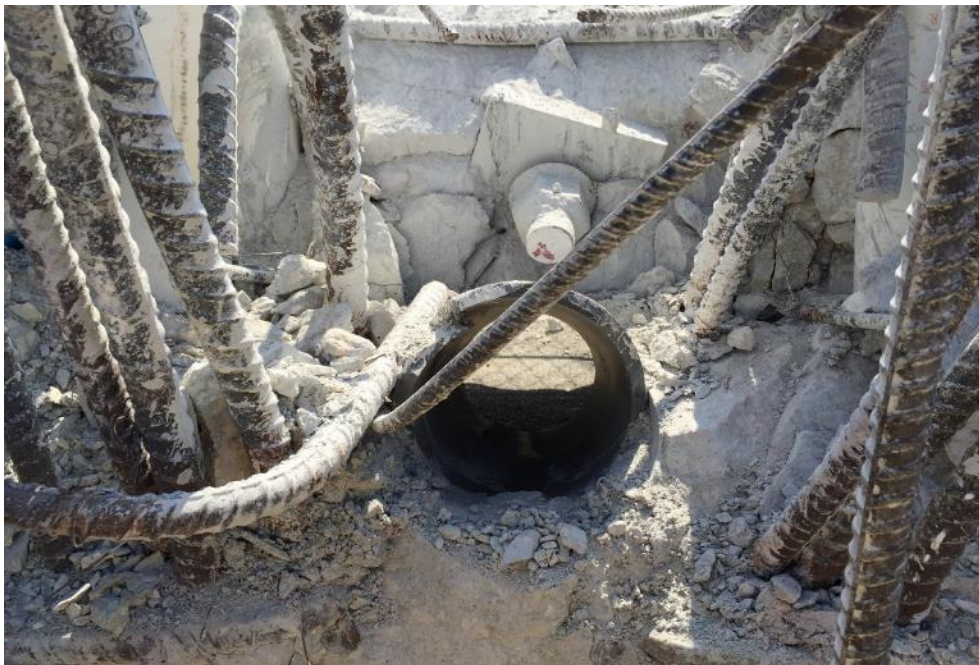
Diaphragm II experienced a blow-out of concrete at the junction of diagonal 11 and column 12 creating a hole shown below in Figure 58 through Figure 70. As a result, column 12 lost support over the pylon and failed with the top tilting approximately 80 degrees towards the south, as shown in Figure 52. The base of column 12 shifted a few feet towards the north but remained on the top of the pylon. Thereafter, collapse of the canopy, diagonal 11 and the deck followed. The canopy partially remained attached to column 12. The remaining diaphragm II and the deck fell approximately 18 ft. to the ground below, see Figure 52. One end of the diagonal 11 remained

Figure 67 Punched hole in Diaphragm II at the time of the bridge collapse – from south looking towards north, April 9, 2018, by OSHA

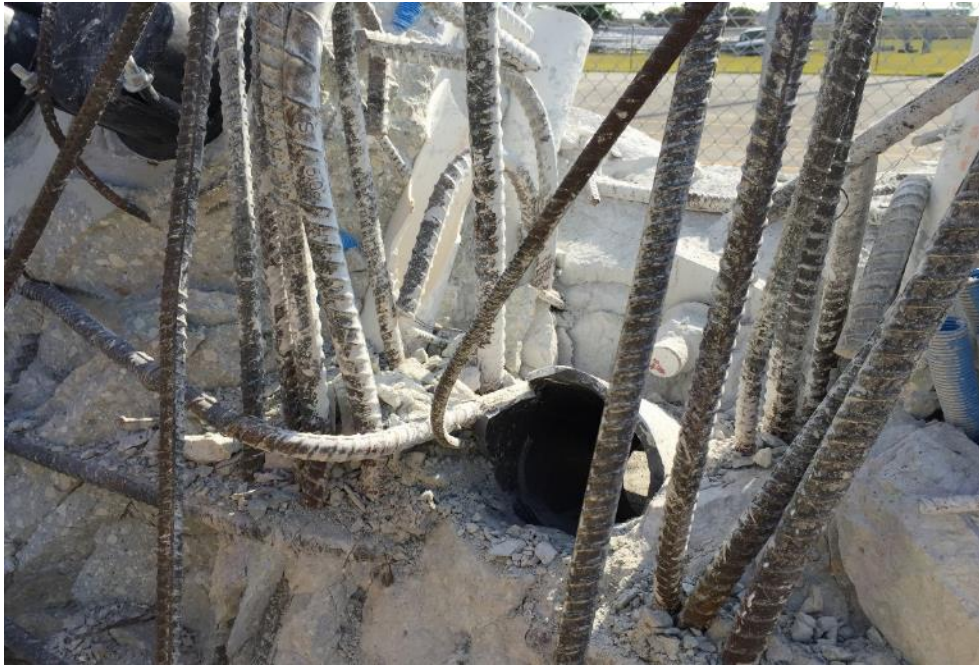
Figure 70 Punched hole in Diaphragm II at the time of the bridge collapse – from south looking towards north, April 9, 2018, by OSHA

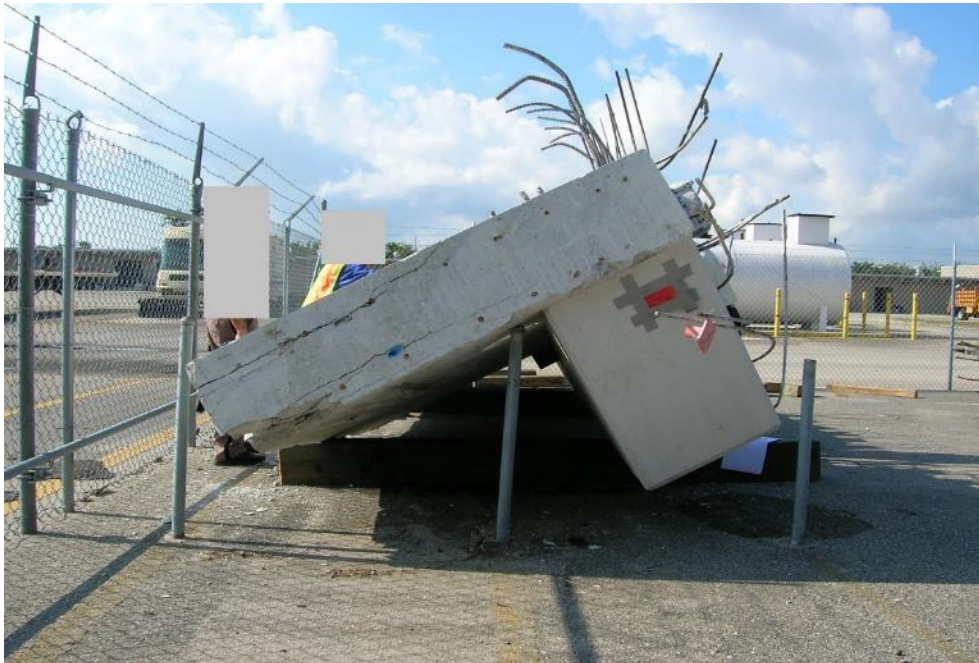
Figure 71 Side view of the saved portion of the diaphragm II in storage yard, April 9, 2018, by OSHA

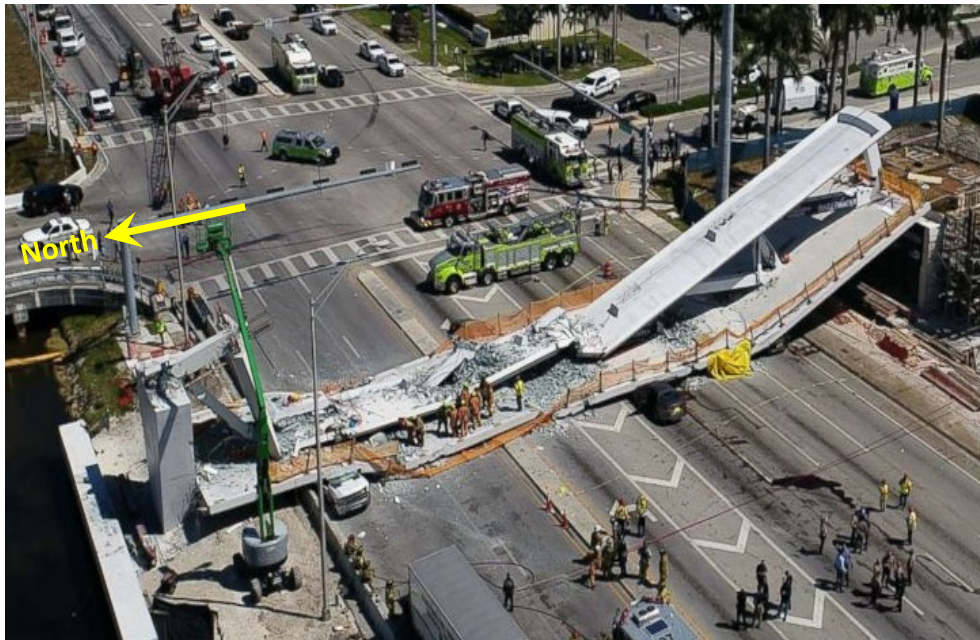
Figure 72 Aerial view of the collapsed bridge, March 15~18, 2018

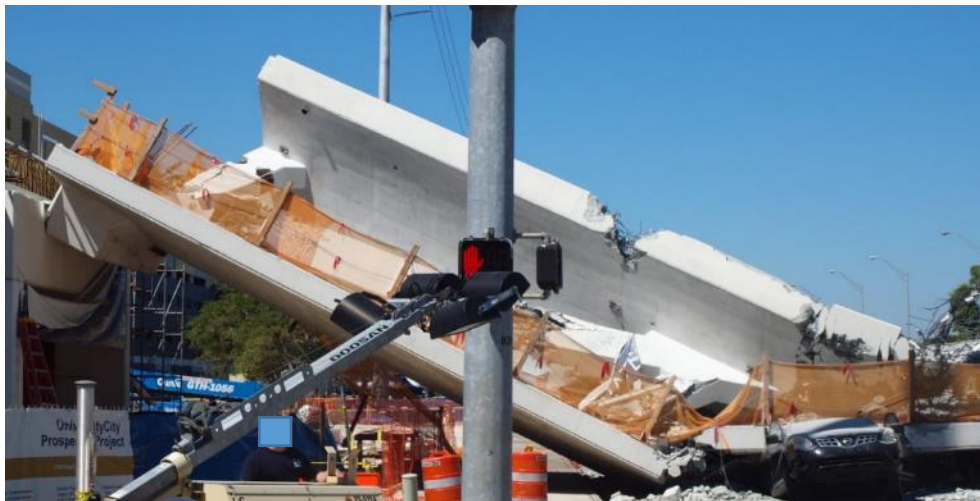
Figure 73 South end of the bridge after collapse – looking west

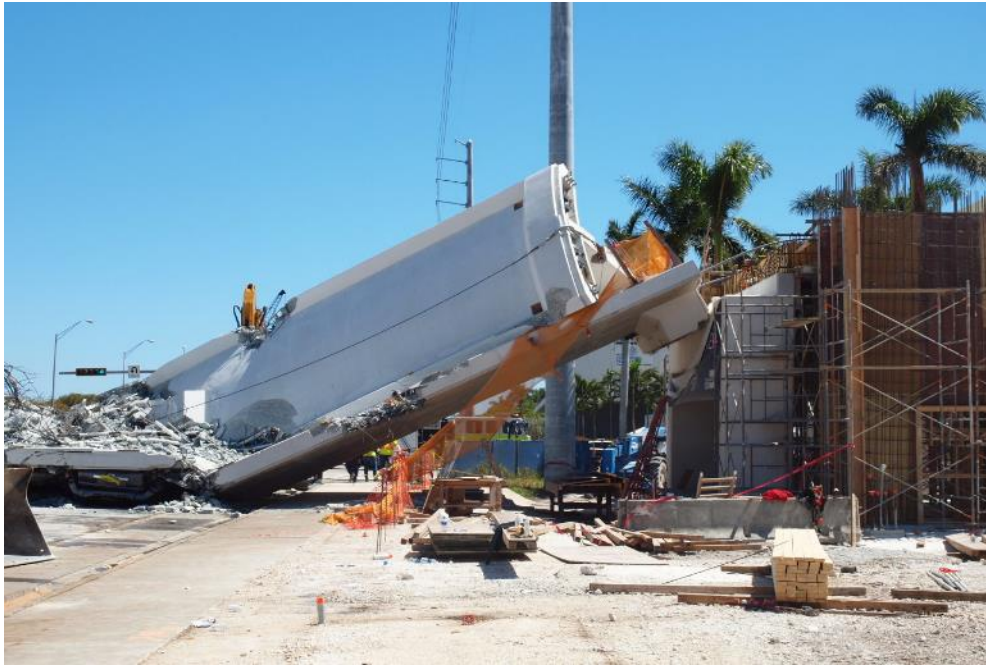
Figure 74 South end of the bridge after collapse – looking east

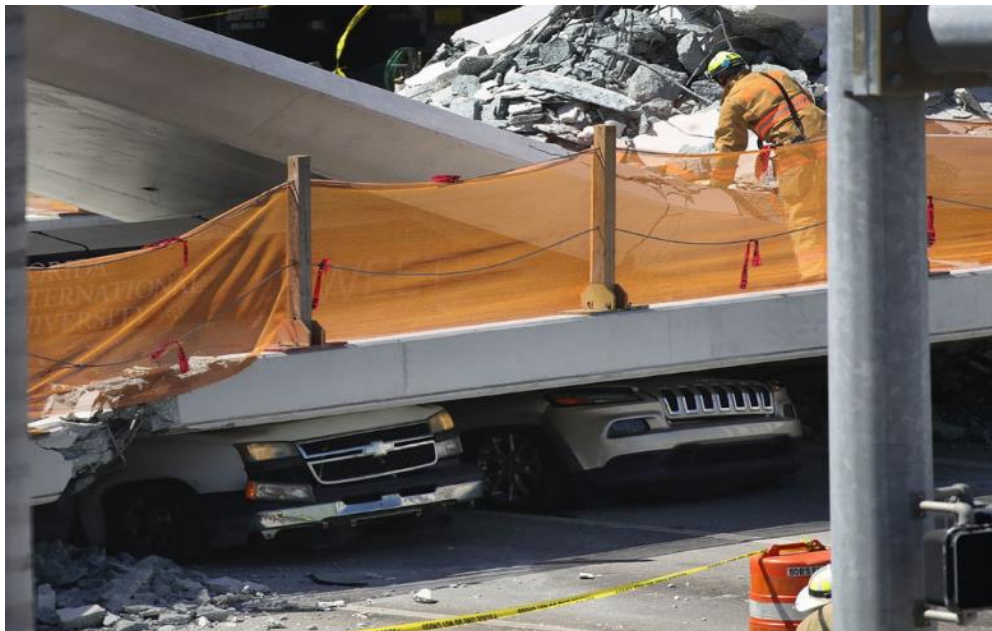
The collapse crushed five motorists in their cars that were stopped at the traffic light at the time of the collapse, see Figure 75. As stated earlier, one VSL employee was fatally injured and another VSL employee was critically injured.

Figure 75 Vehicles crushed by falling bridge

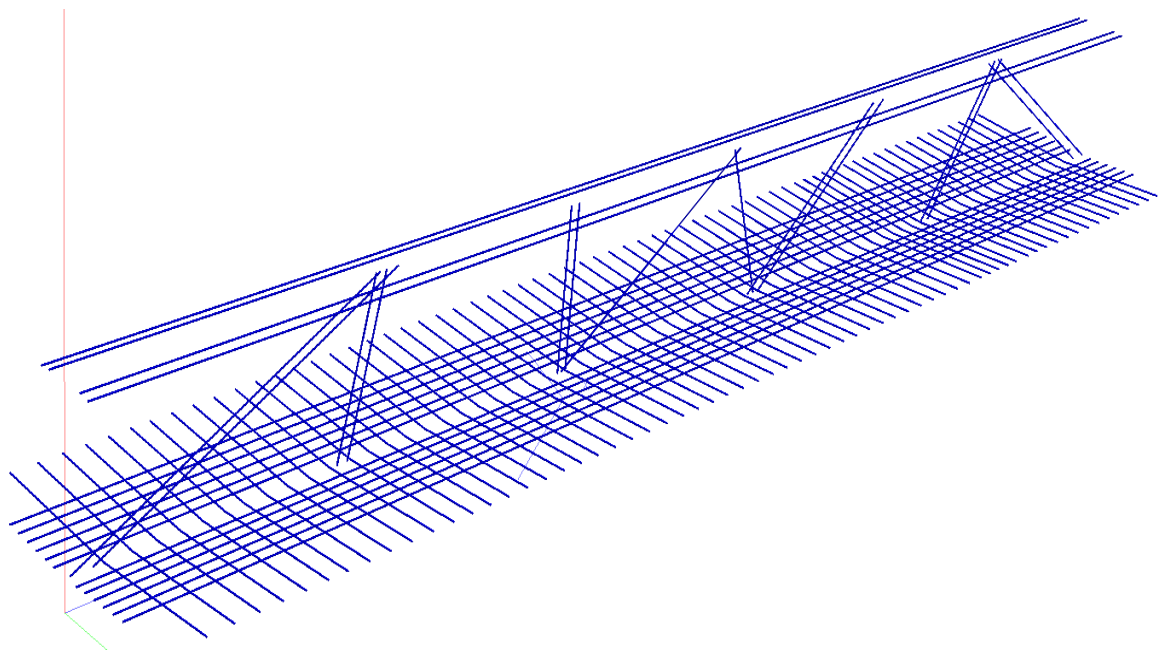
Figure 76 Overview of the main span truss system model

Three-dimensional (3D) finite element models of the main span truss system of the bridge were created in STAAD.Pro, as shown in Figure 76. All concrete components, including the canopy, the vertical and diagonal truss members (members 1 to 12), the deck, and deck diaphragms I and II, were modeled using 3D plate elements. All the steel post-tensioning tendons were modeled using truss elements by sharing the nodes with the plate elements. Therefore, the post-tensioning tendons were coupled to the concrete structures.

The plate element in STAAD.Pro is a 3-noded (triangular) or a 4-noded (quadrilateral) element to which thickness was assigned as a property. The plate element had both attribute membrane (in-plane effect) and bending (out-of-plane effect). To check whether the plate element in STAAD.Pro was valid to model 3D frame systems, verification studies had been carried out before the main span truss system was modeled using the plate elements in STAAD.Pro. Structural models of the bridge main span are shown in Figure 76.
